ANALYTICAL INVESTIGATION OF DETERIORATION ASPECTS IN THE MIHRAB OF MADRASA GAWHARIYYA OF AL-AZHAR MOSQUE, EGYPT

Ali, M. & Omar, Sh.^(*)

EJARS – Vol. 11 (1) – June. 2021: 9-17

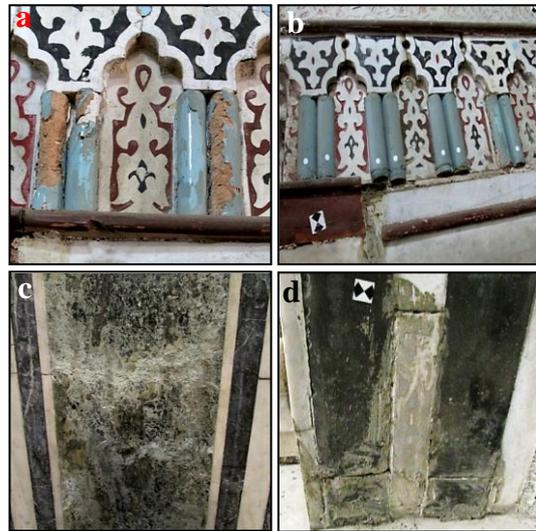
from the previous restoration done wrongly for this mihrab, using materials and methods that increased damage, such as complete missing parts of marble by Portland cement, gypsum. Moreover, the ceramic units were replaced by other wooden ones. The surface of the ceramic units was painted with blue oxide colors. Concerning the mihrab wooden frame, there are missing parts and others painted by Duco, using wax to complement some marble decorations? Moreover, the surface of the marble units was consolidated using Paraloid B72 but in a very high concentration, resulting in a dark thick layer on the surface, fig. (2). The groundwater and salt weathering, which have caused the loss of some parts of the marble surface, depositing thick layers of salt, and soluble salts are considered one of the most important causes of decay. Salts cause damage by the growth of salt crystals within the pores, which can generate enough stress to overcome the tensile strength of the material and turn it into powder [9]. For instance, when the mortar turned into powder (fixing the marble units), some marble units were separated. These soluble salts are very harmful to building materials as they can exist in different states of hydration. The crystallization of these salts within the pores takes place if the saline solution is between the state of saturation and supersaturation. Salts, such as sodium chloride and calcium sulfates (CaSO_4 and $\text{CaSO}_4 \cdot 2\text{H}_2\text{O}$) cause serious damage to building material because the change from one hydrated phase to another is commonly associated with a volume change, which, in turn, gives rise to forces on the walls of the individual pores [10]. Salt damage, in literature also known as salt attack, salt crystallization, or salt decay, can exhibit itself by efflorescence, contour scaling, and granular disintegration (powdering or sanding). During salt crystal growth, high stress can arise even in large pores. The crystallization stress is higher in materials with small pores [11]. This weathering process, besides providing a loss of aesthetical effects, due to the surface

Figure (2) Shows deterioration phenomena of the mihrab **a**, breakdown of some ceramic units as peeling of the glaze layer, **b**, replacing the ceramic units with other wooden units, **c**, flaking of the marble surface, **d**, the use of cement in fixing some marble units and surface deformation

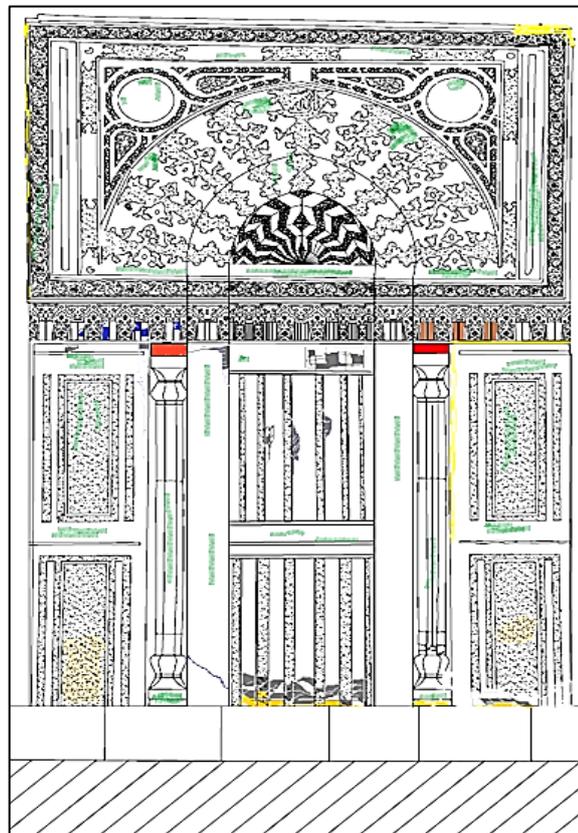
The documentation results using AutoCAD program showed that there are some deterioration features affected the mihrab, fig. (3).

■	Flaking of ceramic units
■	Flaking of wooden frame
■	Replacing ceramic with wood
■	Modern cement mortar
■	Flaking and surface loss
■	Painted wood by Duco
■	Mortar damage and crumble
■	Dirt and plankton surface

Figure (3) Shows geometric documentation of the deterioration aspects of the mihrab

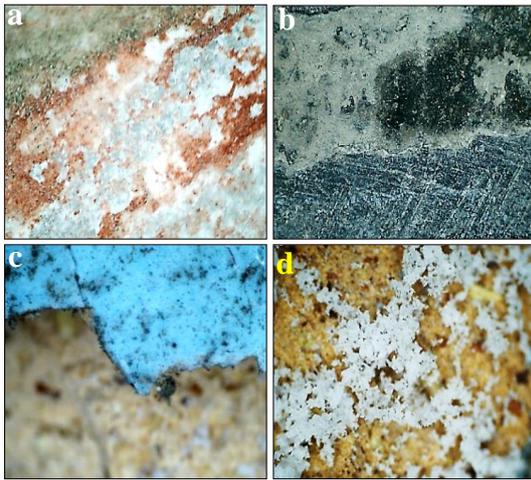
For the marble units, we found dirt and dust in the decorations of the white marble, fig. (4-a). There were also complete black

and red marble units by wax, figs. (4-b), as well as micro-cracks in the marble surface, fig. (4-e). Micro-cracks, a flake of the glaze layer, fig. (4-c), and salt crystals were on the body of the ceramic, in addition to the presence of color stains, fig. (4-d).

Figure (4) Shows USB digital microscope images of the top of the mihrab, **a**, dirt and dust in white and red marble units, **b**, complete the black marble by wax, **c**, micro-cracks and flake of the glaze layer of ceramic units, **d**, salts crystals and color stains on the ceramic body,

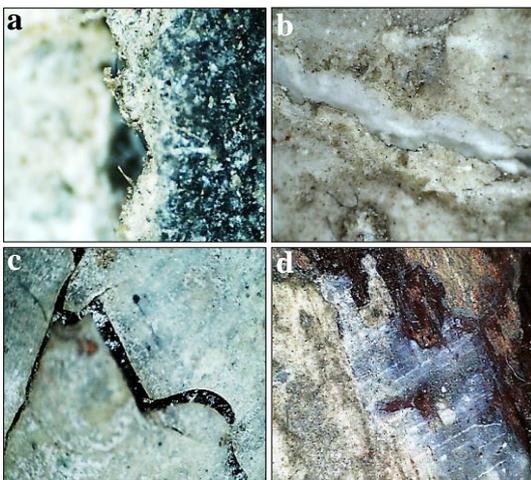
In the lower part, the investigation reveals some deterioration forms due to previous restoration processes as; crusts at the marble surface, fig. (5-a). Dust and cracks in the white marble units, fig. (5-b). Salt layers were also found in many places both in the surface and under the surface, in addition to surface flaking, fig. (5-c). Wax stains attributed to completion of marble, fig. (5-d).

Figure (5) Shows USB digital microscope images deterioration aspects in the lower part of the mihrab, **a**, crusts at marble surface, **b**, dust and cracks in white marble units, **c**, salts under the surface layers of marble and flecking surface layer, **d**, wax used in the completion.

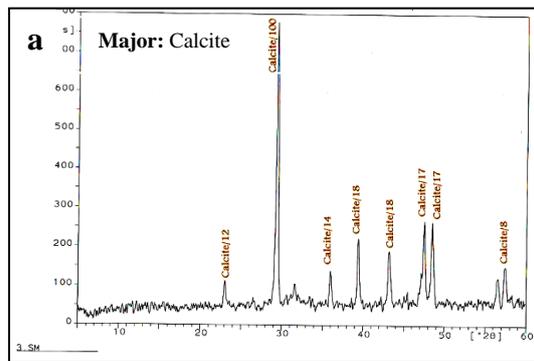
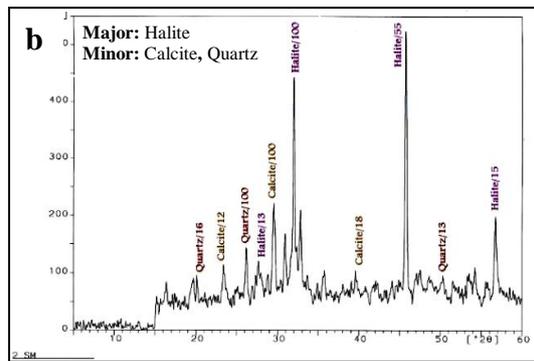
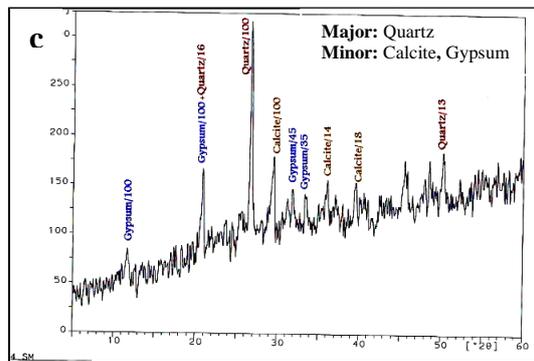
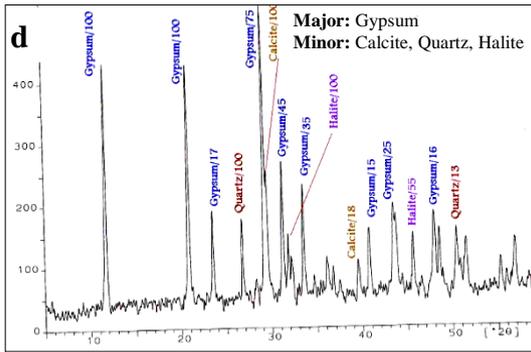
XRD obtained results the samples show that the marble units consist of calcite (CaCO_3) only as a major component, fig. (6-a). The XRD results of the salt sample from the bottom of the right column of the mihrab show that it consists of halite (NaCl) as a major component and calcite (CaCO_3), quartz (SiO_2) as minor ones, fig. (6-b). Also, the XRD data of the completion mortar used in a previous restoration on the top of the left column of the mihrab shows that the sample consists of quartz (SiO_2) as a major component and calcite, gypsum ($\text{CaSO}_4 \cdot 2\text{H}_2\text{O}$), fig. (6-c). The result XRD from the sample of the mortar used to complement marble reveals that the main minerals are gypsum, calcite, quartz, and halite, fig. (6-d).

Figure (6) Shows XRD pattern, **a.** marble sample, **b.** salt sample from the bottom of the right column of the mihrab **c.** sample of the completion mortar used in a previous restoration on the top of the left column of the mihrab, **d.** sample of the mortar used to complement marble.

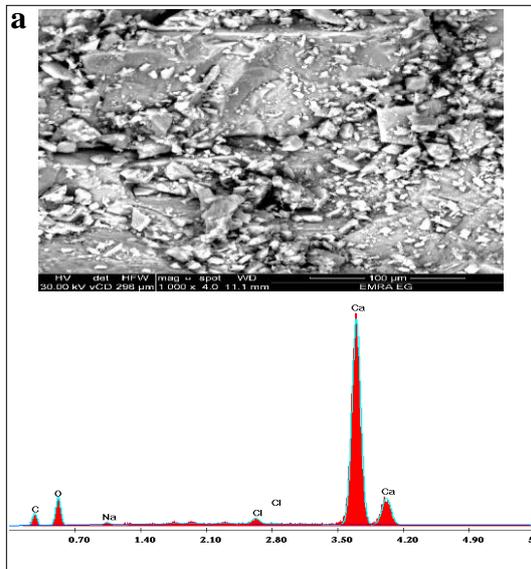
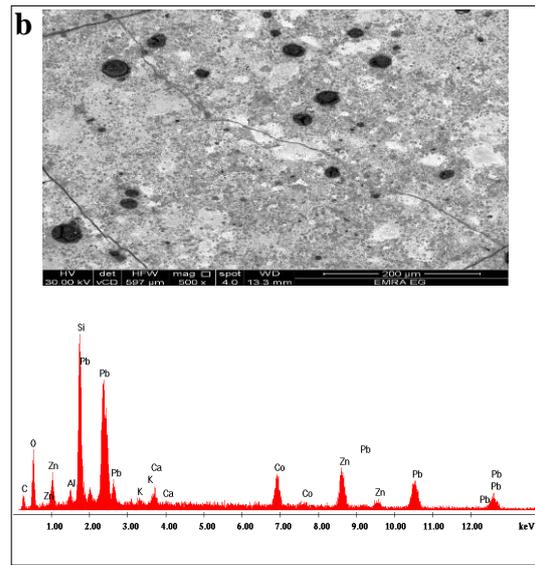
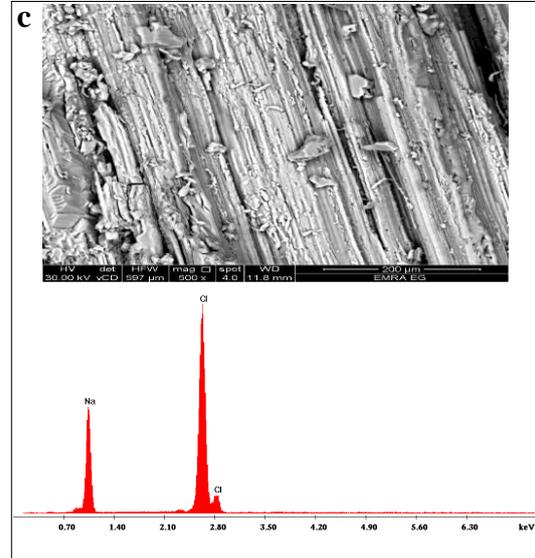
The examination of the samples of marble and salts by SEM shows that salt crystals grew between calcite crystals. As for the result of analysis by EDX of a sample of the marble, fig. (7-a) exhibits (Ca) as the main element, while (Na, Cl) are presented in low percentages. The SEM of the glaze layer shows that micro-cracks and black points spread on the surface, indicating lead oxide. The EDX of the glaze layer, fig. (7-b) shows that (Si and pb) are the main elements, whereas (Al, K, Ca, Co, and Zn) exist but in different percentages. The SEM of the salt sample shows halite crystals. The EDX analysis of the same sample, fig. (7-c) shows (Na, Cl) as a good indication of the salt of sodium chloride.

Figure (7) Shows investigated samples by (SEM-EDX), **a.** micrograph of calcite crystals and salt crystals (1000×), and EDX spectrum of marble, **b.** SEM micrograph of micro-cracks in the glaze layer, with the appearance of lead element (500×), and EDX spectrum of the same layer, **c.** SEM micrograph of sodium chloride (halite) (500×), and EDX spectrum of the sample of the salt from the mihrab

layer sample taken from surface ceramic units showed the degrading effect of the glaze, especially in outer ceramic surface. Moreover, micro-cracks appeared in the glaze layer with lead were [19]. The elemental analysis of the blue glaze layer by EDX showed that the glazing type was (lead glazing) [20] due to the lead pb percentage (36.20%), in addition to the silica Si (21.32%) as the basis for the glazing [21], and alumina Al (1.15%) as a part of the basic composition of the glazed layer. A percentage of calcium Ca (2.70%) appeared because it was used to obtain the glossiness of the glaze layer. It is considered one of the most important materials for flux at high temperatures [22]. Furthermore, the percentage of zinc Zn (3.30%) gave a bright to the glaze. As for the blue color, it is a result of the use of cobalt oxide due to the appearance of the cobalt element Co (8.01%) [23], which is one of the well-known colors used to obtain the blue color. It was used extensively in the Islamic period.
