A LABORATORY STUDY FOR THE CHARACTERIZATION AND
TREATMENT OF AN ARCHAEOLOGICAL RIFLE FROM DHAMAR MUSEUM,
YEMEN

Ali, N. & Megahed, M.

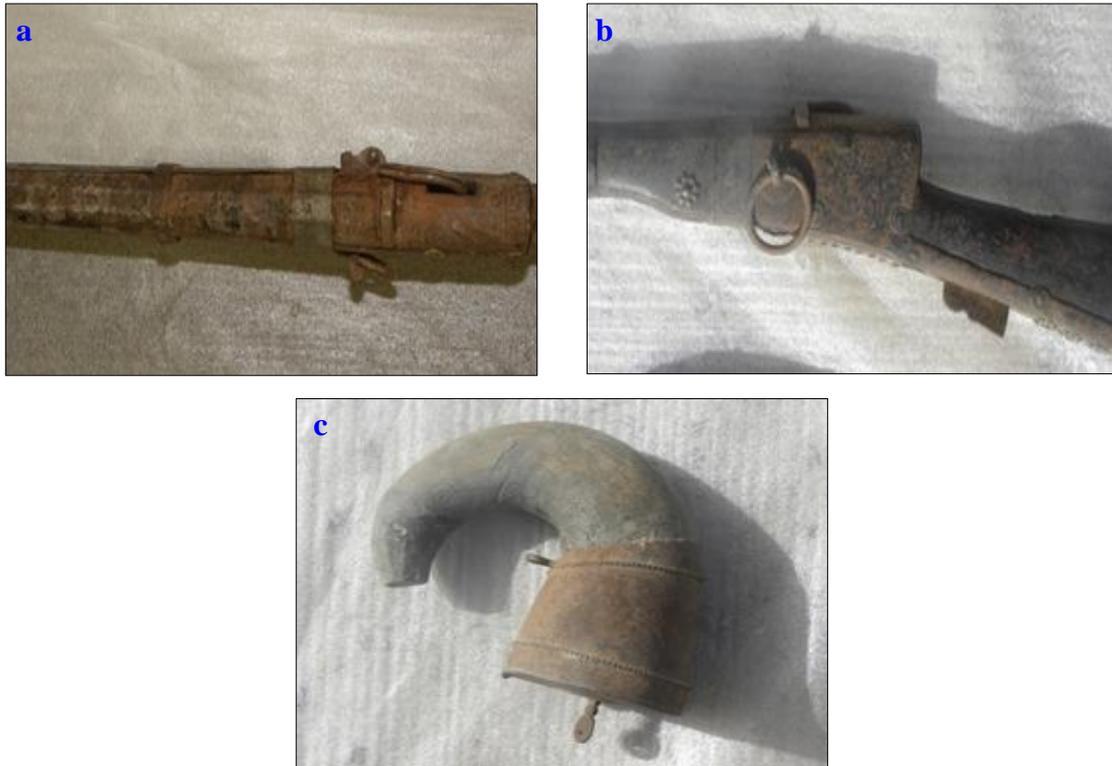
It is a rifle that belongs to the Ottoman period in the collections of Dhamar Museum, Yemen. It is made of iron and wood, and there are 8 rings of copper strips, connecting the iron parts with wood. It is 148 cm long, with a muzzle diameter of 1.2 cm. Its back part is rectangular of 14×6 cm. The rifle shows many manifestations of deterioration such as corrosion of the iron parts and dirt and micro-cracks on the wooden

part. The second object is the ammunition pouch, which is a big, hollow, made of an animal horn, with a cover made of iron. Its length is 36 cm, and its diameter sloping from 10 cm at the opening, to 2.5 cm at the end. It suffered from damage, such as corrosion in the iron parts and dirt and discoloration on the wooden parts and the animal horn, fig. (1-a, b, c).

Figure (1) Shows different parts of the rifle before the treatment **a.** the front part, **b.** the back part, **c.** the ammunition pouch

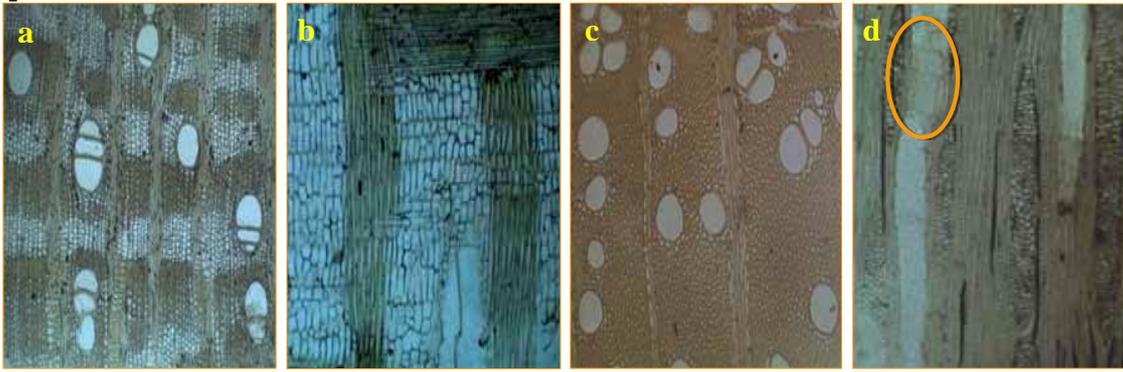
The microscope examination showed that the rifle's wood belonged to two kinds of wood, *the rifle's front parts, Tamarix Tetrandra*, where a cross section of *tamarix* showed ring boundaries growth is distinct by the difference in the vessel size, fig. (2-a, b)[12]. It is an evergreen high shrub that grows in sandy

and salty deserts and wadi [13]. The second kind of wood was *Syacamore Ficus* was at the back of the rifle. The cross section showed that growth rings were absent and vessels were diffused, with a tangential diameter of 90-240 μm and a radial diameter up to 300 μm , as shown in fig. (2-c, d) [14].

Figure (2) Shows **a.** cross Section of Tamarix, **b.** tangential section of tamarix, **c.** cross Section of Syacamore, **d.** tangential section of Syacamore.

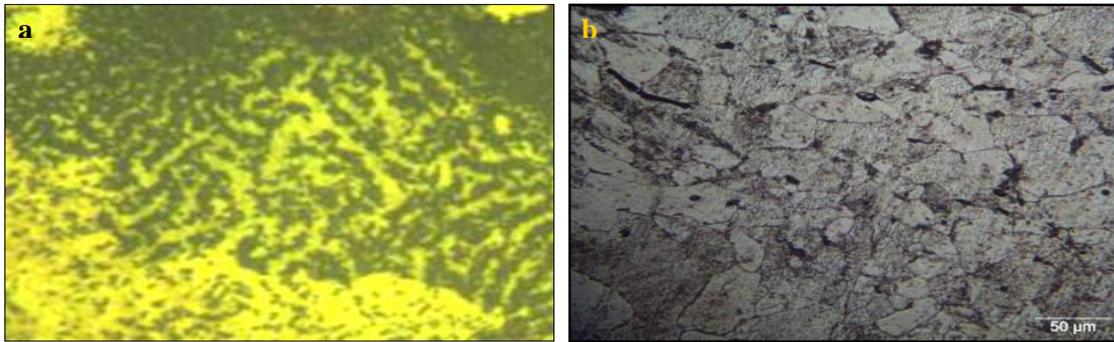
Metallographic examination of the metallic parts of the rifle and the ammunition pouch showed that micro

cracks and pitting corrosion spread on the surface, fig. (3-a, b).

Figure (3) Shows metallographic capture **a.** for the rifle showing the micro structure of the metal on the surface, **b.** for the surface of ammunition pouch showing pitting corrosion and micro cracks dispersed

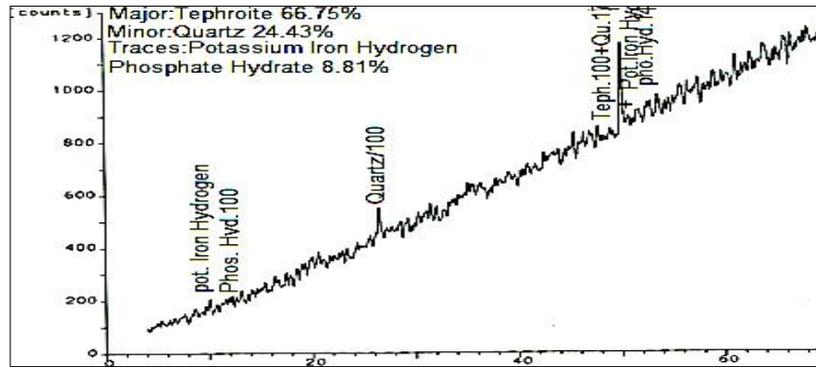
Samples	Major Minerals	Minor Minerals	Trace Minerals
<i>Rifle corrosion</i>	Tephroite [Mn ₂ SiO ₄]	Quartz [SiO ₂]	Potassium Iron Hydgen Phosphate [K Fe H ₁₄ (PO ₄)8.4H ₂ O]

Figure (4) Shows XRD pattern of the corrosion products of the rifle

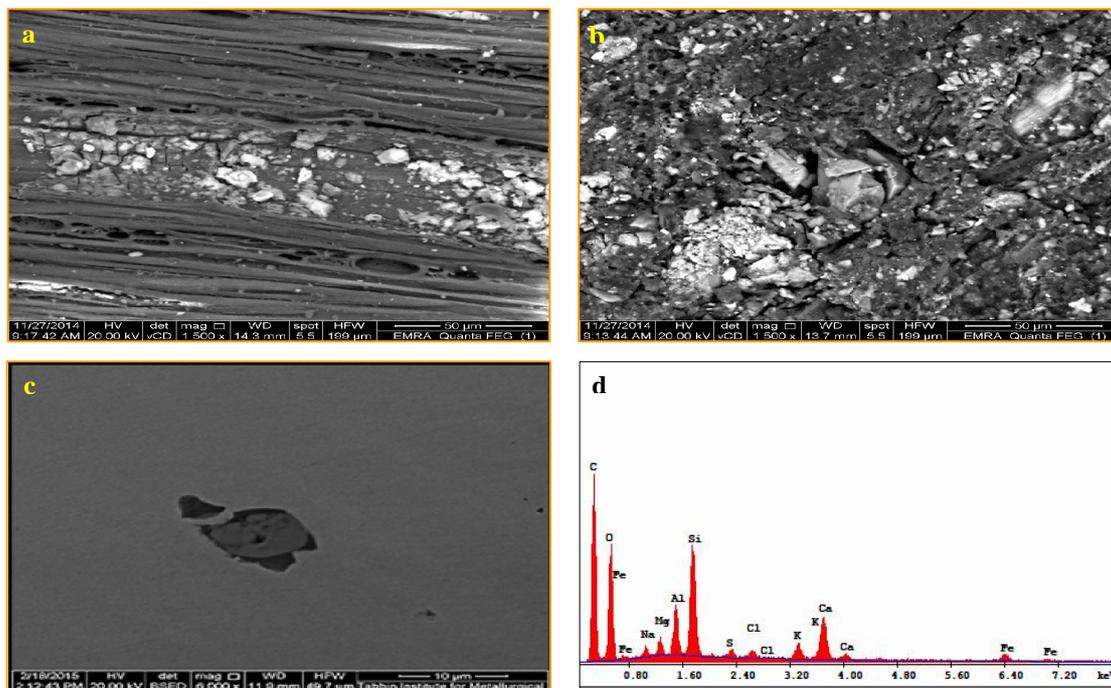
SEM investigations of the wooden part in the Ottoman rifle showed the presence of rust between wooden structures. Where, the rifle's ammunition pouch, (the horn) showed rust between the pouch grains, and the presence of rust was less between wood fibers. In addition, the metal parts showed the microstructure of deterioration spots, all of these features

are shown in fig. (5-a, b, c). EDX analysis proved that the structure of the horn consisted mainly of (C, O, Na, Mg, Fe, Al, S, Si, Cl, and K). Therefore, (Fe and O) were the elements of rust corrosion, (Si, Al, Mg, and K) were the elements of dirt and (Na and Cl) were the elements of Halite salt, fig. (5-d).

Figure (5) Shows SEM photomicrographs of the rifle **a.** the existence of rust between wood fibers X-1500, **b.** the existence of rust between horn grains X-1500, **c.** pitting corrosion and disturbing the of the metal of the ammunition pouch **d.** EDX analysis of the horn structure that consisting of (C, O, Na, Mg, Fe, Al, S, Si, Cl & K)

to protect from other elements. Figure (5-b) showed the microstructure of deterioration spots affected the metal parts through spots. These spots were very tinny because rifle had a good metallic state with some slightly pits in different places. *EDX analysis* showed that the structure of the horn consisted of (C, O, Na, Mg, Fe, Al, S, Si, Cl, and K). Therefore, (Fe and O) were the elements of rust corrosion, (Si, Al, Mg, and K) were the elements of dirt and (Na and Cl) were the elements of Halite. These results mean that there were iron and dust among the grains of the ammunition

pouch. Hence, conservation process of the rifle was conducted. Figure (5-c) of the ammunition pouch, (the horn) showed rust between the pouch grains. The presence of rust was less than those between wood fibers because spaces between horn grains were less than those between wood fibers. So, the percentage of absorbing rust was lower. This rust wrenches the horn surface and plays a role of the accelerated factor to change air pollution gases to diluted acids which destroy horn as an organic material.

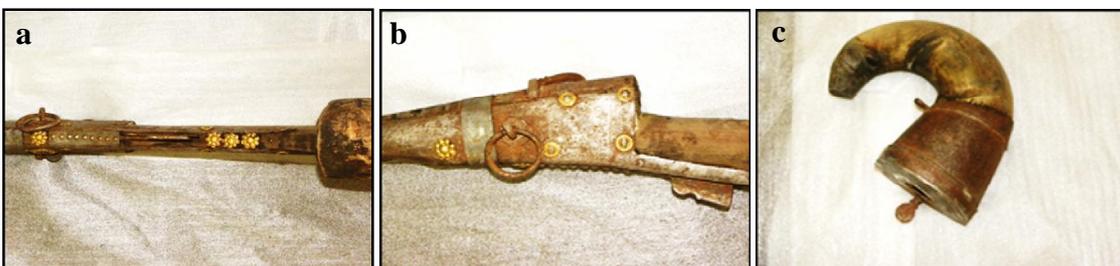
Figure (5) Shows **a.** & **b.** the back part of the rifle, **c.** the ammunition pouch after the treatment after the treatment

nical cleaning was used in a limited area because the rust was a thin layer but it was acceptable after making a test on a replica and in hidden parts with selected solutions. Then, the chemical cleaning was performed on some wooden parts. Here, the rifle and its ammunition pouch were mechanically cleaned, first. Then, the chemical cleaning was performed on some wooden parts that were separated to save them from acids and alkaline solutions. Chemical cleaning of the wood was included using some mixed solution of (1 Alcohol: 1 Toluene) to remove the rest of the rust layer which damaged the surface of wood and horn. Wood and horn consolidation was an important process. Regalorz 1094 was very suitable for brittle wood and horn; this polymer was diluted in toluene of 5 % concentration which was applied with injection technique. The organic parts were left for 48 hours until they were dry in the ambient air. After that, the surface was covered with a thin layer of 2 % Regalorz in Toluene. To clean iron objects, dirt, grease and loose or flaking rust must be removed before applying protective coatings. Such deposits can be removed using chemical or mechanical techniques. Chemical cleaning include using soapy solutions to dissolve grease and remove surface dirt. For example, aqueous alkaline solution (caustic soda) was used to remove grease and paint. Concentrations in the range of 20-40 g. of sodium hydroxide per liter of water are normally used. Corrosion products can be removed using a solution of 50 g. of citric acid in

water. While citric acid is relatively safe on most objects, care should be taken to ensure that cast iron, cast steel or spring steel, or combinations of them are not left unattended for long periods because they will actively corrode. Prolonged gas evolution (which you will be seen as bubbling) indicates that the iron surface is corroding. With harder alloys, this can also cause hydrogen embrittlement in which hydrogen is generated within the metal and the stress of the gas pressure cracks it. Gas evolution can also result in pitted, weakened or destroyed objects. Simple wire brushing can be used. There is doubt regarding the type of iron or the duration of acid treatment, more time should be spent removing corrosion products by mechanical means. Once the worst deposits are removed, short treatment in citric acid should clean the object, with reduced risk of damage. Some forms of corrosion leave spots on the object, which cannot be removed by citric acid and can be mechanically removed. On treating large objects, it is difficult to find large enough containers or tubes to immerse the objects for caustic or citric treatments. If sand blasting is inappropriate, the acid or alkaline stripping solution can be applied to the surface using a bentonite paste or absorbed cotton. Finally, washing the object by deionized water, which should be repeated perfectly to ensure flushing capillaries to remove any chemical residues. Then, soft and clean cloth is used for drying. Coating the rifle and the storage with 3 % solution of Benzotriazole (BTA) soluble in Ethanol, fig. (6-a, b, c).
