## STUDY OF THE PAINTED DOME OF THE CHURCH OF ARCHANGEL GABRIEL, CAIRO

This study was carried out in preparation for the conservation of the oil painted dome of Archangel Gabriel church located at Haret El Saqqayeen in Abdeen (Cairo). Stratigraphic, chemical and environmental studies were conducted to examine the painting technique and to assess the conservation state of the dome. The dome was imaged using Multi-spectral imaging and samples were collected from representative areas. Cross-sections were investigated by the means of scanning electron microscopy coupled with dispersive energy of X-ray spectrometer (SEM-EDS) and stereo microscopy. Fourier transformed infrared spectroscopy (FTIR) and gas chromatography-mass spectroscopy (GC/MS) was employed for the identification of the paint medium. X-ray diffraction (XRD) and the colorimetric measurements were conducted for characterization the differences of hues between the original and non-original pigments. As a part of the study, the environment within the dome was measured with data loggers and gas sampling. The results showed that the painted dome dates back to two different periods. The older paintings were applied before 1907

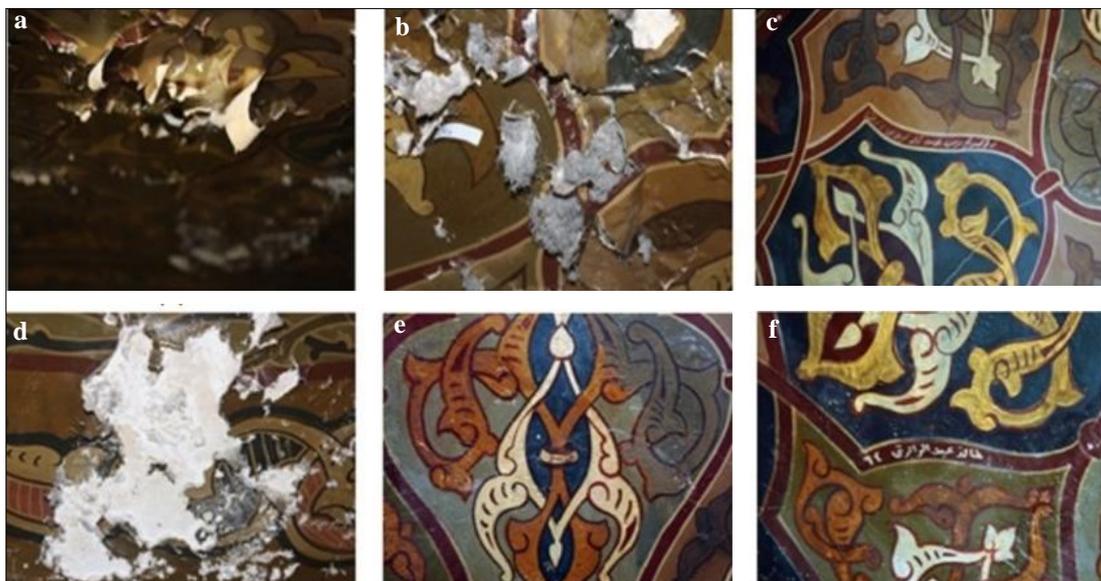
Figure (2) Shows examples of deterioration phenomena of the painted dome **a.** flaking, detachments, **b.** salt weathering, **c.** Conservator's signature, **d.** missing areas, **e.** & **f.** darkening and over-painting

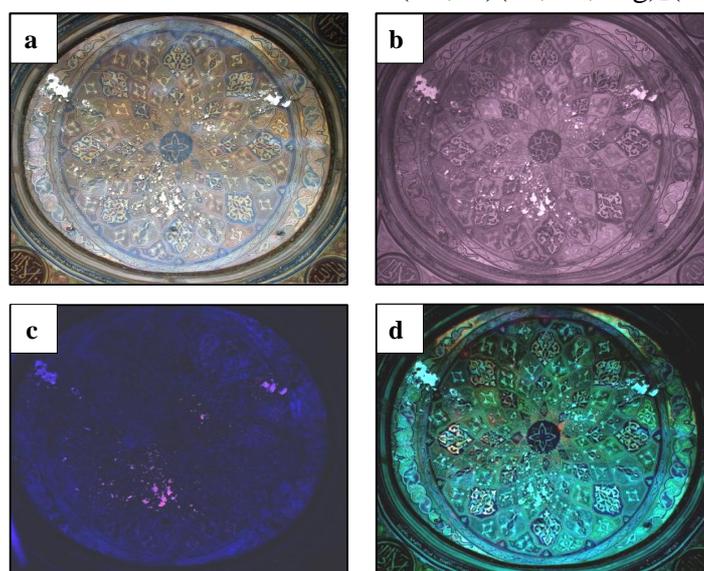
The Ultraviolet fluorescence (UVF) image characterized the signatures of Ismail Mahmoud and Mahmoud Bahgat who are the original painters of the dome with a date of 1907. Infrared reflected (IRR) and UVF images showed that the dome was heavily overpainted during the restoration interventions carried out in 1994. This is evidently detected in darker areas. Since the dome was restored in 1994 after the earthquake of 1992, some of the conservators signed their names with the date of restoration interventions, fig. (3). Colorimetric measurements of the brown over-painted on the original yellow showed a reduction of the luminosity and

yellowness ( $L=33.78$ ;  $a=14.5$ ;  $b=41.8$ ) than the original yellow paint ( $L=40.3$ ;  $a=9.44$ ;  $b=25.29$ ). EDS and XRD analysis showed that Burnt sienna brown pigment was painted over the original yellow ochre. EDS analysis of the dark green pigments (original and overpainting) showed the presence of elements Ba, Na, Fe, Cu, Si, Mg, Al, and Zn. This suggests that the original green earth (Fe, Na, Si, Al, Mg) overpainted by Copper-based pigment (Cu). Furthermore, analysis by XRD indicated that the presence of Malachite [ $\text{CuCO}_3 \cdot 2\text{Cu}(\text{OH})_2$ ] was painted over the original green earth of Glauconite ( $(\text{Na}, \text{K})(\text{Fe}, \text{Al}, \text{Mg})_2(\text{Si}_4\text{O}_{10})(\text{OH})_2$ ).

Figure (3) Shows Multi-spectral images (VIS, IRR, UV, IRFC) of the overpainted areas applied to the original paints

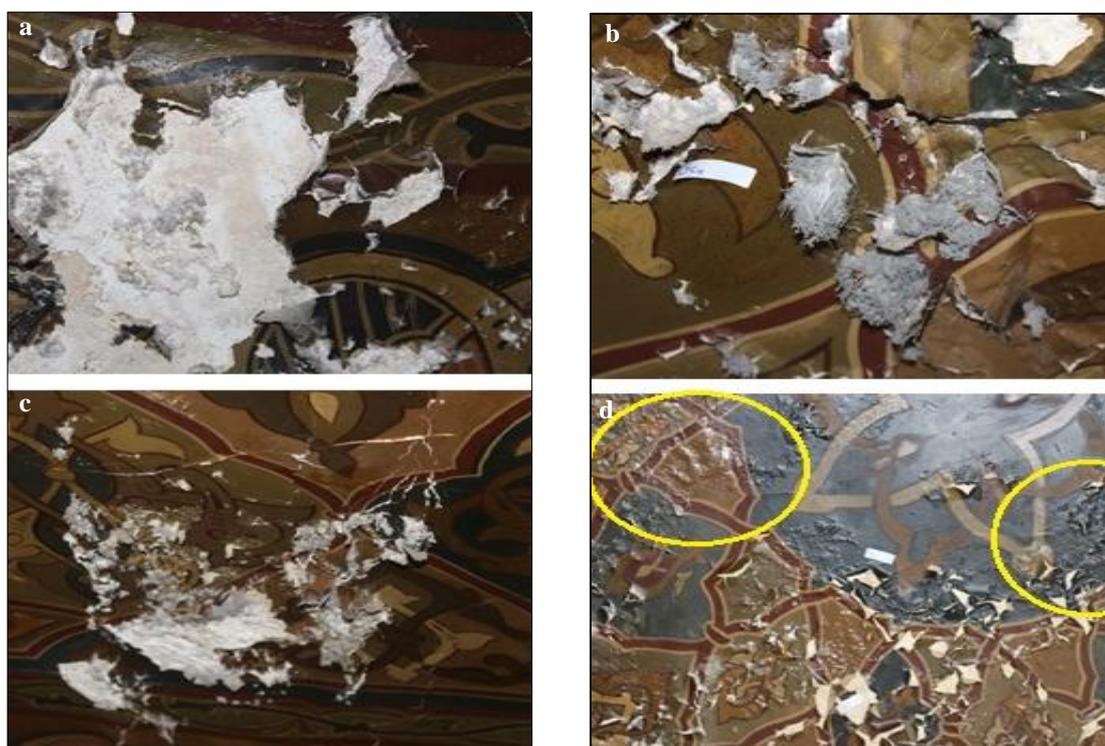
While the roof was isolated since the restoration interventions of 1994, the insulating materials show some deterioration now. This is increasing the likelihood of water infiltration from the roof to the painted surfaces causing salts dissolving from the construction materials. Then the dissolved salts migrate within the multilayered structure of the ceiling and crystallize between the layers creating mechanical pressure which leads to paint flaking, cracking and loss of cohesion of the support and the paint layers to completed loss in paints. SEM-EDS and XRD analysis of soiling revealed the presence of dust elements (Sodium

Aluminum silicates) which may promote the oxidation of pigments [17]. Furthermore, the leakage of rainwater from the roof with fluctuations of the temperature values between day and night and throughout the year could promote salt recrystallization in the ground (plaster) layers that were clearly detected in the form of fluffy and needle forms, fig. (5). Salt crystallization exerts mechanical pressure leading to loss of cohesion, cracks, flaking and complete loss of paint layers. SEM-EDS showed Sodium chloride salt (NaCl) which is associated with deliquescence at 75 % RH [18].

Figure (5) Shows **a.** paint loss and salt crystallization, **b.** & **c.** needle form of salt and paint flaking, **d.** brittleness of paint layer due to salt crystallization below the paint layer

church should be aired regularly by opening windows and doors during and after liturgies to allow pollutant air to escape. Consolidation of the roof with an appropriate insulating material is a significant step to protect the ceiling from water infiltration.

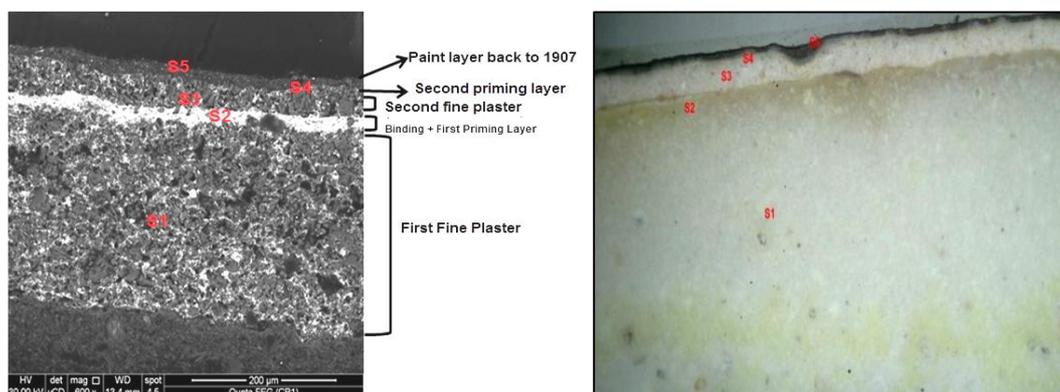
Microscopic investigations of various cross-sections showed that the stratigraphy of the ground layers was formed by four consequent layers that differ in their thickness, fig. (6). EDS analysis indicated that the ground layers are containing Ca, Ba and Zn with different concentrations of each layer. XRD analysis proved that they mainly consist of Calcite ( $\text{CaCO}_3$ ),

Barite ( $\text{BaSO}_4$ ) and Zinc Oxide ( $\text{ZnO}$ ). Finally, FTIR analysis of the ground layers demonstrated the presence both of organic and inorganic materials. Sulfates and Carbonates were easy to be characterized which might have been applied in a drying oil to create a less absorbent surface for painting.

Figure (6) Shows **a.** SEM image, **b.** microscopic investigation of the stratigraphy of 1907 painting

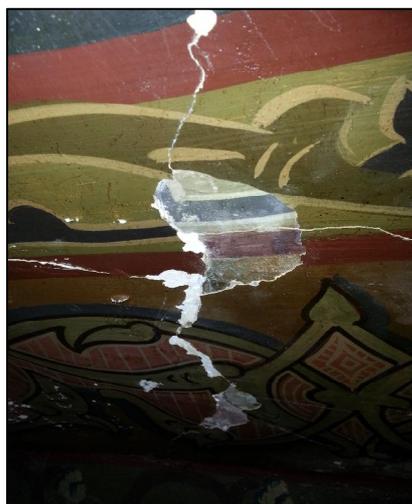
EDS analysis of the gilded pigment from the older paintings, fig. (8) showed that the dominant elements are Cu and Zn with the absence of (Au) suggesting that the gilded pigment might be from a

brass alloy. EDS analysis of the red pigment showed that the dominant element is Fe suggesting that the pigment might be Hematite.

Figure (8) Shows the older paintings
