*Original article***DETERIORATION AND CONSERVATION OF ST. SRABAMOUN CHURCH
BUILDING MATERIALS, AL-PTANON CITY – MENOUFIA - EGYPT**

Khallaf, M.

Abstract

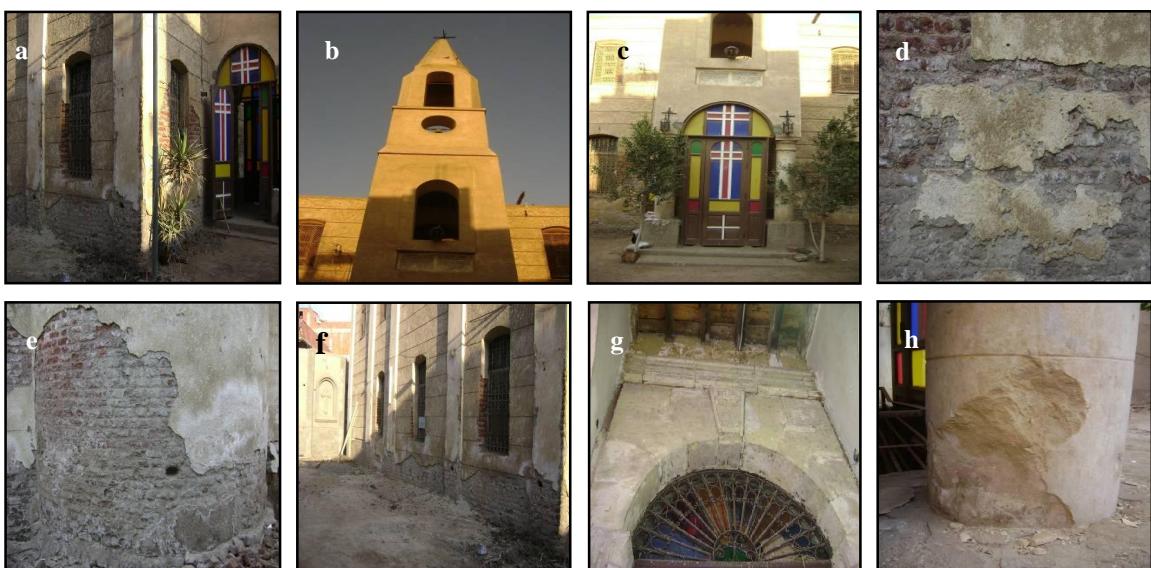
Through field inspection of the site it was noticed that high level of ground water thus affecting the building walls and led to the salts crystallization [5], and the /shedding layers of plaster both in internal and in external walls of the church.

Damage and erosion surfaces and the fragmentation of brick units were observed. In addition, the study indicate the presence of salt deposits on some parts of the stone columns inside the church, all of these features are shown in fig (2).

Figure.(2) **a** deterioration of walls, **b** the tower, **c** the church entrance, **d** damage of brick units, **e** decay of plaster layers, **f** rising damp in the walls, **g** crystallization of salts on stone surfaces, **h** missing parts from one of stone column.

The walls of St. Srabamoun church need to apply horizontal isolation by chemical injecting with water repellent material. Laboratory procedures using water repellent materials must be tested before to ensure their efficiency. According to previous studies the following for treatment and conservation recommend could be concluded. **Brick**, need to mechanical and chemical cleaning to remove dust and stains, and extraction of salts using manual methods and poultices [18]. Consolidation of weak, corroded parts and separate mineral grains using silicon or siliceous based material [19], which increase the

mechanical durability of the brick units [20] and Completing the missing units by using contrived units similar to the original bricks in components and dimensions [21] [22]. **Stones** need to carry out mechanical and chemical cleaning using appropriate materials and methods, for example, manual tools and organic solvents [23]. Also, extraction of salts, using different types of poultices, includes clay and paper poultices. After removing the salts the walls become ready to apply the plaster layers. In the case of surface weakness, plaster layers could not be applied directly and consolidation procedure could be carried

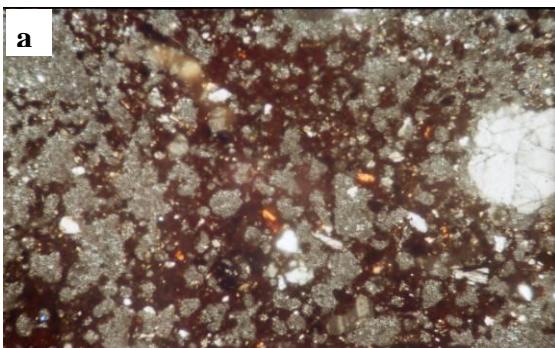
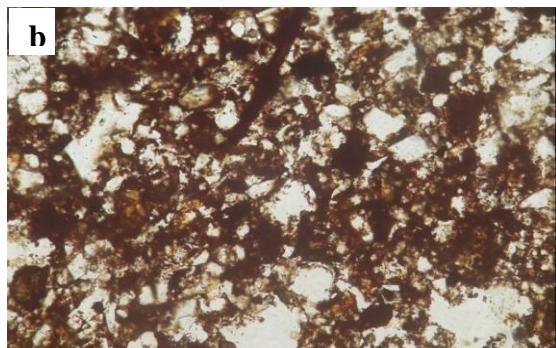
Petrographic study of bricks shows that it consists mainly of clay minerals which had been burned during the manufacture of bricks and quartz. In addition to a percentage of iron oxides. Furthermore some burning fibers were observed, which were added during brick making process, as argued previously by

El-Gohary & Al Naddaf, 2010 [6]. Moreover, presences of some gaps as a result of high porosity, fig. (3). Within the same context the examination of stone samples shows that it consists mainly of calcite, dolomites and, iron oxides in addition to the presence of some types of fossils such as (Nummulites SP.,) fig. (4).

Figure (3) thin sections photomicrographs of bricks showing **a** iron oxides, clay minerals, grains of quartz and crystals of microcline and plagioclase under C.N as follow **a** 25 X, **b** 64 X

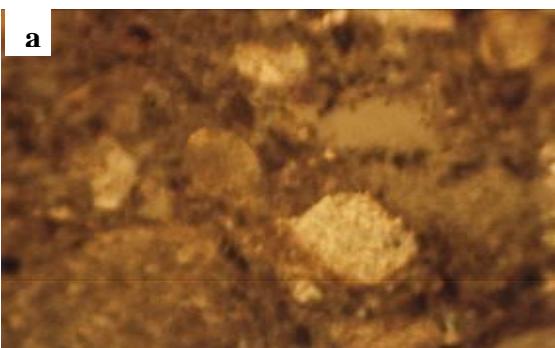
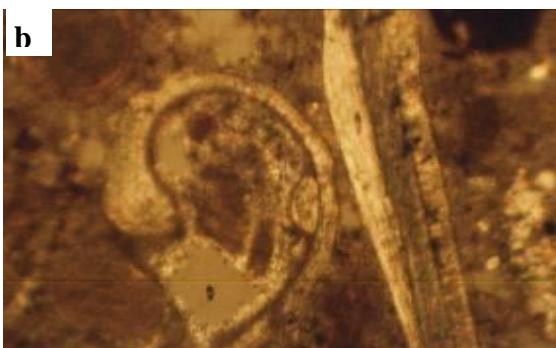
Figure (4) thin section photomicrographs of show equatorial section of nummulites Sp., clay minerals in a fine- grained matrix (biomicrite) under C.N as follow **a** 64 X, **b** 120 X

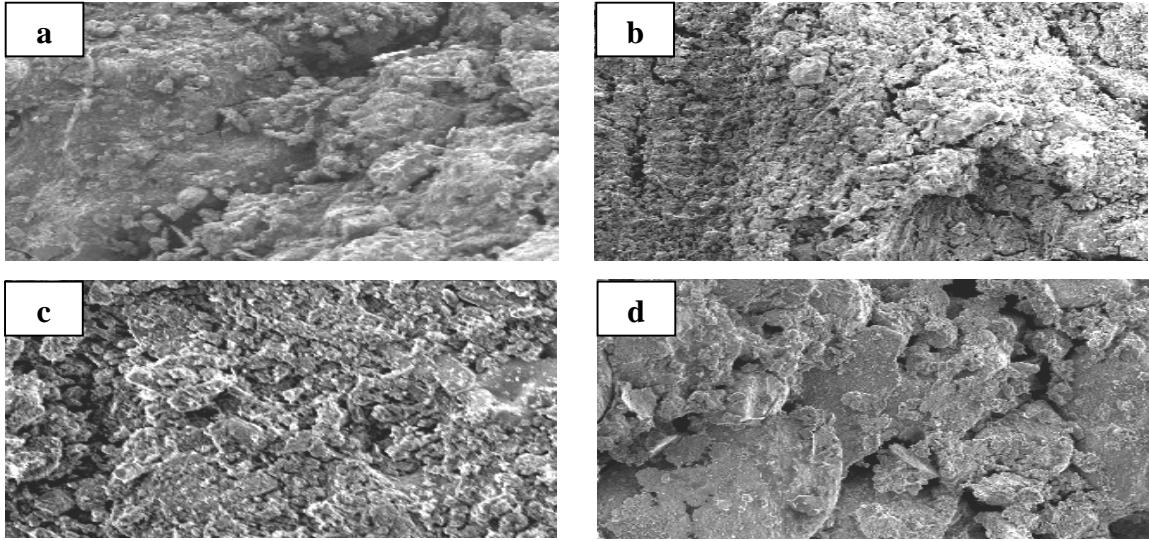
SEM observation, of bricks shows that there are some cracks, gaps and voids, which led to the disintegration, separation,

thus erosion and weakness of the brick internal structure. Also, dissolving of some brick components and crystallizing some

types of salts and thus influence the mechanical properties of bricks and stamina to the pressures and loads, fig. (5). On the other hand, SEM observations of

Figure (5) SEM photomicrographs showing the collapse of internal structure, voids, loose of binding material and salts crystallization between mineral grains **a** & **b** brick samples 400 X, **c** & **d** limestone samples 650 X.

limestone show loss of binding material between mineral grains due to severe impact of the salts crystallization affecting stone components .

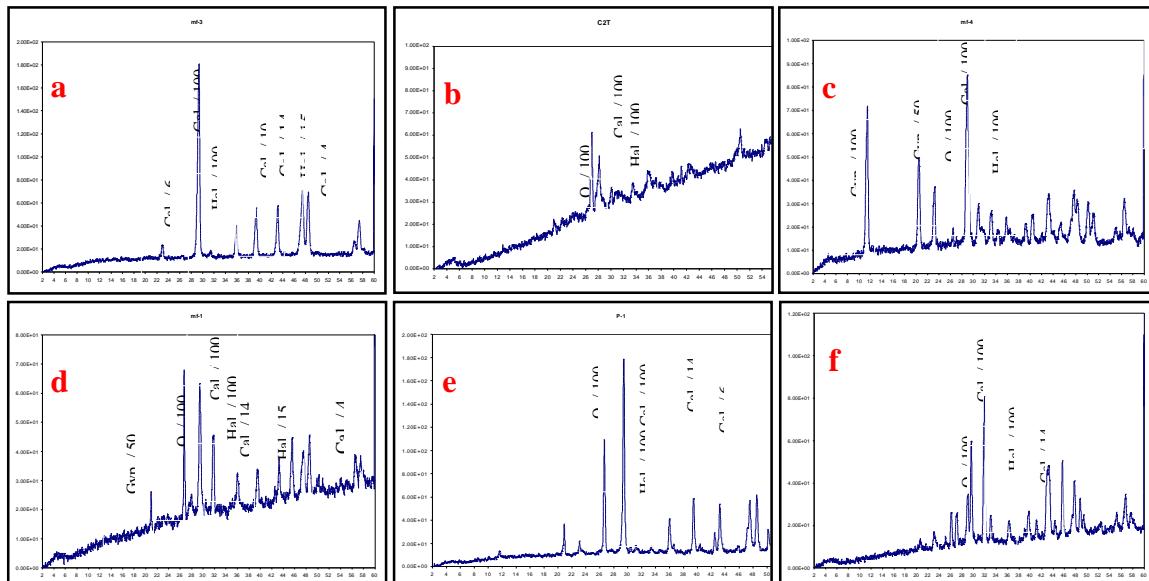
XRD analysis of brick samples proved that it consists of clay minerals, quartz, feldspar and calcite, in addition to halite (sodium chloride). The stone samples consist of calcite and halite. Furthermore, the analysis of mortar shows that the sample consists mainly of quartz, calcite, gypsum and halite. On other hand, analysis of plaster layers of the interior

Figure (6) XRD patterns of **a** limestone, **b** brick, **c** interior plaster, **d** mortar, **e** exterior layer of plaster, **f** salts
