## DAMAGE ASSESSMENT AND NANO TREATMENT OF THE SHARIA JUDGE TOMB AT THE FATIMID CEMETERY, ASWAN - EGYPT

EJARS – Vol. 12 (2) – Dec. 2022: 217-225

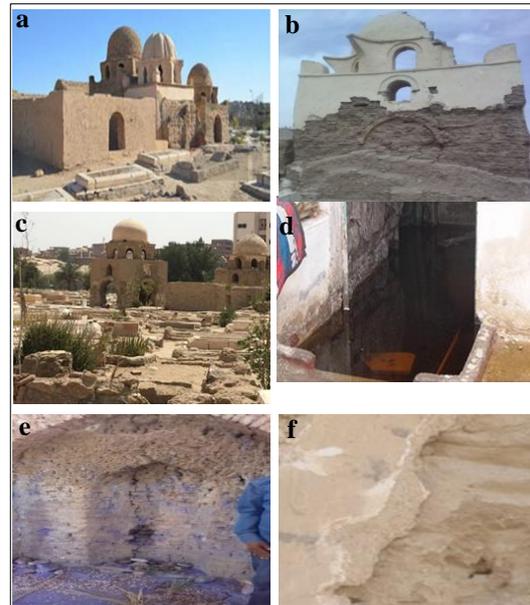
Figure (2) Shows **a**, some different forms of domes in the Fatimid cemetery in Aswan, **b**, fall off of small and large pieces of plaster, **c**, fall of the plaster layers, as well as the trees and plants **d**, accumulation of saline groundwater in the tomb of Sidi Abdel Aal, **e**, blue pigment that distorts the walls and covers the floor of the Sharia judge's cemetery, **f**, fall of the plaster layers with the pigments above from the tomb of the Sharia judge.

Architecturally, the cemetery is a square whose sides are 2.70 m. Its walls were built of mud. In the middle of the eastern side is a doorway with a pointed arch and in the middle is an apse of a mihrab erected with an arch. As for the other three sides, an opening with a pointed arch is in the middle of each side. The square is topped by an octagon with concave sides to show its edge in the form of horns, followed by the smooth dome body [12]. The Fatimid cemetery in Aswan includes ancient domes with unique architectural styles, fig. (2-a). However, the cemeteries generally suffer from the fall of plaster layers, whether in the form of small or large parts, fig. (2-b) as well as various sources of moisture. They also suffer from weeds, trees, and plants, which are irrigated with water, causing a rise in the content of the groundwater or gathering of grou-

ndwater inside cemeteries whose floors are lower than the surface of the earth, dome of Sidi Abdel Aal, fig. (2-c). The Sharia Judge cemetery is considered the oldest Islamic cemetery in Aswan and one of the oldest Islamic cemeteries in Egypt, as the construction of some tombs dates to the first Hijri century. It suffers from human damage, represented in the blotting of its walls in blue, cracks, and joints, fig. (2-d). It also suffers from falling and eroding layers of plaster, fig. (2-e). This study aims to preserve pigmented and non-pigmented plaster layers in the studied tomb, enforce these architectural treasures that extend for more than four centuries, draw the attention of specialists and officials of the antiquities of Islamic Aswan, and pave the way for further studies that help preserve this unique, diverse architectural heritage because of its archaeological and architectural importance of these tombs.

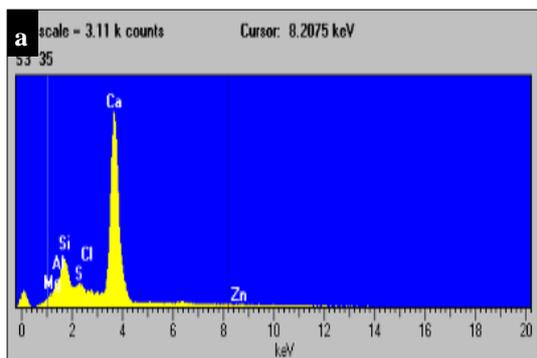
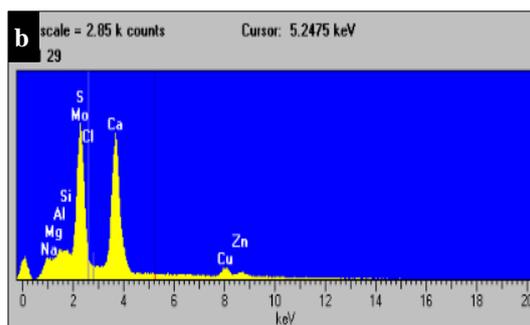
Figure (3) Shows EDX analysis of **a.** constructed sample composed of calcium, quartz, and halite, **b.** white lye sample contains calcium, sulfur, halite, and quartz.

The morphology of the plaster samples of the Sharia Judge Tomb in the Fatimid cemetery examined using SEM-EDX. EDX. A constructed sample was found to be composed of calcium 74.43%, quartz 20,36%, and chlorine 5.21%, fig. (3-a). The sample of whitewash was found to be composed of calcium 43.23%, sulfur 45.12%, halite 2.42%, and sand 9.23%, fig. (3-a).

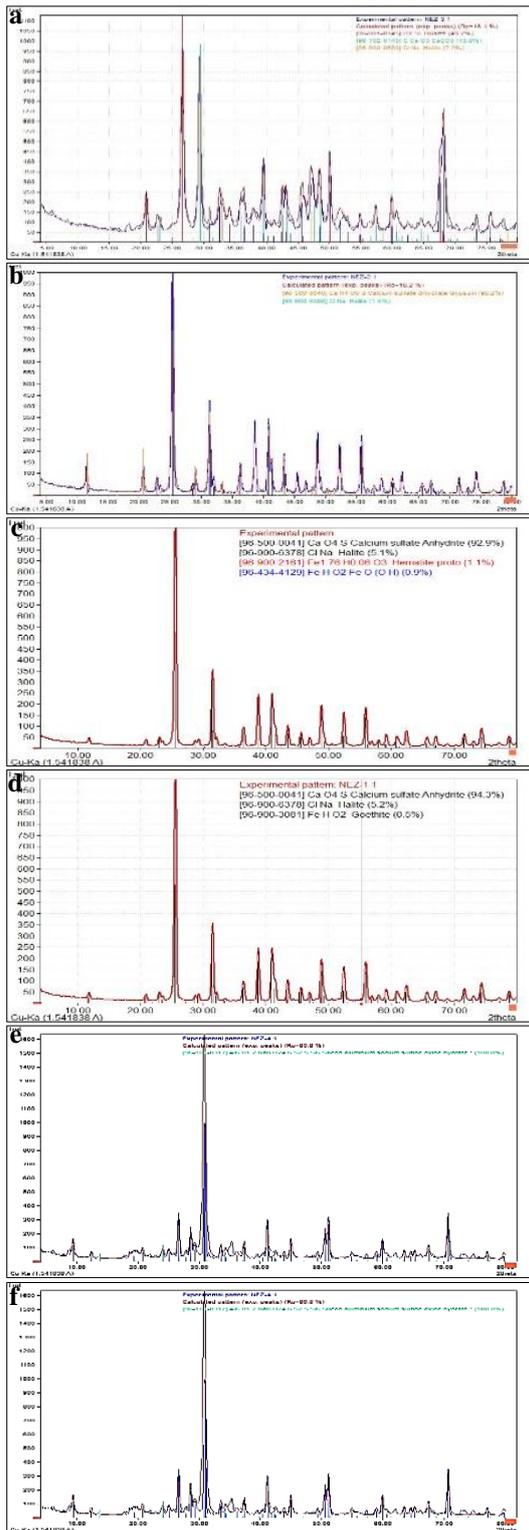
Figure (4) Shows X-ray diffraction patterns of **a.** constructed sample contains lime, sand, and halite, **b.** whitewash sample contains gypsum, halite, and salt, **c.** pigment sample contains gypsum, goethite, halite, and bixbyite, **d.** pigment sample contains gypsum, halite, and goethite, **e.** blue sample contains ultramarine blue, **f.** blue washing flower sample contains ultramarine blue.

Six different samples were analyzed from the cemetery of the Sharia Judge, and the results were - according to JCPDS 1967 [15,16]- as follows: sample (1) is a coarse plaster sample, had 43.6% calcium carbonate  $\text{CaCO}_3$  (lime) according to card no. 96-702-0140, 49.2%  $\text{SiO}_2$  (sand) in card no. 96-901-0145, and 7.2% sodium chloride  $\text{NaCl}$  (halite salt) in card no. 0630-900-96, fig. (4-a). Sample no. (2) is a whitewash sample- had calcium sulfate dihydrate  $\text{CaSO}_4 \cdot 2\text{H}_2\text{O}$  (gypsum) by 98.2 % in card no. 96-500-0040, and  $\text{NaCl}$  (halite) sodium chloride at 1.8% card no. 96-900-6388, fig. (4-b). Sample no. (3) is a pigment sample composed of 92.9% calcium sulfate dehydrate; card. 96-500-0041, 5.1% sodium chloride  $\text{NaCl}$  (halite) card no. 96-900-6378, 1.1% hematite  $\text{Fe}_2\text{O}_3$  at card. 96-900-2161, and 0.9% goethite  $\text{Fe}_2\text{O}_3 \cdot \text{H}_2\text{O}$  card 96-434-4129, fig. (4-c). Regarding the sample (4), it is a pigment showed contains 94.3% calcium sulfate dehydrate; card 96-500-0041, and 5.2% sodium chloride  $\text{NaCl}$  (halite); card 96-900-6378, in addition to 0.5% goethite  $\text{Fe}_2\text{O}_3 \cdot \text{H}_2\text{O}$  by card no. 96-900-3081, fig. (4-d). Sample (5), is a blue pigment similar to the pigment of the blue washing flower distorted the walls and covered the cemetery floor. It had 100% ultramarine  $\text{Na}_6\text{Al}_4\text{Si}_6\text{S}_4\text{O}_{24}$  appeared at card no. 96-101-0317, fig. (4-e). Sample (6); it is a pigment of the blue washing flower showed 100% ultramarine card no. 101-96-0317, fig. (4-f).

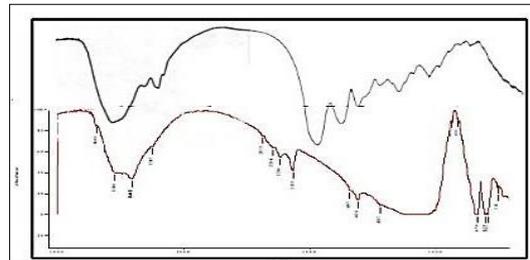
Figure (5) Shows FTIR pattern of the standard sample of animal glue and the archaeological pigment sample.

After matching the absorption areas of the archaeological sample with the absorption areas of the standard one of glue, it could be noted that it composed of glue. This result were close, according to Derrick, et al. [17], which indicating that the organic medium was animal glue, tab. (1) & fig. (5) Table No. (1) The convergence of the active groups in the tow samples.

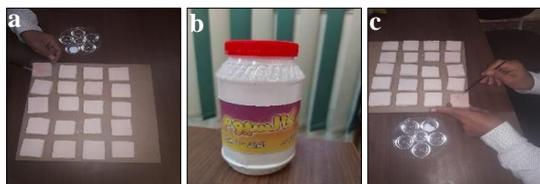
Figure (6) Shows **a.** simulation samples, **b.** calcium nano hydroxide, **c.** applying the consolidant.

The study was achieved upon the samples consolidated by calcium nano-hydroxide mixed with  $\text{TiO}_2$  nanoparticles, which were applied in different concentrations. It was carried out on samples to the high penetration and homogeneity of nanomaterials in the mineral composition [18]. The lime-based is a deep penetration consolidant because of the grain size [19,20]. Nanoparticle composites have attracted great interest in cultural heritage conservation [21]. Due to their unique multifunctional properties, nanoparticles have a role in producing hydrophobic surfaces [22]. Silane makes them more water-repellent [23], which can be used to protect stones [24]. Adding titanium dioxide and silica nanoparticles to polymers was also found to improve their mechanical properties [25]. The use of  $\text{TiO}_2$  nanoparticles to protect materials to increase the durability of these materials, especially in polluted environments, is encouraging [26]. The application of nano treatments on stones becomes a

useful tool for the realization of preserving and maintaining stone surfaces [27]. To reach the best results for reinforcing materials, they were applied several times after ensuring complete impregnation with an interval of two to three weeks to complete the polymerization process, fig. (6).

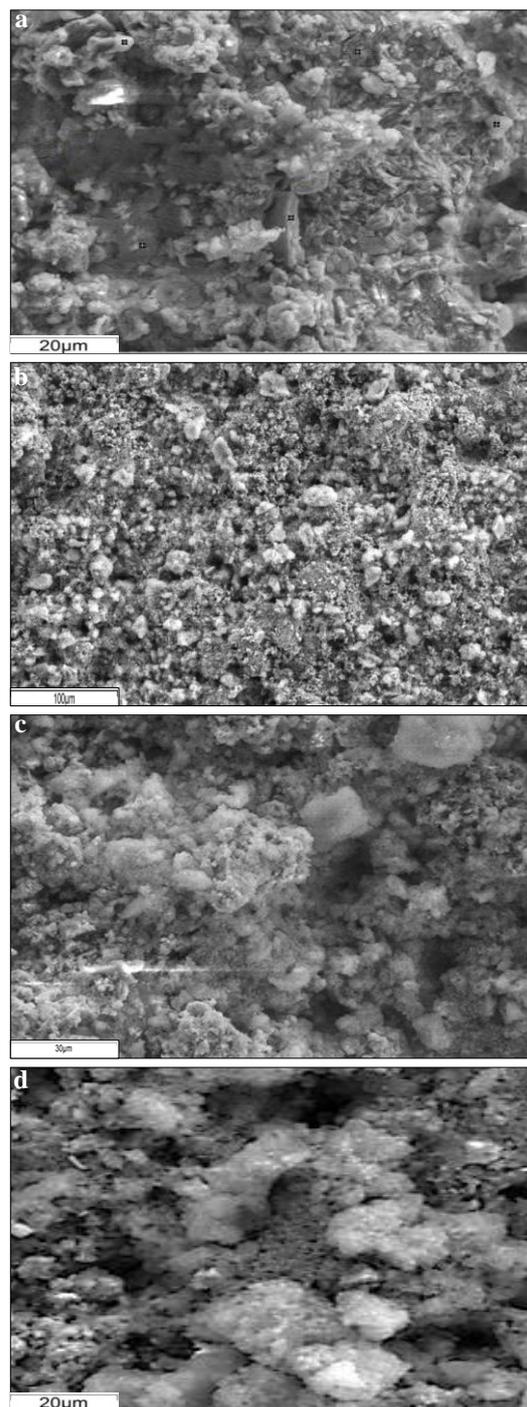
Figure (7) Shows SEM micrograph of **a.** morphology the lower layer of the Sharia Judge's tomb in the Fatimid cemetery, distribution of **b.** (2:1) nano calcium hydroxide mix with TiO<sub>2</sub> nanoparticles in treated plaster, **c.** (1:1) nano calcium hydroxide mix with TiO<sub>2</sub> nanoparticles of the treated plaster, **d.** (1:2) nano calcium hydroxide mix with TiO<sub>2</sub> nanoparticles treated plaster

The objective of the examination is to compare the untreated and treated samples according to Briffa & Vella [28] and El-Gohary & Al-Shorman [29]. Moreover, evaluate the extent of the consolidant's ability to bind the granularity of the plaster, the presence of the mineral composition in a homogeneous manner for the concentration materials, as well as the ability to distribute, sediment, and fill the gaps. In this regard, the untreated (*archaeological sample*) showed the granular formation of the surface, its interspaces, and the surface texture, fig. (7-a). Within the same context, the treatment effectiveness of the second sample (*consolidated with 2:1 calcium nano hydroxide mixed with TiO<sub>2</sub> nano particles*) showed the spread and homogeneity of the treated material on the plaster layer, fig. (7-b). The third sample (*consolidated with 1:1 calcium nano hydroxide mixed with TiO<sub>2</sub> nano particles*) showed good diffusion, good distribution and clear penetration into the pores, fig. (7-c). The fourth sample (*consolidated with 1:2 calcium nano hydroxide mixed with TiO<sub>2</sub> nanoparticles*) showed the spread of TiO<sub>2</sub> nano particles on the plaster layer and increased the penetration bet-

ween the pores, in addition to the presence of good connection between the mineral composition, fig. (7-d).

naked eye and the SEM examinations before and after the consolidation process showed that the consolidation with calcium hydroxide nano material mixed with  $\text{TiO}_2$  nanoparticles consolidation at a concentration of (2:1) achieved a remarkable spread to fill the gaps and microcracks. The consolidation with calcium hydroxide nano material mixed with  $\text{TiO}_2$  nano particles consolidation at a concentration of (1:1) achieved a better and satisfactory spread. The consolidation with calcium hydroxide nano material mixed with  $\text{TiO}_2$  nanoparticles consolidation at a concentration of (1:2) spread widely and worked to bind the granules better. It was also able to fill the joints and cracks that reached the depth with good distribution and spread between the cracks and gaps resulting from the mineral disintegration and the weakness of the internal structure. It is still necessary to conduct several new studies by making a mixture of nano-calcium hydroxide and other materials [35,36] to improve the properties of the preservative materials based on the dispersion of nano-calcium hydroxide.
