MICROCLIMATIC MONITORING FOR THE ENVIRONMENTAL RISK  
ASSESSMENT OF THE CAPILLA MAYOR, SANTIAGO DE COMPOSTELA  
CATHEDRAL (SPAIN)

**Abstract**

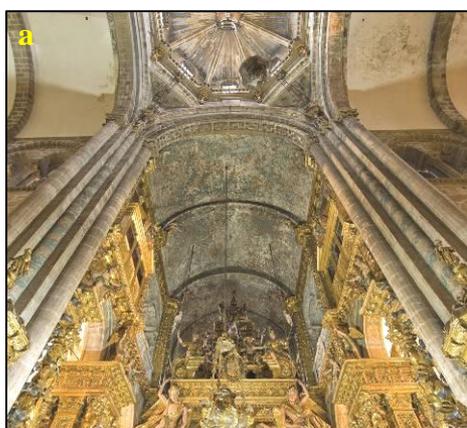
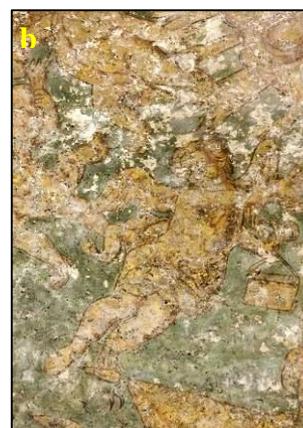
Figure (1) Shows the Capilla Mayor: **a.** general overview, **b.** close views of the frescoes of the apse vault heavily deteriorated

The old city of Santiago de Compostela is included in the UNESCO World Heritage Site since 1885 and the Cathedral, one of the main destinations of pilgrimage since the Middle Ages, was declared Heritage of Cultural Interest in 1896. The *Capilla Mayor* can be considered the heart of the Cathedral. An enormous gilt wood baldachin, with a sumptuous carved stone statue of Saint James from the 13<sup>th</sup> century, rises above the main altar, fig. (1-a). The choir is covered by three bays and surrounded with an ambulatory and five radiating

chapels. The vault of the apse is pierced by round windows, forming a clerestory, that give light and fresh air to the matroneo. The frescoes of the dome were realized between 1764 and 1766 by Gabriel Fernández; on a blue background, probably representing the sky, putti and angels dance holding symbols of Christ's Passion. At today the painted surface shows a remarkable weathering: decohesion, pulverization, detachment, loss of fragments of material, craquelure and fractures make its viewing extremely difficult, fig. (1-b) [15].

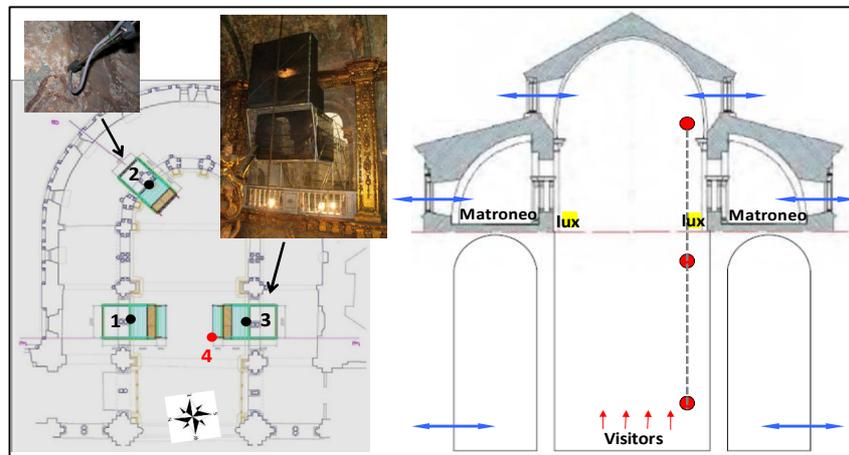
Figure (2) Shows **a**, horizontal (at the height of the matroneo), **b**, vertical (south-north axis) sections of the Capilla with the indication of the monitoring points in correspondence of the three scaffoldings installed for the investigations.

The microclimate in the Capilla was monitored from January to December 2010, following the methodology described in details in [1,6] that includes automatic monitoring of: **i)** air temperature (T) and relative humidity (RH) in proximity of the frescoes and few centimeters far from them in three selected points “1,2,3” in fig. (2) differently oriented (north, east and south) to investigate the exchanges between the surface and the internal atm-osphere; **ii)** the air thermal vertical profile in the apse point “4” in fig. (2) at three levels from the floor: high (close to the vault), middle and low (about 2.5 m) to evaluate the risk of vertical air movements and consequently transport of pollutants towards the dome where they can deposit [16,17], thus contributing to its weathering; **iii)** surface temperature (Ts) in three selected

points of the apse vault differently oriented “1,2,3” in fig. (2) to monitor the thermal behaviour in different orientations (north, east and south) and evaluate the risk of condensation; **iv)** anemometric measurements in the same three points “1,2,3” in fig. (2) to control the air velocity close to the frescoes. In order to have a more complete picture of the microclimate, the monitoring program included also manual campaigns [6] to be performed for few days in the four seasons to investigate the thermo-hygrometric horizontal distribution at the level of the matroneo, fig (2). Air temperature and relative humidity were also collected automatically outside the Capilla to study the influence of the external climatology and the exchanges indoors/outdoors through the windows located in the external perimeter

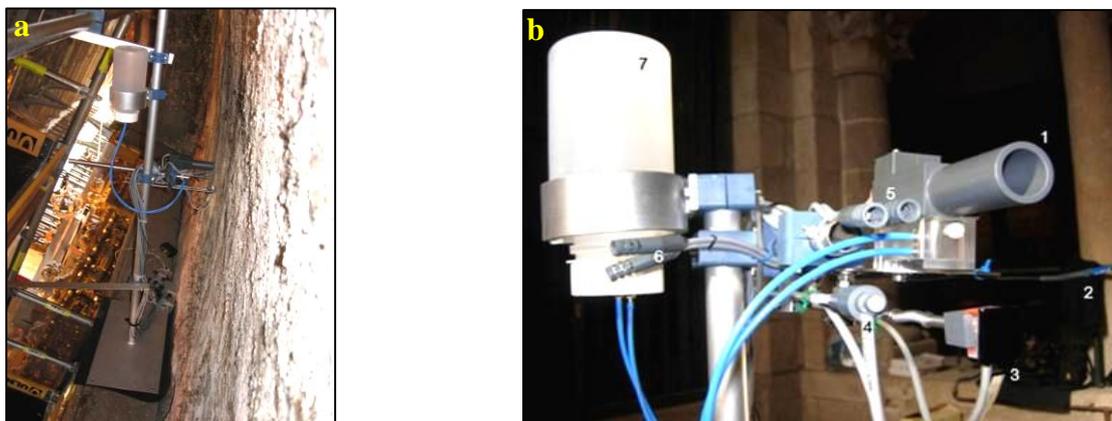
Figure (3) Shows equipment for microclimatic monitoring **a**, installed close to the apse vault, **b**, close view of the instruments: psychrometer **1**, anemometer **2**, dew sensor **3**, contact temperature sensor **4**, air temperature and relative humidity sensors **5** & **6**, water reservoir for the psychrometer **7**.

of the matroneo. Due to the difficulties in the signal transmission, a wired system was preferred to a wireless system for the continuous monitoring of air and surface temperatures (platinum thermo resistances, accuracy respectively  $\pm 0.2^{\circ}\text{C}$  and  $\pm 0.1^{\circ}\text{C}$ ), relative humidity (capacitive sensors, accuracy  $\pm 3\%$ ) and wind velocity (hot wire anemometers, accuracy  $\pm 0.05$  m/s), fig. (3). The risk of superficial condensation was evaluated with calculations but its presence on the surface was also measured directly with an innovative dew sensor [18]. Air T and RH very close to the vault surface were measured with a psychrometer specifically built ( $\pm$  accuracy  $\pm 0.01^{\circ}\text{C}$  and  $\pm 3\%$  RH), fig. (3). All the sensors were connected to a central PC where the management software of the monitoring network and the data trans-mission software were running. The data were collected every 20 minutes and

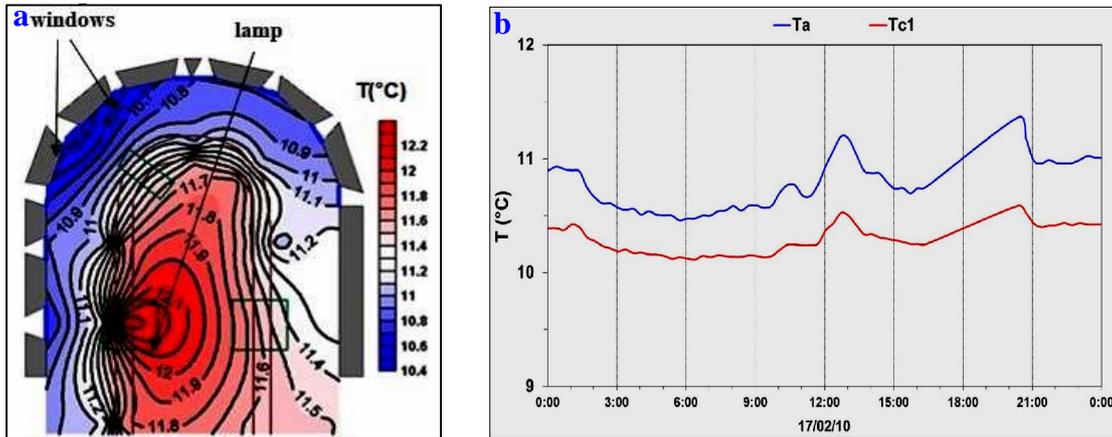
Figure (4) Shows **a.** thermal horizontal distribution on the 17/02/2010 in the matroneo, **b.** daily trend of the air (Ta) and surface (Tc1) temperature of the vault in the north side in June showing peaks in correspondence to the masses due to the operation of the lamps and the presence of visitors.

The elaboration of the data put in evidence that the microclimate inside the *Capilla* was strongly influenced by the external climatology notwithstanding its high heat capacity and large thermal inertia. In fact, the temporal trend of the thermo-hygrometric levels inside the *Capilla* followed the external values, with variations reduced in amplitude. The temperature inside was higher than outside (2-4°C on average depending on the month), influencing the indoor relative humidity that resulted 10-20% lower than outside. The impact of the external climate was also evident from the analysis of the data collected during the manual measurements in the *matroneo*. In general, the thermal minima were measured in proximity of the north and east walls, whilst the south wall was characterized by the maxima. In fact, the windows are located alongside the perimeter of the *matroneo*, except for the most part of the south side. In each season the thermal horizontal distribution showed the entrance of colder air from the open slots at the bottom of the windows that were sometimes left partially open, fig. (4) for the air exchange inside the cathedral. The manual measurements showed also the impact of the lamps located in the internal perimeter of the *matroneo*, especially the one in correspondence of the north scaffolding. The heating due to their operation during the opening hours of the cathedral was clearly visible in the thermal horizontal distributions characterized by thermal maxima nearby the light sources. At the same time, a rise in the air temperature measured close to the vault and of the surface temperature of the frescoes was detected. An example of the perturbing action of the lamps is shown in fig. (4), where an increase of about 1 °C in air temperature and of about 0.5 °C in surface temperature was detected in 1 hour on the 17<sup>th</sup> Feb. 2010.

The analysis of the thermal vertical profile in the apse showed a 1-2 °C increase of air temperature during the masses due both to the operation of the lamps and to the presence of a huge number of people that remarkably perturbed the internal microclimatic conditions of the whole cathedral, especially during the holidays when it is overcrowded (i.e., Saint James, at the end of July, is very popular). In particular, in spring and summer when this increase in air temperature occurred, e.g., during the masses, the more general conditions of atmospheric stability turned to instability [16]. This means air vertical movements and risk of aerodynamic deposition [17] of pollutants on the surfaces, especially between the high and middle levels, fig. (5). On the contrary, independently from the moment of the day, in winter and autumn the stratification of air masses created two different air circulations closed at the middle level: between the low and middle levels the thermal vertical profile was always stable, unstable between the middle and high levels. Conditions of instability were also favoured by the vault not properly insulated that contributed to cool down the temperature of the air in its proximity. The atmospheric stability between the low and middle levels inhibited the transport towards the dome of the pollutants that entered the cathedral through the doors or that were brought in by the visitors. Hence, the presence of visitors in the currently allowed areas of the cathedral didn't enhance the risk of deposition of pollutants on the frescoes. Nevertheless, the atmospheric instability between the middle and high levels favoured the resuspension and the aerodynamic deposition of the pollutants previously settled on the wood baldachin, always covered by dust [17]. The air velocity close to the apse vault reached its highest values in the middle of the

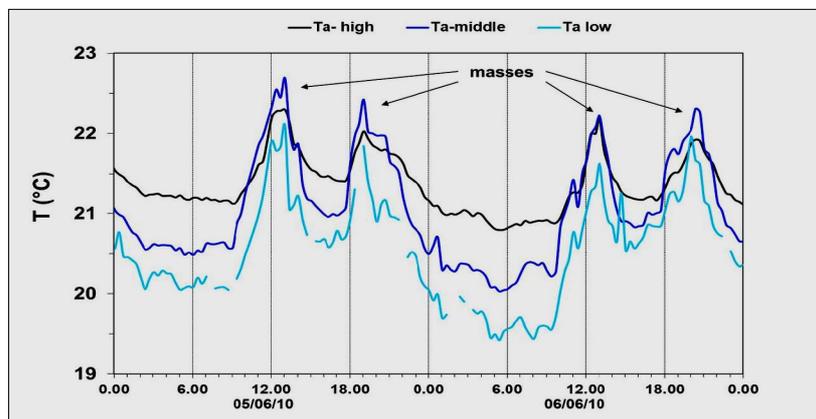
Figure (5) Shows atmospheric instability between the middle and high levels of the air vertical profile in the apse during the masses in late spring.

day (up to 40 cm/sec in summer, to 30-35 cm/sec in the other seasons), in correspondence of the pilgrims' mass, whilst during the night the air movements slowed down. The frequent conditions of atmospheric instability between the high and middle levels and the high air velocity values favoured aerodynamic deposition of micronic particles, that may react with the heritage surfaces under specific microclimatic conditions, in particular in presence of water (condensation on the surface or in the micropores of the material) [1,6]. The analysis of the temperature of the internal surface of the apse vault and of the air close to it showed throughout the year that surface temperature was lower than air temperature. This thermal gradient favoured the phenomenon of thermophoretic deposition of submicronic particles (diameter less than 1 $\mu$ m), characterized by a greater resident time in atmosphere [17], fig. (4). The analysis of the hygrometric gradients close to the surface indicated that the diffusiphoretic deposition [1,6,17] was on the contrary inhibited in summer and autumn, whilst in the other seasons this phenomenon occurred, acting in synergistic combination with the thermophoretic process. Hence, the two different phoretic processes had synergistic or opposite action, depending on the season and moment of the day. The hygrometric values in the *Capilla* were generally quite high, with an annual average of 70% RH and maxima of 90% frequently reached in autumn and winter. It is well known that high levels of relative humidity favour biological life [1,6]. The threshold hygrometric level depends on the type of species considered, and it is also related to other environmental conditions (e.g., air and surface temperature, equilibrium moisture content, ventilation, air pollution, etc.). Anyhow, in temperate regions, the RH level should prudentially remain below 70% in order to protect

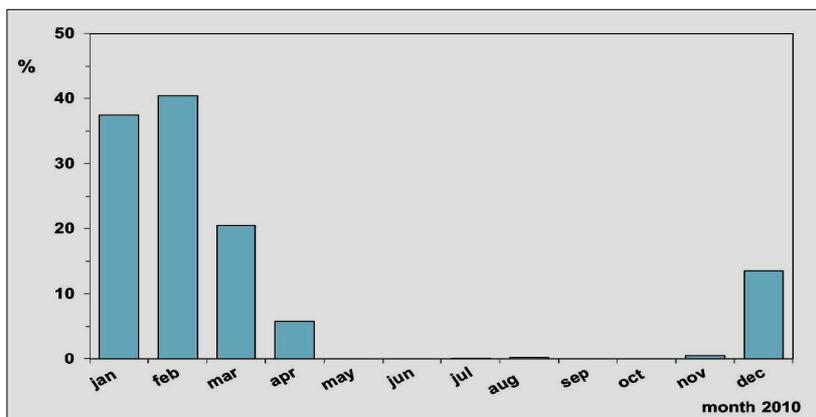
Figure (6) Shows monthly risk of superficial condensation (percentage of total time) for the Capilla.

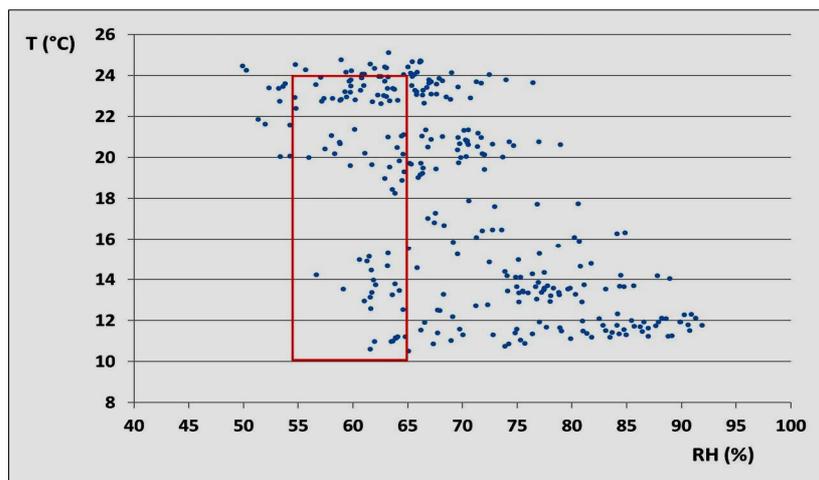
Figure (7) Shows daily average temperature and relative humidity matrix. The square indicates the recommended T-RH range for the frescoes conservation according to the Italian Standard UNI10829.

have a high impact. The importance of the anthropic factors was high too, but their perturbing action was sporadic, being related to the management and use of the Cathedral. Among the anthropic factors, the presence of visitors was the less important one for the Capilla, mainly because of the presence of the big wooden baldachin that acted as a hygrometric buffer. The synergistic action of all the mentioned factors lead to microclimatic conditions that might reduce the durability of the frescoes even after the restoration. In fact, the thermo-hygrometric reference range for the conservation of the frescoes, reported in the currently approved Italian standard UNI 10829 [5] (i.e. 10-24°C for T and 55-65 % for RH), was satisfied only for the 26% of total time of monitoring. This low percentage was mainly related to RH, whose measured values were almost always over the upper limit of the range, as is clearly visible in fig. (7).
