**STUDY OF DURABILITY OF ALABASTER USED IN THE TEMPLES OF LUXOR AND KARNAK AND LABORATORY EVALUATION OF CONSOLIDATION TREATMENT**

Abd El-Tawab, N.<sup>1</sup> & Askalany, M.<sup>2</sup>

<sup>1</sup>Conservation dep., Faculty of Archaeology, South Valley Univ., Qena, Egypt

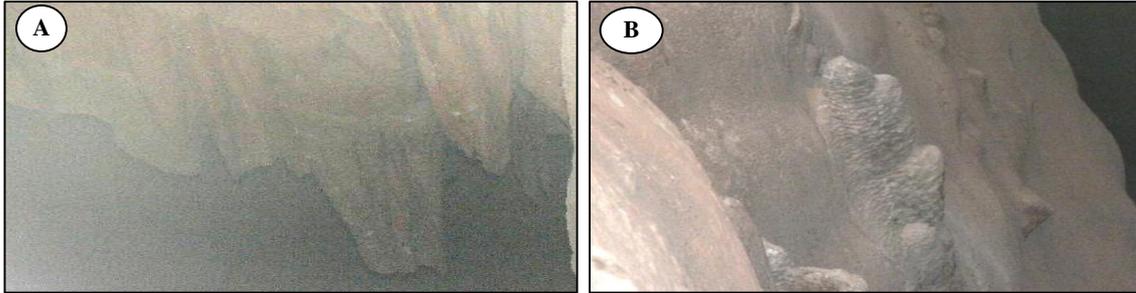
Figure 1 (a, b) alabaster stone in Wadi Sannur, **a** Stalactites, **b** stalagmites

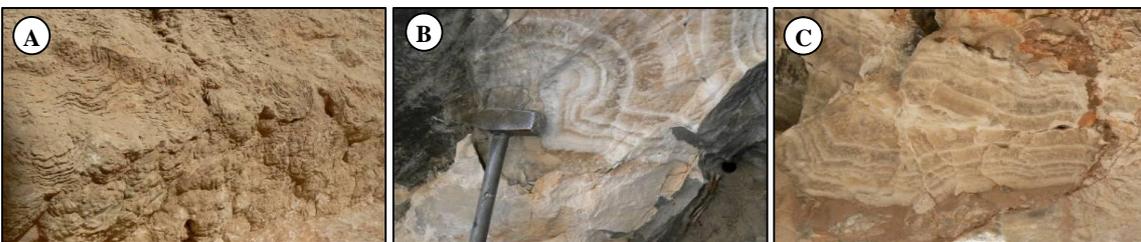
Figure 2 (a,b,c) the colloform structure of alabaster in Wadi Sannur and thin bands of milky to creamy white, opaque calcite alternating with thicker bands of brownish.

tinted with orange or especially yellow), translucent calcite, fig. (2-a, b, c). ‘Amber’ and ‘honey’ are two particularly apt terms often used to describe the color of the

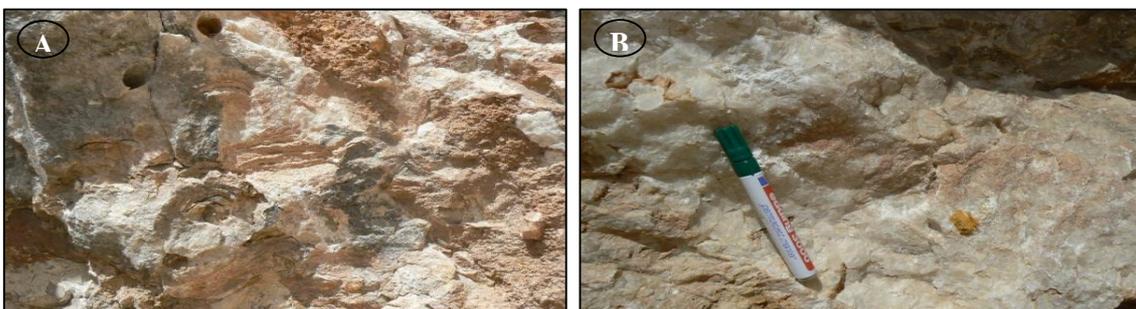
Figure 3 (a, b) massive alabaster from the Wadi Asyut, contains affluent tiny cavities stained with red iron oxide.

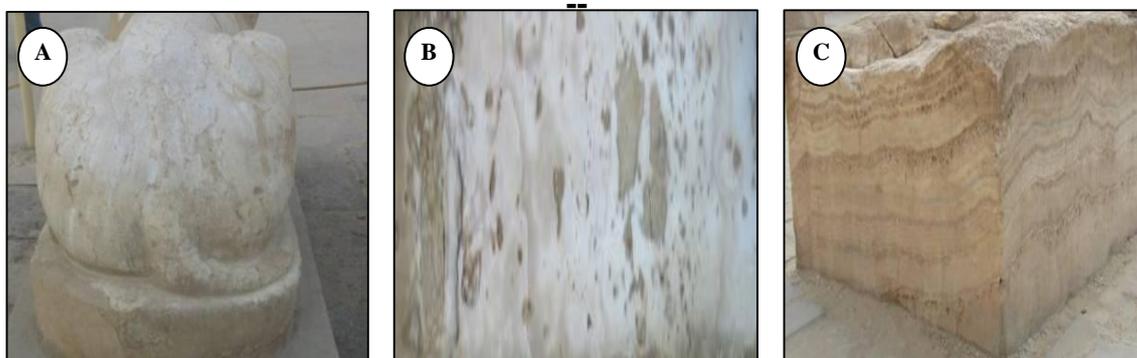
Figure 4 (a, b, c) Alabaster monuments at Karnak temple showing the effects of bleaching by sunlight

portions begin to fade and eventually are bleached to white. Any alabaster artifact left outdoors will suffer the same fate. The exterior surfaces of the chapel of Thutmose IV, offering table and barque shrines for kings Amenhotep I/Thutmose I at the Karnak and the statue of Amonite at Luxor, fig. (4-a, b, c), which exposure to sunlight for long time suffering from this phenomena. The bleaching is caused by sunlight ultraviolet, which deactivates the color centers in the calcite [3]. The alabaster monuments at Karnak and Luxor temples suffer from fracture and loss some architectural elements, fig. (5-a, b, c). Alabaster is far too soft for external use, it is hopelessly vulnerable to the elements, and it is too weak for building. It is so soft that it can be cut with a penknife, making it a ready target for vandals over the ages. Weathering of alabaster is accompanied by the formation of microcracks in the interior, primary in the boundaries between the mineral grains, fig. (6-a, b, c). Microcracks as a result of mechanical stresses which may originate from mechanical loads, from of variation in temperature and humidity, from aggressive environment which can be acid residue from rainfall and product from a calcite reaction [15]. Alabaster decay represented characteristic in numerous pitting and cavities, fig. (7-a, b, c).

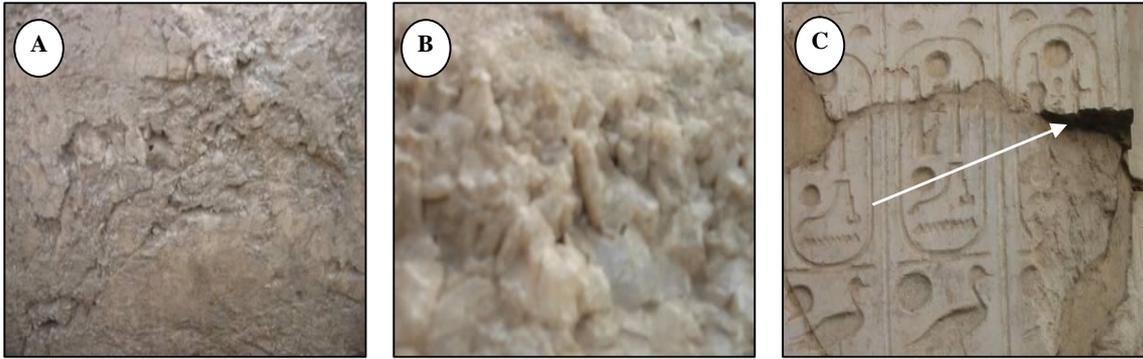
Figure 5 (a,b,c) the Granular disintegration on the surface of alabaster offering table at Karnak temples and fracture and loss some architectural elements of alabaster monuments at Luxor.

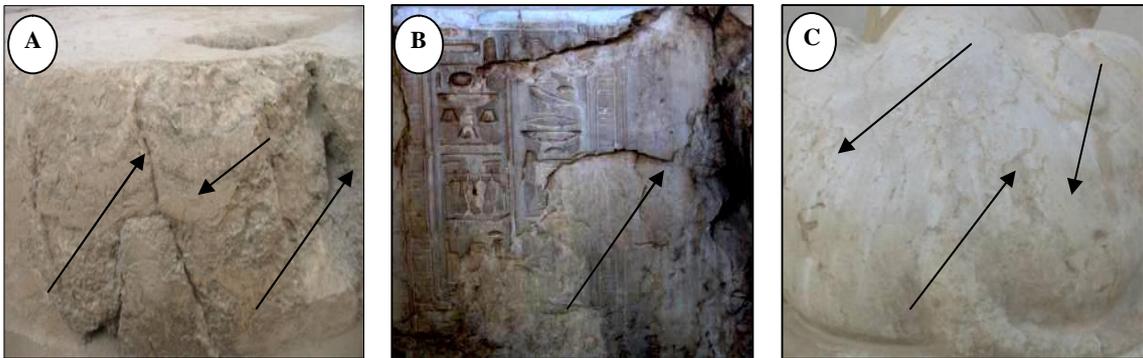
Figure 6 (a, b, c) the cracks and microcracks and fissuring at the alabaster monuments at Luxor and Karnak temples.

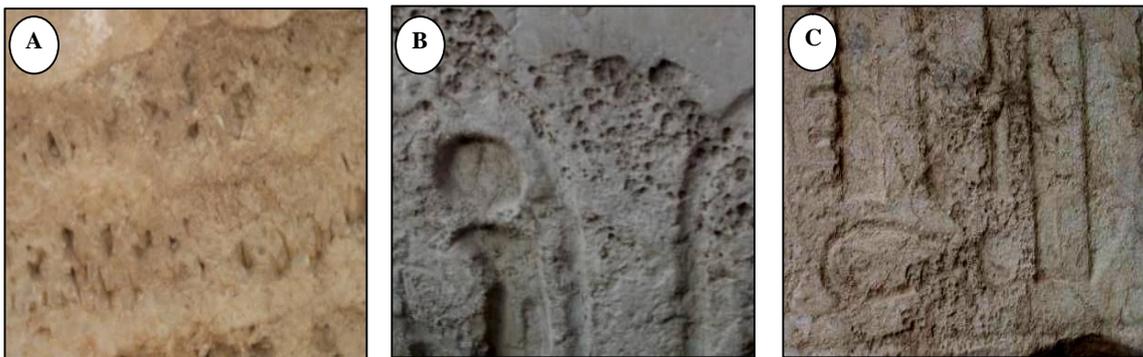
Figure 7 (a, b, c) the different pitting and cavities in the alabaster monuments at Luxor and Karnak temples.

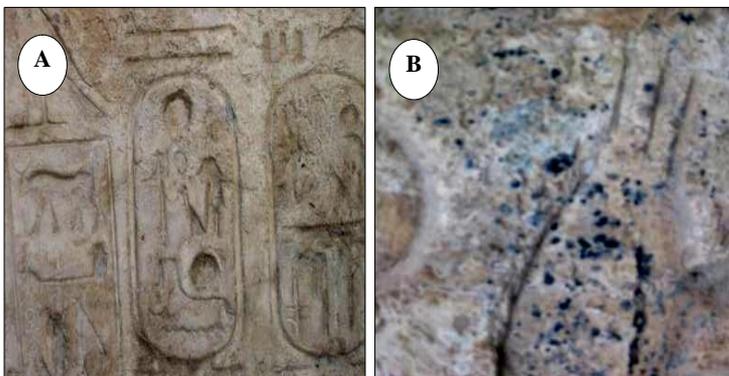
Figure 8 (a, b) the biodeterioration weathering at alabaster monuments.

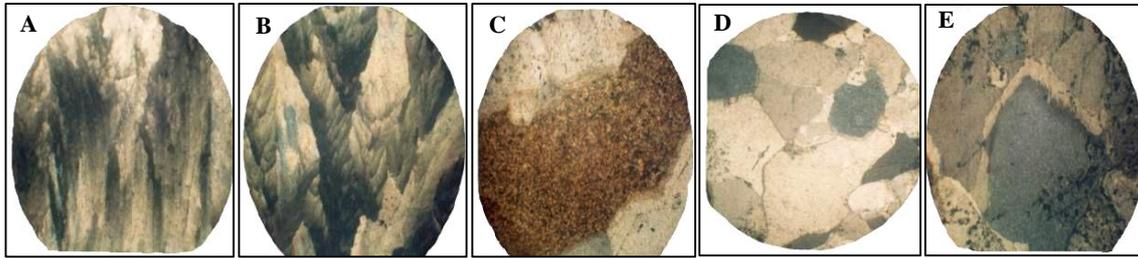
Figure 10 (a,b,c,d,e) petrographic view of massive alabaster at **a** Wadi Sannur, **b** Coarse elongated calcite crystals, **c** cavernous alabaster **d** the grains are cemented in some parts by iron oxides, **e** crystals show rows of fibrous mosaic, (X40)

crystalline rock with abundant cavities. These cavities are filled in some parts by red to reddish soils. The unfilled voids are present between the progressive crystalline calcite. From specialized point of view, the petrographic examination of translucent alabaster of the Wadi El-Assiuty shows calcite spar crystals with variety of bands consists of elongated fibrous crystals with the opaque milky white type. The petrographic examination of the Archaeological alabaster samples shows calcite grains with milky white grains which are very fine grained (micrite) to visible medium grains; it was observed destroyed calcite grains and micro crack in other crystals with halite crystal and hexagonal gypsum crystal with fine opaque iron oxide. The micro cracks, halite and gypsum crystals related to weathering processes, all of these features are shown in figs (10-a, b, c, d, e) (11-a, b, c) (12-a, b)

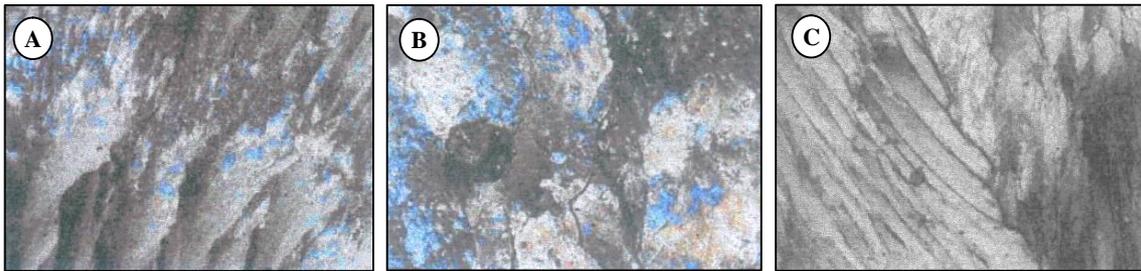
Figure 11 (a, b, c) the petrographic view of translucent alabaster of the Wadi El-Asuity, (X40).

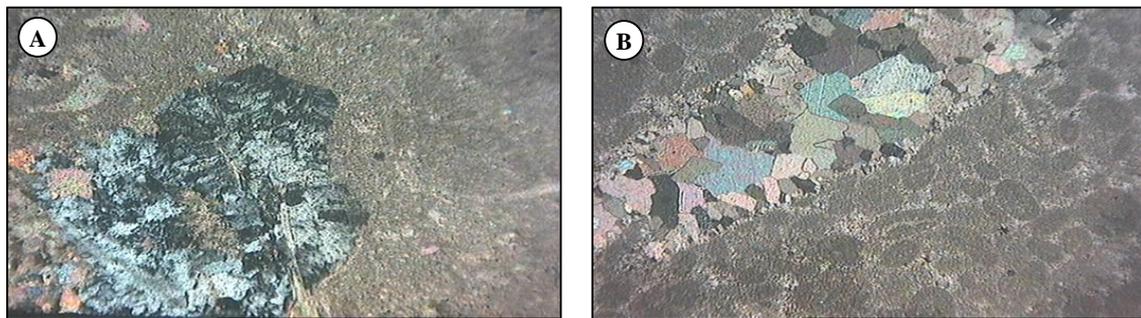
Figure 12 (a, b) the main minerals constituents of alabaster offering table on Karnack temples and Amon statue at Luxor temple (X40)

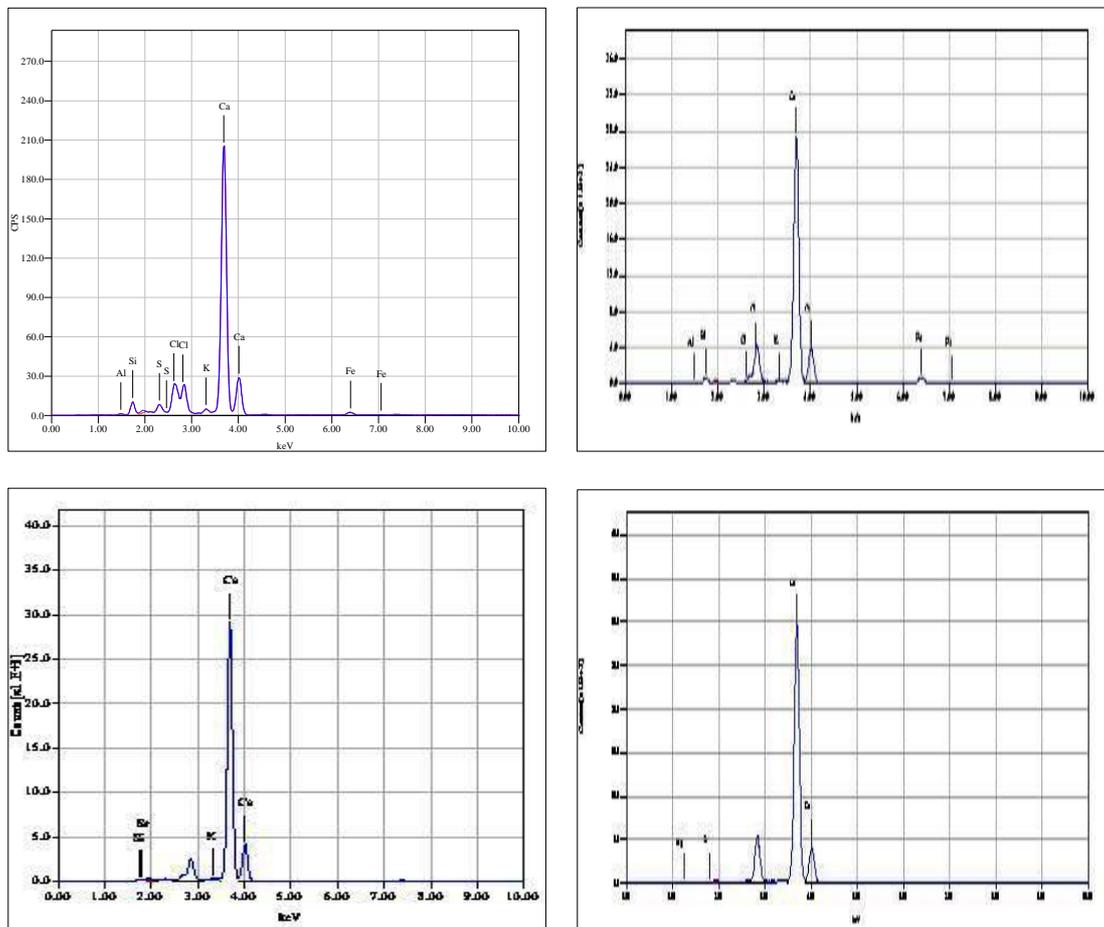
Figure 13 (a, b, c, d) the XRF pattern of **a** Amone samples, **b** Ammonite samples, **c** Wadi Sannur samples, **d** Wadi Assiuty samples

X-ray fluorescence detects higher calcium content in all samples and traces of S, K, Fe, Al, Sr and Mg contents in Wadi Sannur samples. The analysis

detects higher silica and chloride content in archaeological samples and less content of calcium. The values are showed in tab. (1) & figs. (13-a, b, c, d).

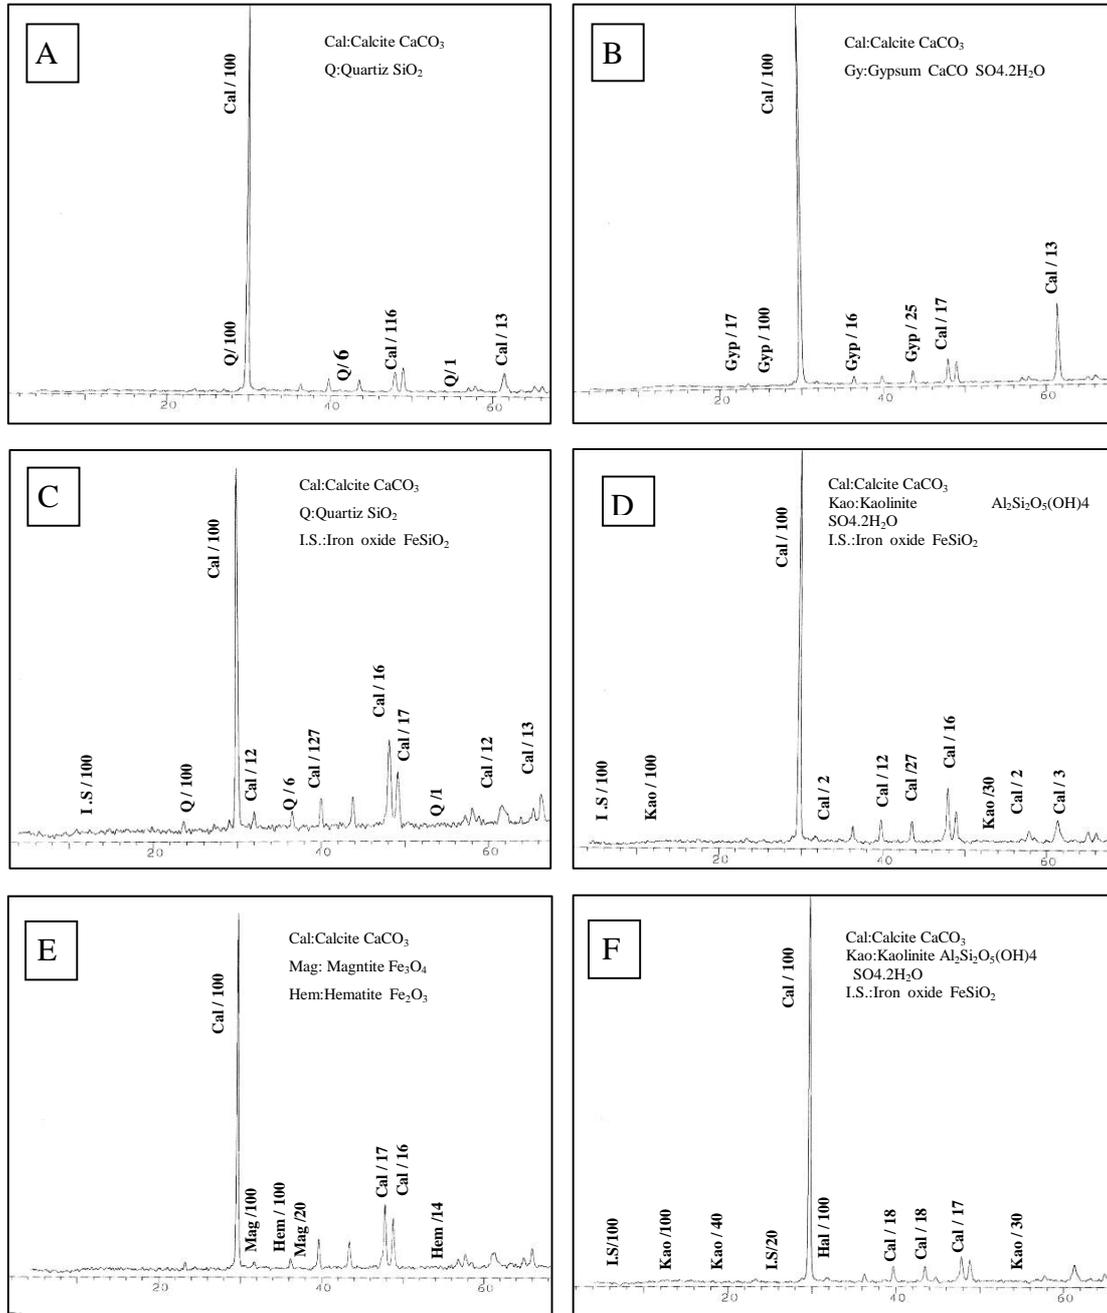
Figure 14 (a, b, c, e, f) XRD pattern of alabaster samples, alabaster consists of calcite ( $\text{CaCO}_3$ ) as a major minerals.

The results obtained by XRD analyses showed that all samples consist of calcite CaCO<sub>3</sub> as main mineral component with a smaller quantity of Quartz SiO<sub>2</sub>, Iron Silicate

FeSiO<sub>2</sub> and Kaolinite. Archaeological alabaster samples shows less ratio of Halite NaCl and Gypsum, fig.14 (a, b, c, d, e, f)

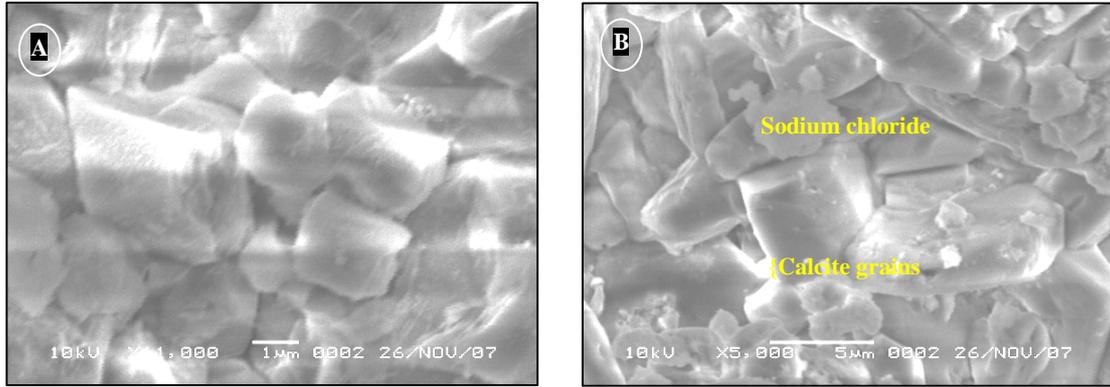
Figure 15 (a, b) SEM micrograph shows the different morphology of the calcite grains of the alabaster stone.

The study carried out through SEM allows us to confirm the result already obtained through other analysis. It revealed that the main mineral constituent of studied alabaster are calcite grains with cubic and longitude form, fig. 15 (a, b), cemented in some parts by iron oxides. The clay minerals and Gypsum are also existing among the calcite grains, fig. 16 (a, b, c). Scanning study also indicated sodium chloride in

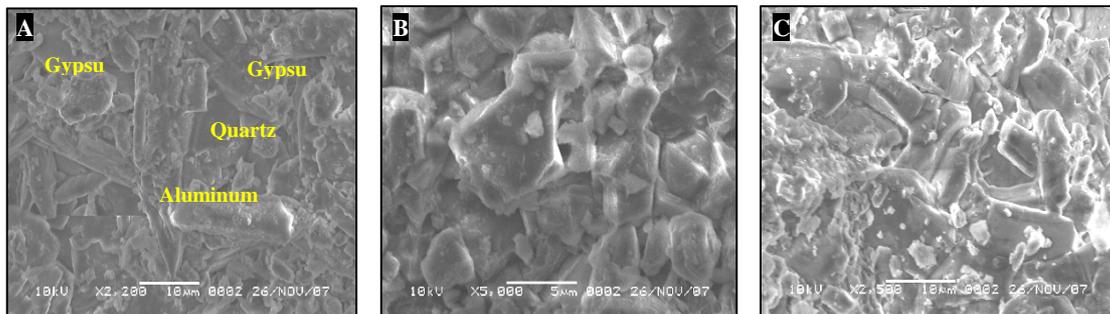
Figure 16 (a, b, c) SEM micrograph shows **a** clay minerals, prismatic crystals of halite and gypsum, **b** sodium chloride in cubic form between grains of calcite from statue of Amen in Luxor temple, **c** destroyed of calcite grains from the Thutmose IV offering table in the Karnak temple

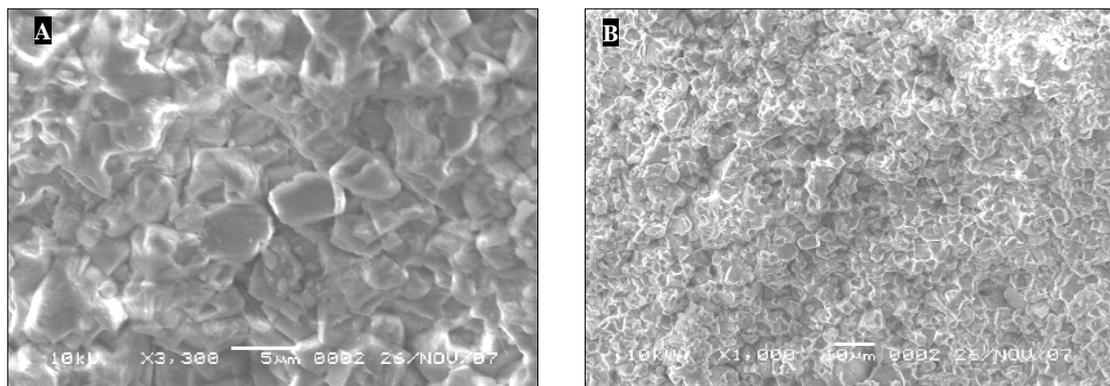
Figure 17 (a, b) SEM micrograph shows the mineralogical component of alabaster at Wadi Sannur.

to phases of crystallization, they are cubic form, fig. 17 (a, b) and prisms one like crystals, fig. 18 (a, b). SEM shows the disintegration of Calcite grains and has different weathering noted as grain surface damage and micro-exfoliation due to the effect of soluble salts. Also, it showed the content of gypsum in the samples is due to the transformation of calcite into gypsum.

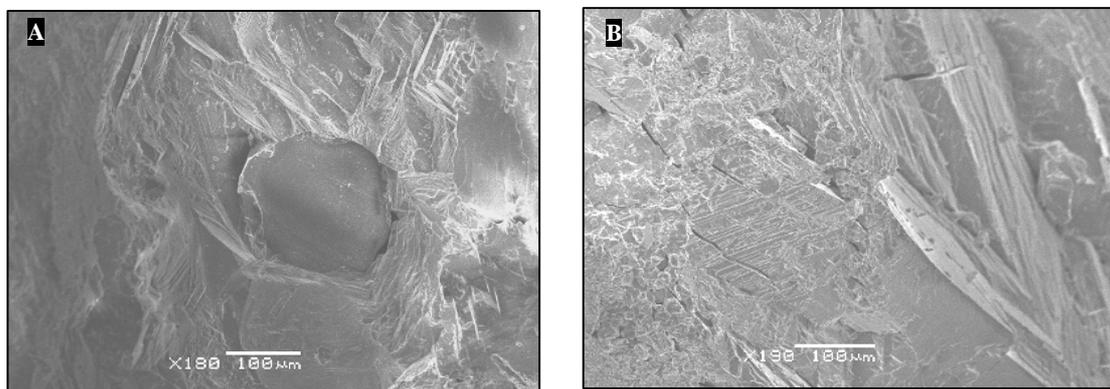
Figure 18 (a, b) SEM micrograph shows the mineralogical component of alabaster at Wadi El-Assuity.

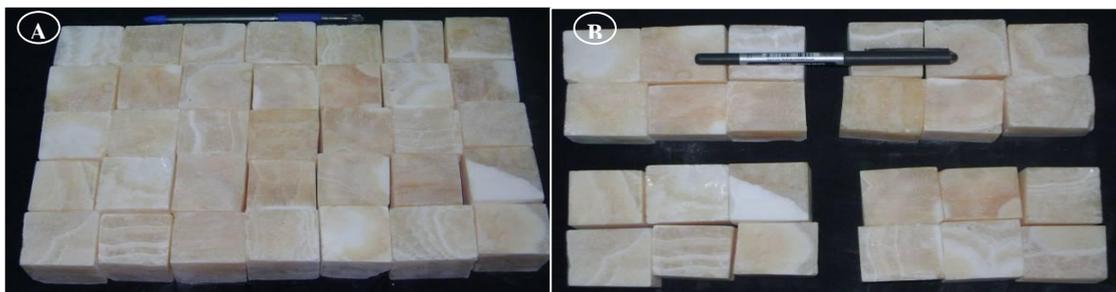
Figure (19) the alabaster samples before any treatment or artificial weathering.

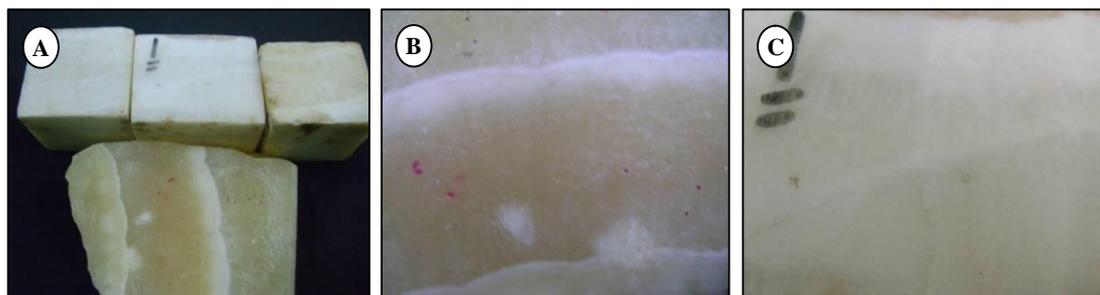
Figure (20) alabaster samples after heating ageing cycles.

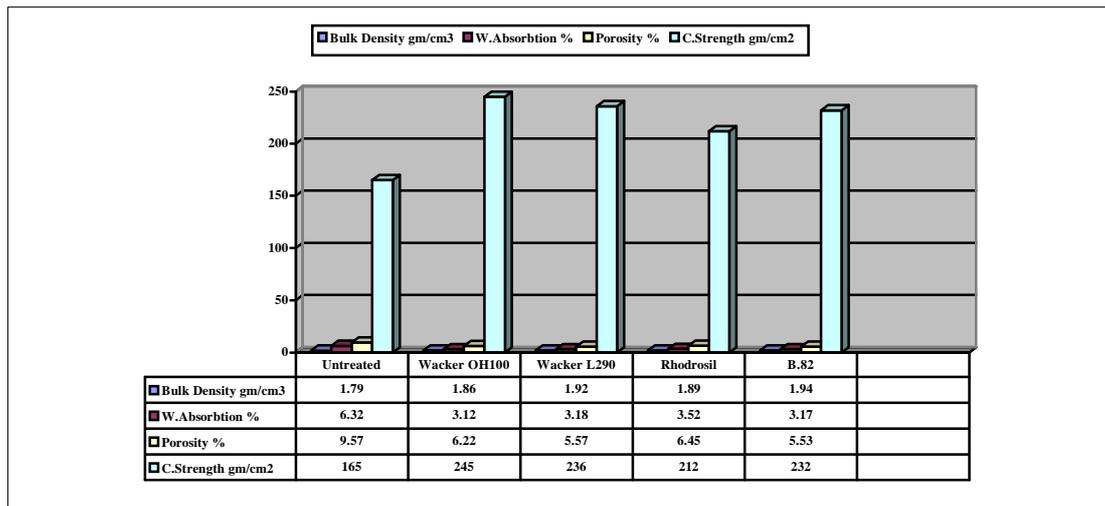
Figure (21) physical and mechanical properties of consolidant materials applied on Alabaster

the treatment, the best products are Rhodorsil 224 and Wacker L290+B66, for the Acryloid B-82 changes are quite slight and did not modify the total appearance of the treated stone. The Wacker OH+B72 change the color of the alabaster significantly to an unacceptable level. The performance of the physical properties and changes in porosity of the consolidant materials applied on the alabaster samples is shown in fig. (21).

treated samples. The sodium Rhodorsil 224 has diminished the water absorption practically to minimum: from the 6.32% for untreated stone to 3.52% for the treated, it improved the bulk density from 1.79 in untreated sample to 1.86 for the treated and the compressive strength increase from 165 kg/cm<sup>2</sup> for untreated samples to 212 165 kg/cm<sup>2</sup> to

the treated samples. The Wacker L290 + B66 has the lowest diminish of water absorption (3.18%). It improved the compressive strength from 165 kg/cm<sup>2</sup> for untreated samples to 236 kg/cm<sup>2</sup> to treated samples. silicon compound Wacker OH+B72 have very close properties in all the tests characterized by the good absorption diminish about

3.12% for water absorption and gave the high degree of compressive strength 245 kg/cm<sup>2</sup>. The Acryloid B-82 has the most effective diminish of the water absorption (3.17%). According to the obtained data from the evaluation of the efficiency of the compressive strength of the products laboratory, it could be concluded that: all consolidant treatment improved the compressive strength of all samples. The consolidant samples were subjected to 20 wetting-drying and sodium chloride ageing

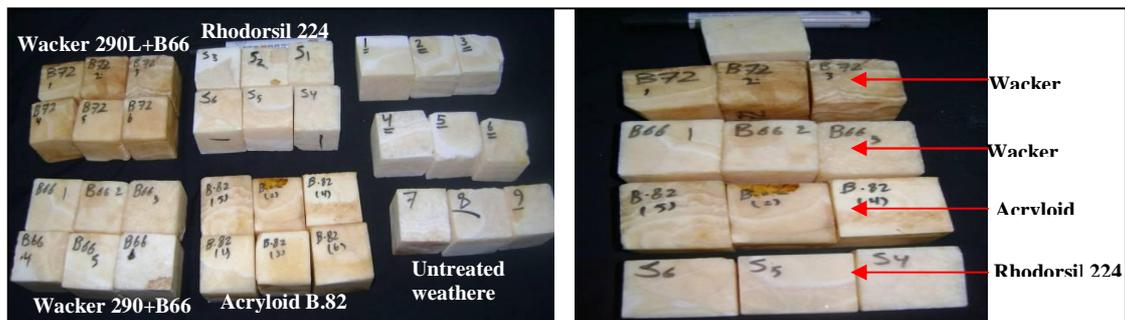
Figure 28 (a, b) alabaster samples after treated with consolidants .

cycles. The same pervious properties were measured. Samples of alabaster endured all 20 wetting-drying cycles without heavier damage but some deposits started to form on the surface. There was no perceivable change in the appearance of samples treated with silicone-based, remarkable change arose in the Acryloid B.82 which employed changed the alabaster-color turned darker, local glossy areas appeared on the stone surface after ageing cycles as shown in fig. 22 ( a, b).

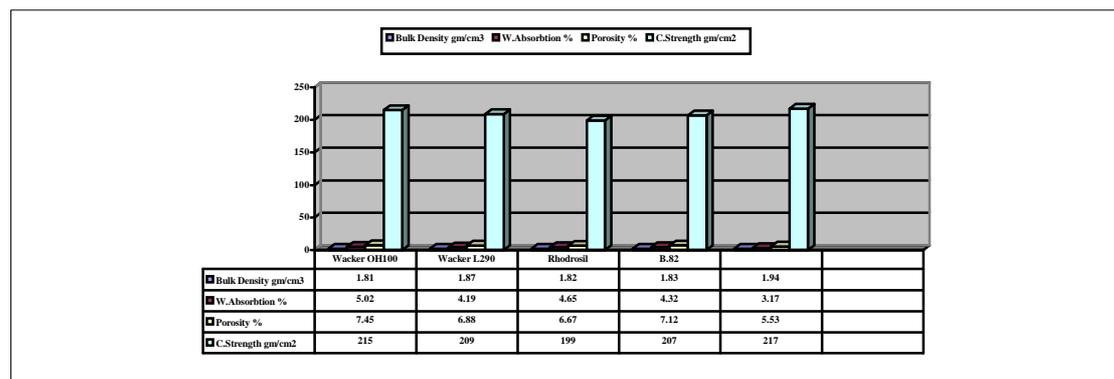
Figure (23) physical and mechanical properties of consolidant materials after weathering cycles

As expected, the percent water absorption was significantly diminished by treatment with the Rhodorsil 224 consolidant, but not for those treated with the B 72. Reduction of porosity was small with both treatments,

indicating the retention of a relatively open pore structure. There was a substantial increase in compressive strength in samples treated with the B 72, B 66, and B 82 consolidants, fig. (23).

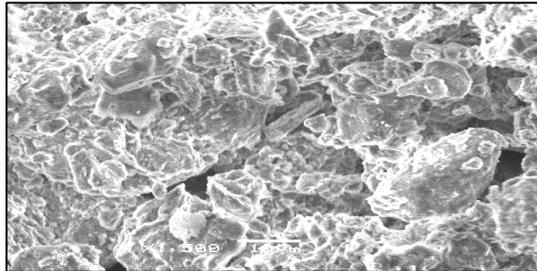
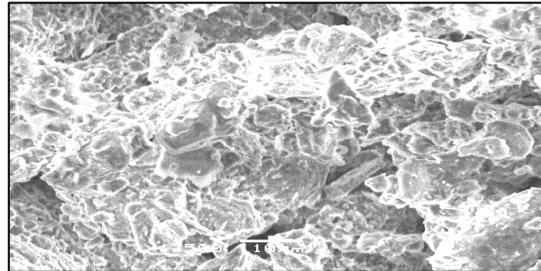
Figure (24) SEM micrographs of alabaster samples treated with *Rhodorsil. 224*

was to be expected, the consolidants were deposited in the pores and in less dense sections of the contact zone. The consolidant were found to be present on the surface of the alabaster grains and on the other structure units neighboring the pores, as well as in the contact zone. Only in the case of the Wacker-silicone

them on others. Wacker OH + B72 show some micro-cracking after ageing, all of the morphological features of the investigated samples are as shown in figs. (24, 25, 26, 27).

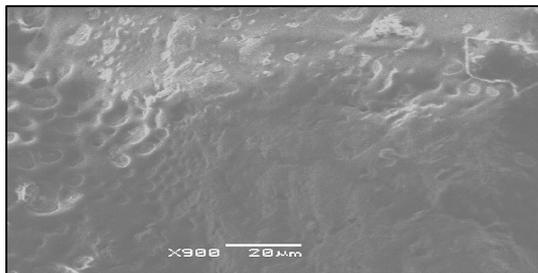
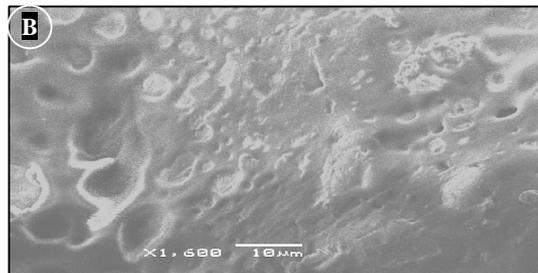
Figure (25) SEM micrographs of alabaster samples treated with *Wacker-silicone 290L*.

290L is there variation in the initial aspects of the samples after the treatment.. Where the mineral grains seem clearer after covered them, one may also note a rigid layer being formed, covering grains sometimes and joining

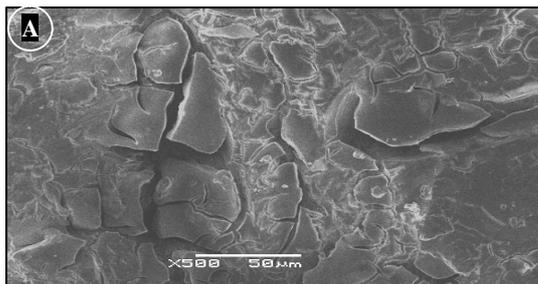
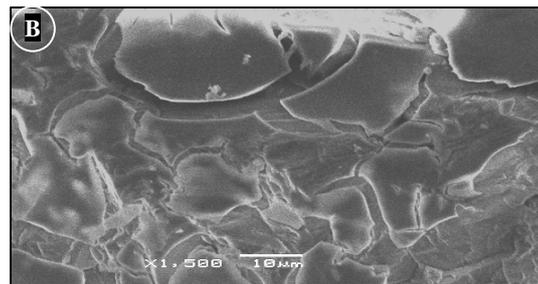
Figure (26) SEM micrographs of alabaster samples treated with *Wacker OH+B72*

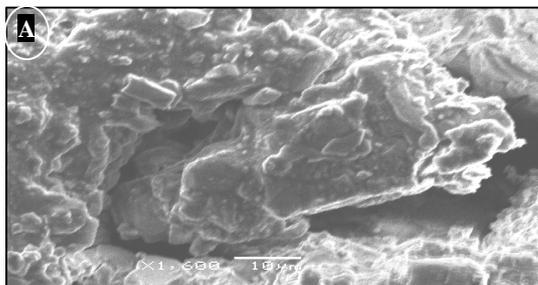
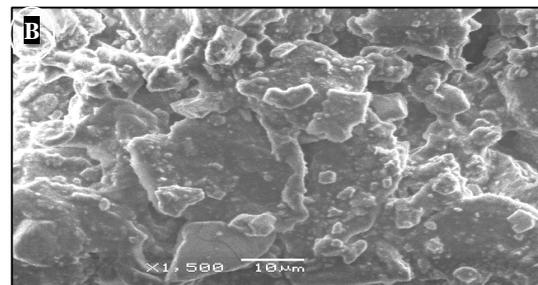
Figure (27) SEM micrograph of treated Alabaster sample with *Paraloid B.82*
