Original article

DETERIORATION MECHANISMS AFFECTING THE BRICKS USED IN THE
BUILDING OF THE WATER WELLS AT KARNAK TEMPLES, LUXOR, EGYPT

El-Badry, A.

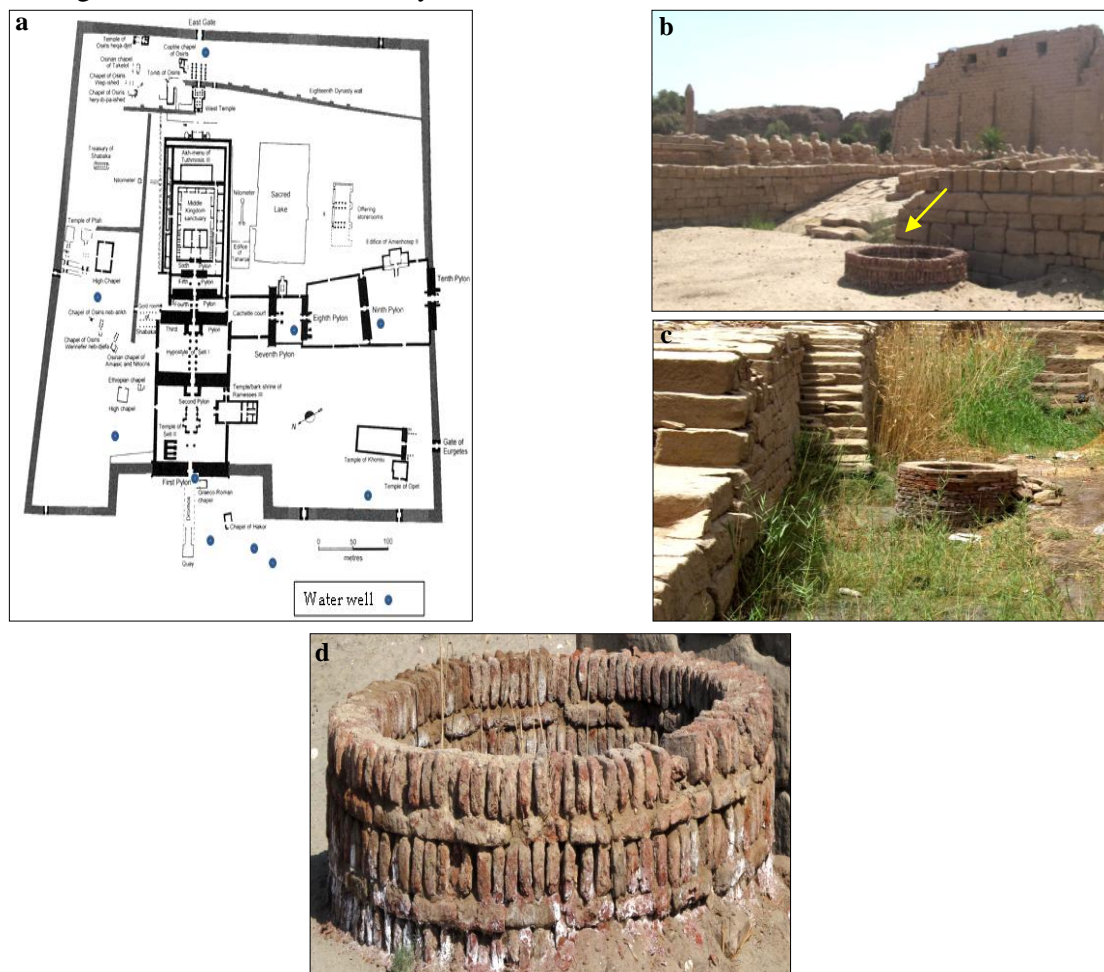
and buried under soil. There were several methods for building in ancient Egypt and from the field observation we conclude that, the building method used in construction the water wells at Karnak temples is the Egyptian bond (English bond), fig. (1-d), the bonding on the faces of those walls shows alternate layers of headers and stretchers [6] different sizes of red brick employed in construction of those water wells and the almost brick's dimensions are $28 \times 14 \times 6$ cm. So that, the red brick dimensions vary according to the geographical area, the historical period [7] and the construction type also. According to [8] the mortar used in these wells was lime mortar. That mortar was suitable for use in damp places, since it is impermeable to water and is found in Ptolemaic and Roman fired-brick structures, especially baths and conduits, where it was necessary to make the joints waterproof. During the Graeco-Roman and Byzantine

Figure (1) Shows **a.** location of water wells inside Karnak temples complex (after Blyth, 2006 & CNRS 2019), **b.** well in the front of the first pylon of Karnak, **c.** well close to embankment at El-madrassa site, **d.** building methods of water wells at Karnak temples

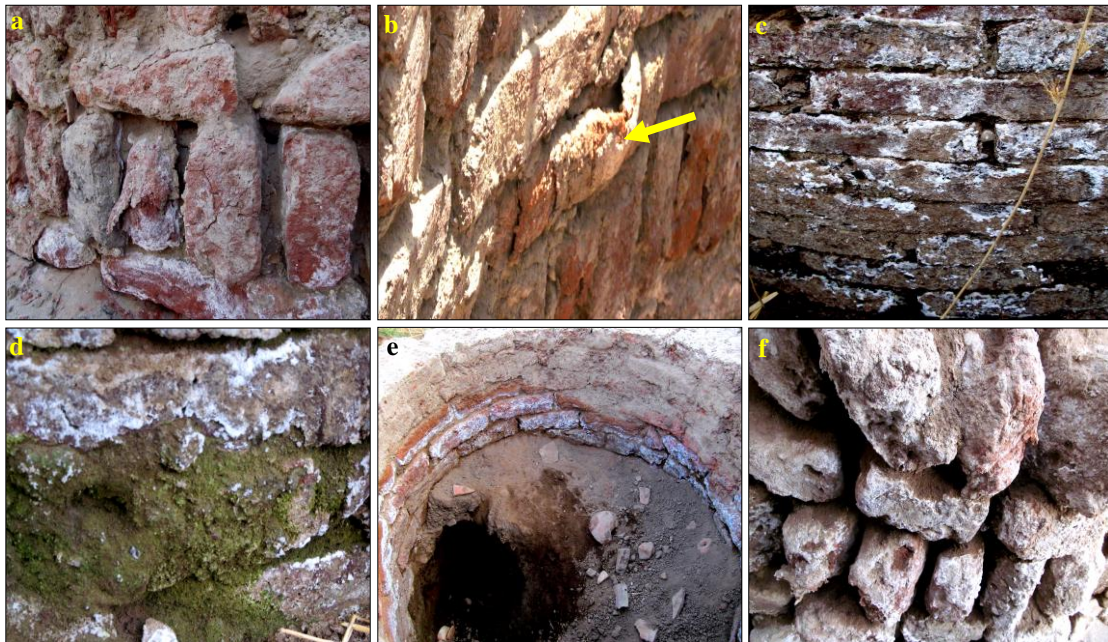
Field observation for water wells at Karnak temples has proved that, the bricks had been exposed to either burial and aerial environments so the bricks become very weak and losing cohesion among their components because of its exposition to many deterioration factors such as; extreme temperature, solar radiation, moisture variation, saline solutions, atmospheric gases, and microorganisms effects in addition to the intrinsic physical properties, mineralogical composition of the raw materials and firing temperature of the bricks [12], in addition to other parameters that include the composition of the mortar, and the properties of the masonry unit/mortar combination [13]. All these conditions play an important role in the deterioration aspects such as; changes in chemical and physical compositions of the bricks especially when buried in a salty ground. In addition to exfoliation [14] and formation hard crusts due to crystallization of salts under

sub-strata, disintegration, spalling, cracks and fractures. Also, moisture penetration along these cracks or pore passageways causes the severe damage for the red bricks and the mortar [15]. Other deterioration aspects are represented such as the action of biological colonies [16] and vegetation. The damage and collapsing of the architectural features or destruction some parts of the construction were observed in some wells due to deposits press before excavation. All these deterioration phenomena caused decohesion and weakness of the structure and texture of wells and brick units also loss of the binding mortar used in construction process as shown in, fig. (2-a,b,c,d,e,f). The aim of this article is to study the deterioration mechanisms of the brick units used in building of these wells and to prepare a conservation plan.

Figure (2) Shows deterioration features of water wells at Karnak temple **a.** exfoliation, **b.** crumbling, **c.** efflorescence, **d.** algae colonies, **e.** filling up with debris, **f.** partial collapse of the structure.

Field observations and lab analyses have cleared that the brick used in water wells at Karnak temples suffer from many deterioration factors and their features. Therefore, the wells need to different treatments and conservation processes, such as:

- * Performance archaeological studies on that wells to determine their historical periods.
- * Mechanical cleaning and complete the excavations to remove debris from inside the wells.
- * Cleaning and removal of vegetation, weeds and grass from inside and outside that wells.
- * Periodically mechanical cleaning of crystallized salts on the surfaces of the brick, during the lack of water and/or during the dryness periods.
- * Restoration and completion of the missing parts from the wells using a suitable brick blocks and mortar of natural lime.
- * Consolidation weak brick units using appropriate water-repellent materials or with Ethyl Silicate (TEOS) which gave a significant improvement for the physico-mechanical properties of the red brick [37] and provide an efficient protection against sodium sulfates [38].
- * Decoding and re-installation of some fragmented brick blocks using appro-

- * Mechanical removal of dry biological colonies from the bricks and using chemical pesticides for future resistance and prevent their growth in the future.

- * Periodical and continuous monitoring the status of water wells to observe any changes in their conditions.
- * Removal of soluble salts by appropriate techniques; mechanical cleaning with brushing and scalpels or using a suitable poultice; sepolite clay, or any other appropriate poultices.

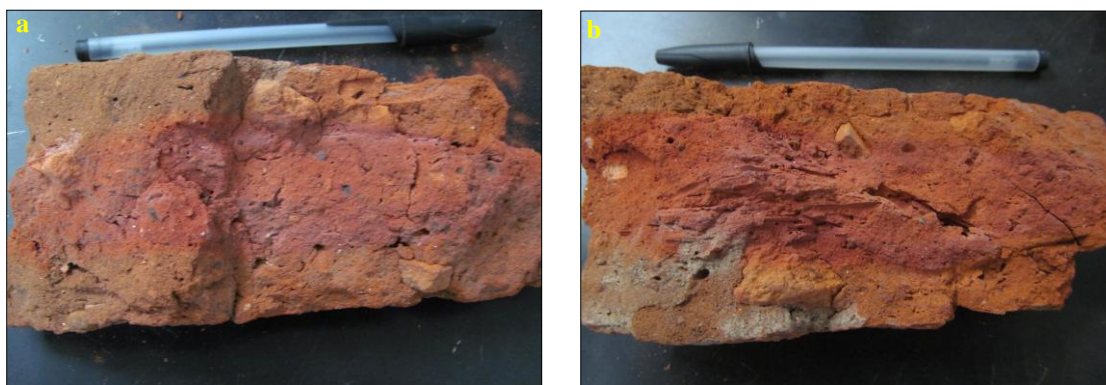
A scientific digital camera was used for determining the visual features of brick samples especially the texture and color; the images of red brick samples, fig. (3-a,b) have illustrated different colors

and textures, that range from very fine to very coarse, and that the bricks contain different materials such as; pottery shreds, red brick fragments, chert pebbles.

Figure (3-a, b) Shows different colors and texture features of the red brick samples collected from Karnak temple wells

Through analyzing the previous data it could be noted that visual examination by scientific digital camera, fig. (3) has cleared that, the brick samples of water wells at Karnak temples contain different textures range from fine grains (silt) to very coarse (sand) due to the variation of the materials of raw clay used in making that brick which include pottery shreds, red brick fragments, chert pebbles, the color of brick is also varied greatly between light, yellow, reddish, to brown and black due to the variations of firing temperature, and the placing of the brick units in the kiln [19] in addition, the color is an indicator of the type of soil used. LOM investigation, fig. (4) has illustrated that, the brick contains some components which were added during manufacturing process such as; pottery shreds, limestone and red brick fragments, moreover organic materials such as; chopped straw (hay) and animals dung, the presence of these materials in the structure after firing the brick considers as the manufacture defects and indicate that; the red brick was fired in low temperature [20]. The LOM investigation also has revealed that, the samples suffer from several deterioration aspects such as; large holes, deep voids, fissures, cracks and fractures, all the previous highly affected on the physical status of the brick. Furthermore, the petrographic study, fig. (5) has revealed that, the brick samples contain both inorganic and organic materials as follows: The inorganic materials represented mainly in quartz, feldspar, mica, allanite, zircon,

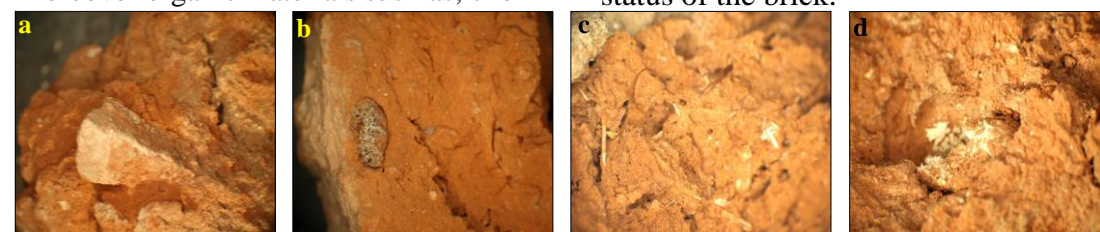
Light Optical Microscope (LOM) images of brick samples, fig. (4-a,b,c,d), have illustrated that, the brick contains different components such as; pottery shreds, limestone and red brick fragments, moreover organic materials such as; cho-

pped straw and animals dung. LOM also has revealed that, the brick suffers from several deterioration aspects such as; large holes, voids, fissures and cracks, all the previous highly affected on the physical status of the brick.

Figure (4) Shows micrographs of investigated red brick samples by LOM (4-X) **a.** pottery fragments, **b.** red brick fragment, **c.** different organic materials, **d.** animal dung.

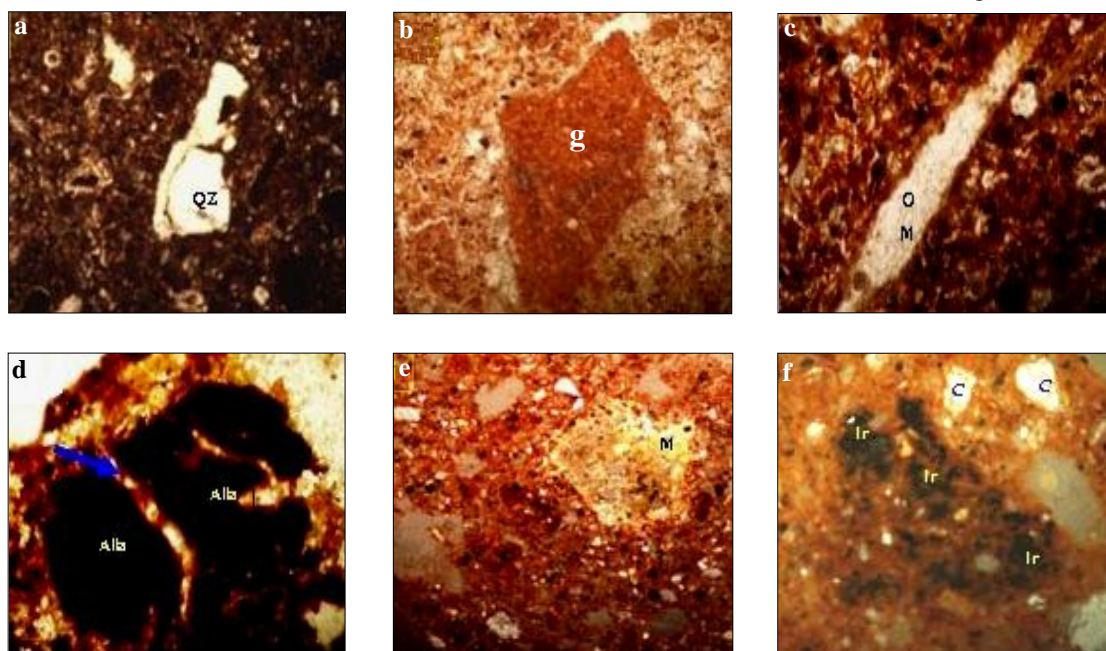
The Petrographical study by polarizing microscope (PM) was carried out for the concerned red bricks, which illustrates that, the brick samples from water wells at Karnak temples, fig. (5-a,b,c,d,e,f) illustrates that, the brick is mainly composed of quartz, feldspar, mica, allanite, zircon, iron oxide and rock debris as original constituents. Sericite,

chlorite and epidote are secondary constituents due to many alteration processes. Pottery fragments and chopped straw as an additional constituent. Quartz grains or free crystalline silica, varied in size, shape, mainly angular to sub-angular in rich ground of iron oxides and clay minerals mixture, fig. (5-a). Feldspars minerals also are represented as one of the main

components in the brick samples. They are as plagioclase (albite) and alkali feldspars (microcline); plagioclase crystals occur as subhedral to anhedral, characterized with twin lamination, turbid, cracked and commonly stained by iron oxides and enclosed with iron oxides granules, which gives it a brown pigmentation due to the intensive alteration. Microcline crystals appeared as subhedral to anhedral, characterized by cross hatch twinning. Some samples of the brick contained a high amount of accessory constituents such as zircon, pyroxene, garnet and amphibole. In addition to several lithic fragments of various igneous and siliceous rocks such as; chert and micro-granite, fig. (5-b). In the all studied samples of bricks, abundant amounts of some none clay minerals such

as limestone fragments (calcite) as one of the main components in the brick, while pottery fragments (Grog) occur as sub-angular to sub-rounded shape and calcite rim surrounded the pottery fragments. Furthermore, some burning fibers such as chopped straw one of organic matters which were added during brick making is more abundant in the samples, fig. (5-c). The deterioration features of the brick such as deformed and cracked allanite crystal filling with calcite vein, fig. (5-d), as well as mica mineral (biotite) which is strongly altered to chlorite and epidote, fig. (5-e). One of the main features in the studied samples is that, the iron oxides stained most of the mineral grains in the brick especially calcite grains with reddish and chocolate brown colors, fig. (5-f).

Figure (5) Shows petrographic micrographs of weathered redbrick from water wells at Karnak temple; by PM (40-X) **a.** quartz grain in rich ground of iron oxides and clay minerals, **b.** microgranite fragment, **c.** chopped straw, **d.** deformed allanite crystal filling with calcite vein, **e.** mica crystal altered to secondary chlorite and epidote, **f.** iron oxides stained calcite grains with chocolate brown colors.

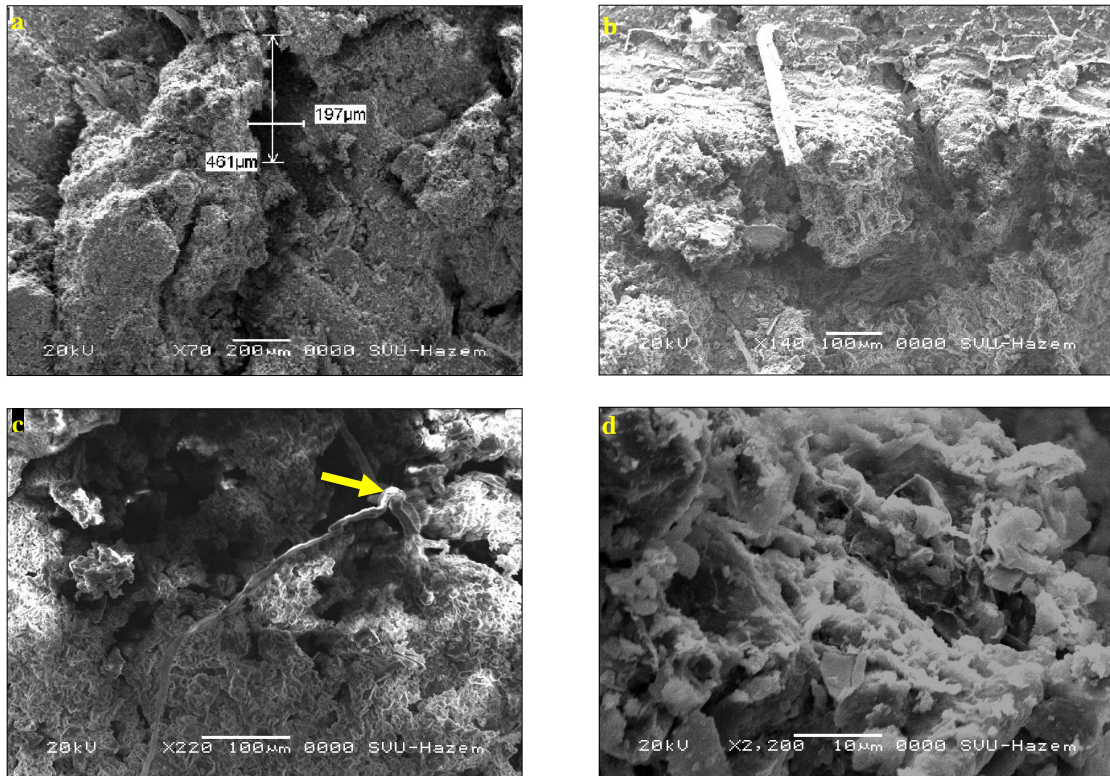
Some samples of weathered brick were studied by Scanning Electron Microscope (SEM) and have proved that, the brick is highly affected by deterioration mechanisms as follows; The formation of network of cracks and fissures, fig. (6-a) which lead to increase the porosity, loss of strength and durability of the brick, in addition to collapse, internal exfoliation

and rupture of internal structure of the brick, some of dilated fractures caused the discontinuation and splitting the brick texture and that promoted the penetration water and saline solutions inside the pores of brick, and (by) that means contributes to dissolving and loss of the chemical components. Furthermore migration and wash up of clay nodes, disintegration, eroded

quartz grains and formation the large voids and cavities in the brick. The SEM micrographs have cleared also that; some fibers and residual organic matters which were added during brick making process for instance, chopped straw, fig. (6-b) resulting from inappropriate firing temperature, these organic materials aid (assist) to the microbiological attack and growth the algal and fungal colonizations which generated a severe damage and degradation of brick originating from the growth of fungal hyphae or the fruiting bodies, fig. (6-c) either on or below the surface and caused dislodging of the various mineralogical grains of the brick and motivate the salty weathering of brick. The SEM investigation has revealed also that;

different forms of crystallized salts such as halite and thenardite, fig. (6-d) [according to XRD analysis for the same samples] both are very common salts in a wide range of locations and environments, and extremely destructive and represent aggressive deterioration forms because of its extreme hygroscopic, frequently dissolution and crystallization, hydration and crystallization pressures of that salts which lead to a high degree of volume changes when hydrated, consequently these dangerous salts also cause weakness, destruction, breakdown the brick, disassembling and dislocation of the mineralogical grains as well as dechosition and disintegration of the brick.

Figure (6) Shows SEM Micrographs of weathered redbrick from water wells at Karnak temple; **a.** cracks and rupture of internal structure, **b.** chopped straw, **c.** the growth of fungal hyphae, **d.** salts of sodium sulfate (thenardite).

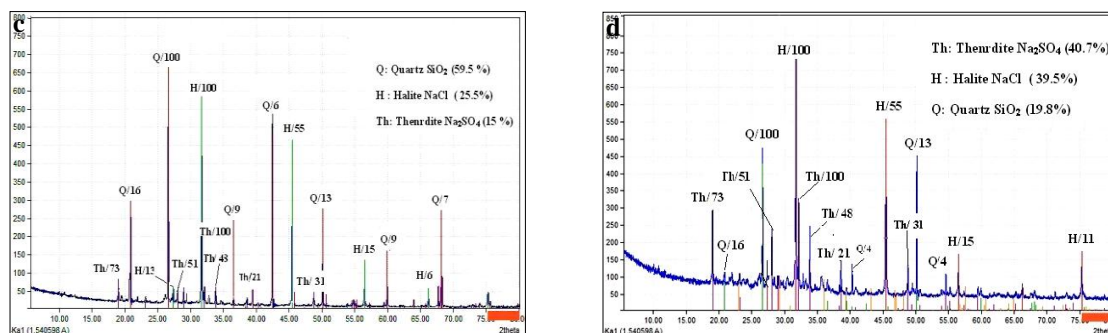
The X-ray diffraction analysis (XRD) for weathered samples of brick show that; the bricks suffer from aggressive damage by salts as shown in tab. (2) & fig (8). The results of XRD have revealed that, the brick consists of quartz SiO₂ and

plagioclase feldspar (albite Na Al Si₃O₈) as main components in clay. In addition to sodium chloride (halite NaCl) and sodium sulfate or (thenardite Na₂SO₄) as deterioration or weathering products.

Figure (8) Shows some XRD patterns of weathered red brick of water wells at Karnak temples.

Thenardite may be transformed from water free stage (Na_2SO_4) to the hydrated phase mirabilite ($\text{Na}_2\text{SO}_4 \cdot 10\text{H}_2\text{O}$) and that may cause increasing the volume between 70-250% [34] and/or reach to 308% [35] this change in the volume leads to the creation of severe damage such as; fractures, crumbling, disintegration in addition to salts crystallization, the salt
