**CHARACTERISTICS OF BUILDING MATERIALS EXPOSED TO
GEOENVIRONMENTAL IMPACTS IN MAKAAD RADWAN, OTTOMAN
CAIRO, EGYPT^(a)**

Ali, M.¹, Alenbaawy, M.² & Moussa, A.¹

Abstract

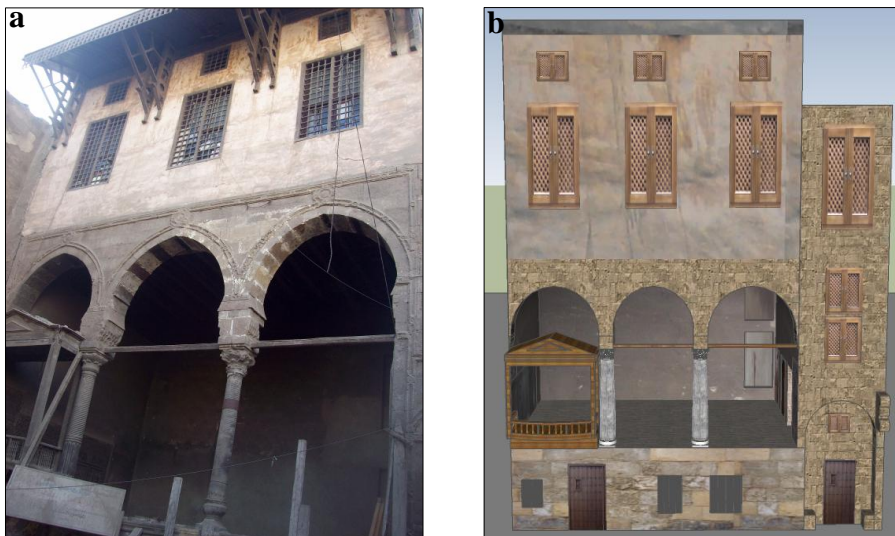
Figure (2) **a** the Mekaad Radwan, **b** The Mekaad Radwan façade (AutoCAD)

Makaan Radwan, fig. (1) is one of the civil architectural buildings that were founded by the ottoman pasha Radwan Al-Faqary who used to be the governor of Al Mansoura governorate in the ottoman period of Egypt. It has been built in 17th century (1635 AD). The building is located in old Cairo front of Bab Zweilah (Zweilah gate) and behind Souq El Khayameya, fig. (2). The monument is a part of a complex known as Radwan Palace or Qasabet Radwan which carries number 406 in the Egyptian classification of Islamic and Coptic monuments, while Makaan Radwan carries number 208 which is a separate number apart from the main monument [1]. The references available on the place and surrounding territory don't

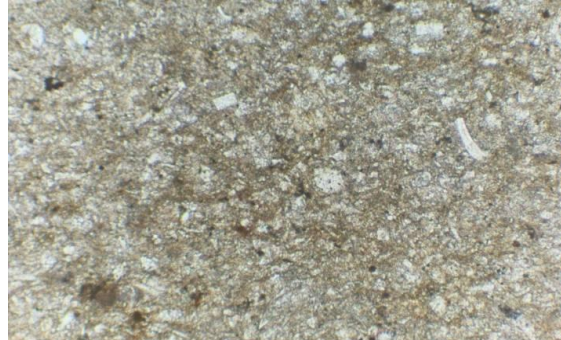
Figure (4) micro-porosity with numerous dissolute pores and microcavities in the first limestone type at Makaad Radwan

type (Foraminiferal lime-mudstone or wacked-stone), figs (3 & 4). The most common type consisting the limestone blocks of the internal western and eastern walls of the Makaad Radwaan meetings room and is represented by sample (LSC). The second type (Dolomitic skeletal

ranges from foraminiferal lime-mudstone to wakestone showing microporosity with numerous dissolute
