STUDY AND CHARACTERIZATION OF XENOLITHIC STRUCTURES TRAPPED IN GRANITIC MONUMENTS: A CASE STUDY

Hefni, Y.

EJARS – Vol. 11 (1) – June. 2021: 39-46

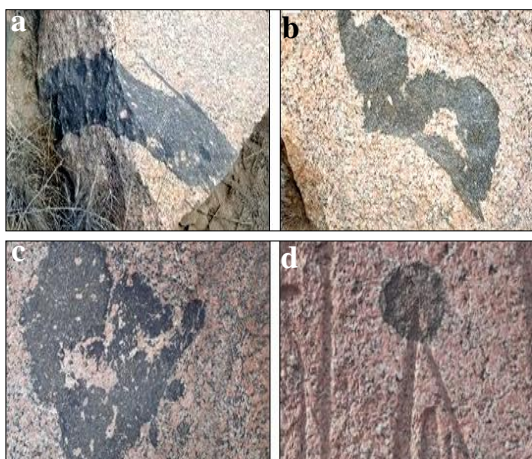
Figure (1) Shows xenolithic structures in Egyptian granitic monuments; **a.**, **b.** granitic remains at the city of Bubastis; **c.**, **d.** granitic remains at the city of Tanis.

fallen from the walls or roof of the magma chamber. Xenoliths are usually visible and easy to be recognized, due to their different compositions, colors and density than the host igneous rocks. Generally, they appear in different irregular shapes, but most of them are rounded, subrounded and angular. They range in size from small fragments (few centimeters) to very big blocks (several meters) [10-12]. Xenoliths are called cognate xenoliths or autoliths if they are derived from fragments genetically related to the host igneous rocks. The fragments of cognate xenoliths crystallized from the same magma of the enclosing rock, but at the early stage of crystallization. Xenoliths provide some valuable information on the composition and nature of basement in the inaccessible areas. They also present obvious examples of the complex interactions occurred in the underlying lithosphere (lower crust and upper mantle) [13,14]. Xenolithic structures are considered to be natural defects in the granitic rocks that highly affect their physicochemical and mechanical properties [15,16]. The ancient Egyptian sculptors and builders avoided using the defective granitic rocks in the fields of sculpting and architecture [17]. In rare cases, some sculptures and architectural elements were carved from granitic rocks containing xenoliths, fig. (1).

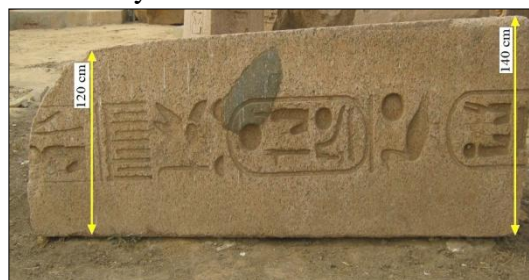
Figure (2) Shows xenolithic structure trapped in the studied granitic obelisk at Tanis.

liths appeared in Egyptian granitic monuments. The case study is a large piece of granitic obelisk related to the king Ramesses II, which was discovered in the temple of Amen at the archaeological city Tanis (*San El-Hagar, Nile Delta, Egypt*). The studied granitic obelisk represents one of the rare monuments that contain xenolithic structures, fig. (2). The main purpose of this work is to study and characterize the xenolith fragment trapped in the studied granitic obelisk. This study will provide good information about the nature of xenolith in addition to explain its effect on the granitic obelisk. Moreover, the results will help in making the future plan for restoration and conservation of the studied monument. The analytical study was carried out using different techniques such as polarizing microscope, x-ray diffraction, scanning electron microscope, EDS elemental analysis and BET surface area.

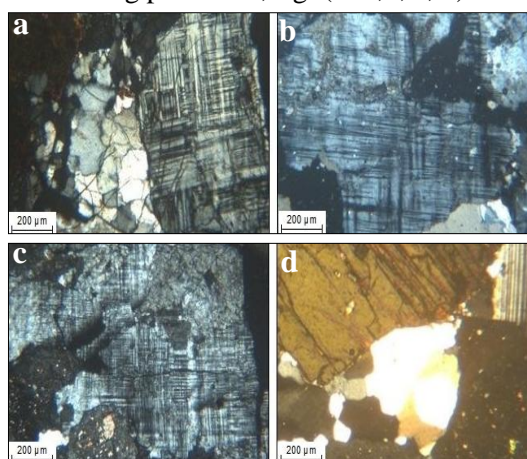
Figure (3) Shows cross-polarisers micrographs of the granitic obelisk; **a.** micro cracks of quartz and microcline, **b.** microcline and orthoclase showing perthitic texture, **c.** partial alteration of orthoclase into sericite, **d.** high deformation of biotite.

The petrographical study of the granitic obelisk and its xenolithic structure proved that the obelisk was sculpted from coarse grained granite. The granitic type is mainly composed of potash feldspars (microcline and orthoclase perthite), quartz and plagioclase feldspar associated with considerable amounts of biotite and hornblende. In addition, trace amounts of sphene, zircon and opaque minerals were detected. Potash feldspars (microcline and orthoclase perthite) are the most common constituents of the rock. They appear with medium to coarse-grained, generally subhedral to anhedral crystals and slightly altered to sericite. Plagioclase (albite) occurs as subhedral to euhedral crystals with albite twinning. Quartz appears with fine to medium-grained, anhedral crystals. It occurs as crystal ag-

regates that fill in the interstitial spaces between feldspar and mica crystals. Biotite exists in small amount as fine to medium-grained, flaky crystals in the interstices of feldspars and quartz. It suffers from surficial corrosion and partial alteration to iron oxides. Hornblende presents as fine to medium-grained crystals, associated with biotite. It is slightly converted to iron oxides. Moreover, quartz, feldspars and biotite are generally fractured and sutured due to weathering processes, fig. (3-a, b, c, d).

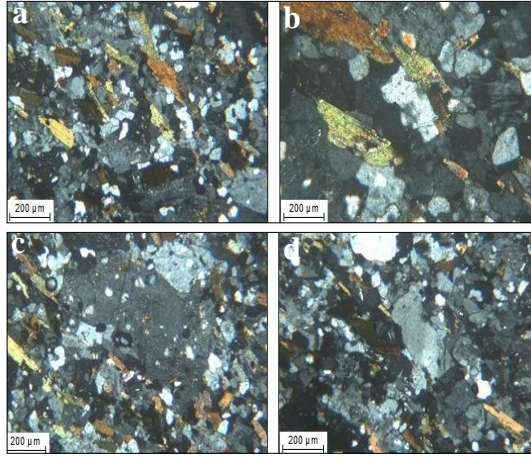
Figure (4) Shows cross-polarisers micrographs of xenolith trapped in the granitic obelisk; **a.** parallel alignment of minerals displaying schistose texture, **b.** plagioclase is altered to sericite and biotite is altered to sericite, chlorite and iron oxides, **c.** partial alteration of plagioclase to sericite, **d.** elongation of quartz in the direction of schistosity.

Based on the petrographic study, fig. (4-a, b, c, d) the xenolith fragment can be classified as biotite schist. The sample is principally comprised of biotite, plagioclase, quartz and hornblende. Trace amounts of sphene, muscovite and opaque minerals were also existed. These minerals are arranged in parallel alignment forming schistose texture. Biotite occurs as medium-grained to very fine anhedral to subhedral aggregates. It is partially to highly altered to sericite, chlorite and iron oxides in the cleavage planes and borders. Plagioclase presents as fine to coarse-grained, subhedral to euhedral crystals. It is partially and highly altered to sericite. Some plagioclase crystals are slightly elongated in the direction of schistosity. Quartz exists as very fine to medium-grained, anhedral, interlocked crystals. Some quartz crystals are stretched along the direction of schistosity. Hornblende exists

as fine-grained, subhedral prismatic crystals and commonly associated with biotite. It is partially altered to iron oxides in the cleavage planes and borders. Opaque minerals occur in minor amounts as fine to very fine-grained, anhedral to subhedral crystals.

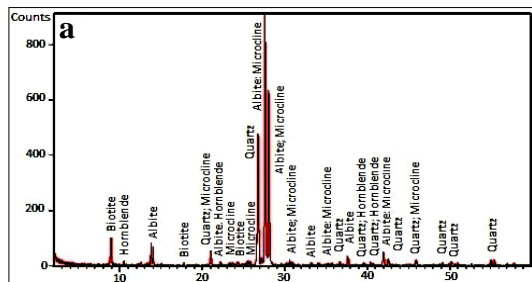
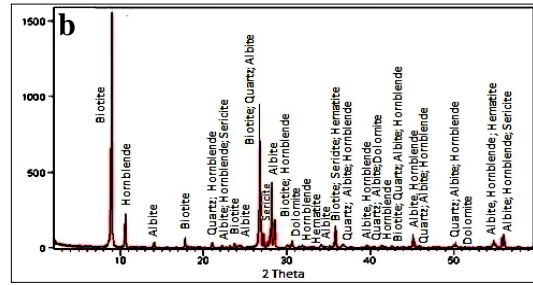
Figure (5) Shows x-ray diffraction patterns of **a.** granitic obelisk, **b.** xenolithic structure.

XRD pattern of the granitic obelisk, fig. (5-a) shows that it is composed of microcline, albite and quartz as main minerals. In addition, small amounts of biotite and hornblende are also detected. On the other hand, XRD pattern of the studied xenolith, fig. (5-b) declares that biotite, albite, quartz and hornblende are the primary and most abundant minerals. Furthermore, the minerals of sericite, dolomite and hematite were detected as secondary weathering products. Approximate percentages of the minerals detected in the studied samples are summarized in tab. (1).

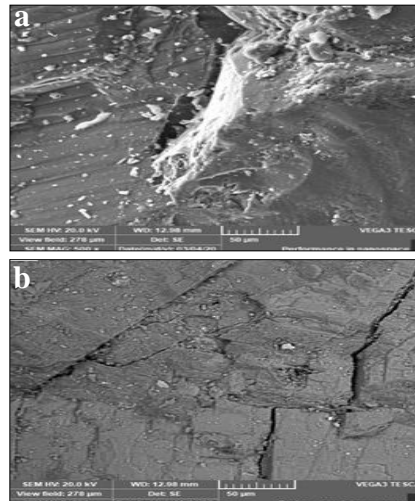
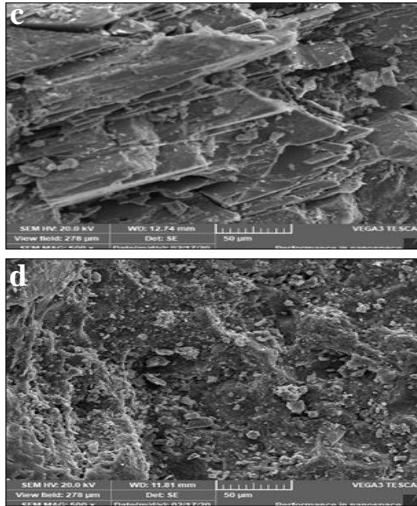
Figure (6) Shows SEM micrographs of the studied sample; **a.**, **b.** surficial corrosion, cracks and pits of granite samples, **c.**, **d.** xenolithic structure with very fragile surface with flakes, micro cracks, voids, etch-pits and surficial deformation accumulation of weathering products on the surficial layer.

The morphological features of the studied granitic obelisk and its xenolithic structure using SEM reveal that, on one hand, the granitic sample, fig. (6-a, b) has no significant mineralogical alterations occurred in the primary minerals. Surficial corrosion and tiny cracks were found as mechanical deterioration aspects. On the other hand, SEM micrographs of the xenolithic structure, fig. (6-c,d) indicate that it highly suffers from mechanical and physiochemical weathering. The sample appears to be very fragile and has many voids, micro-cracks, fissures, flakes, etch-pits and weathering products. These results illustrate the high weakness grade of the studied xenolith.

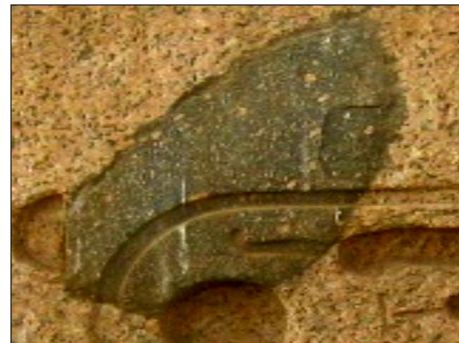
Figure (7) Shows the studied xenolith suffers from etch-pits, surficial deformation, flaking and erosion.

is associated with their expansion along cleavage planes and grain boundaries [32-34]. This expansion generates internal mechanical stresses which highly affect the surrounding minerals, leading to cracking, surficial deformation, granular disintegration and finally flaking of superficial layer, fig. (7). Furthermore, daily and seasonal variation of air temperature has contributed to the mechanical damage of xenolith [35]. These deterioration mechanisms led to the increase of porosity and surface roughness of xenolith, which caused its high surface area as observed by BET technique. High porosity of xenolith allows water to permeate through the outer layer, accelerating the physiochemical and microbiological deterioration factors [36,37]. It is worth noting that the characteristic schistose texture allows schist to be easily broken into very thin fragile flakes parallel to the schistosity [12,23]. Ultimately, the studied biotite schist xenolith is a very weak rock and more susceptible to damage comparing with its host granite.
