ANALYSIS AND TREATMENT OF MURAL PAINTINGS COVERED WITH PLASTER LAYERS IN YAKAN HOUSE IN HISTORIC CAIROAli, M.^{1(*)}, El-Habashi, A.², Taha, Sh.³ & Abd Elkawy, M.³¹Conservation dept., Faculty of Archaeology, Cairo Univ., Cairo, Egypt²Architectural Engineering dept., Faculty of Engineering, Menoufia Univ., Egypt.³Conservation dept., Ministry of Tourism and Antiquities, EgyptE-mail address: mona.aly@cu.edu.eg**Article info.****Article history:**

EJARS – Vol. 13 (1) – June 2023: 47-59

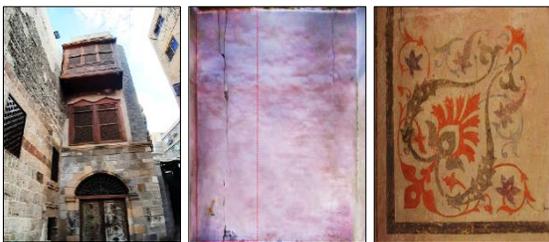
Figure (2) Shows **a.** the main entrance of the Yakan house, **b.** the mortar covering murals, and **c.** the mural paintings discovered after removing the mortar layers.

Ahmed Pasha Yakan restored the house after erasing many elements to show the prevalent Baroque character during that period. The family stayed in this house until the end of the seventies, after which it was subjected to deterioration and lack of maintenance [6]. Then, the house's ownership was transferred to one of those interested in heritage, who pledged to preserve and restore it to become a scientific and cultural center in which training workshops were held to revive traditional crafts and integrate the house and the surrounding community through various cultural activities [7,8]. However, it became a community center for drawing up plans and developments for future neighborhoods [9]. The house was restored in accordance with the principles of restoration and additions following the Venice Charter of 1964 [10, 11]. Executed murals were discovered on one of the house's walls, fig (2-a, b, c), during the architectural restoration process.

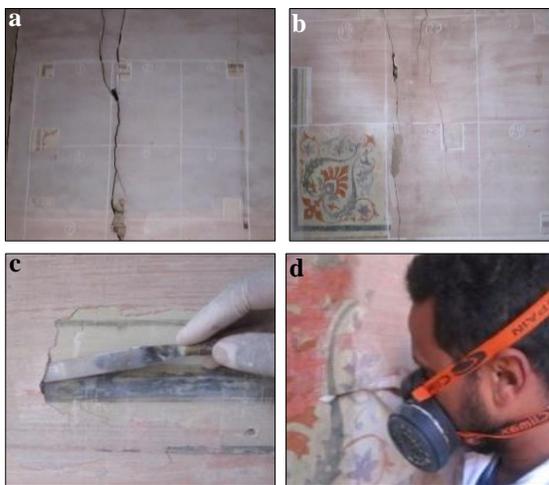
The mortar layer was removed mechanically by shaking the outer layers with blunt tools. Since the lime and gypsum layer was weak and convertible into powder until the borders of the murals appeared, the illustrated spaces were revealed carefully. Windows were used for mechanical detection. Then, the remaining paint layer was softened with a diluted chemical as an aid during detection and removal in some cases, as ethyl alcohol and water were used in a ratio of (1:1) and then in a ratio of (1:2) when approaching the surface of the mural paintings to soften divided into squares and numbered, and the layers were removed one by one, fig (3-a, b, c, d).

Figure (3) Shows **a.** & **b.** dividing the wall before mechanical detection and the appearance of the borders of mural paintings, **c.** the detection of the lower part of mural paintings, **d.** the detection methods by water and alcohol.

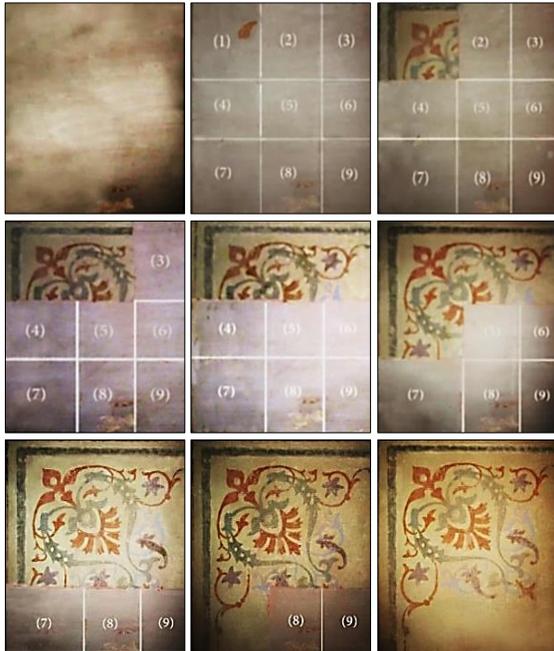
A group of detection windows was implemented with the surface paint layer in separate areas with an approximate area of 40×40 cm, fig. (8) to locate the colored murals. It was found that there was a decorative frame with the appearance of the remains of preliminary

indications of the presence of wall decorations in the upper part and the corners, but the lower parts of the wall were devoid of decorations. The surface layer of paint was removed mechanically. Since the main component of the paint was lime, characterized by poor cohesion and ease of removal until the appearance of the mural, great care was given not to lose or distort any details of the murals.

Figure (8) Shows the method of detection by the mechanical method regularly through successive squares and a set of display windows to identify the locations and boundaries of the murals before revealing them.

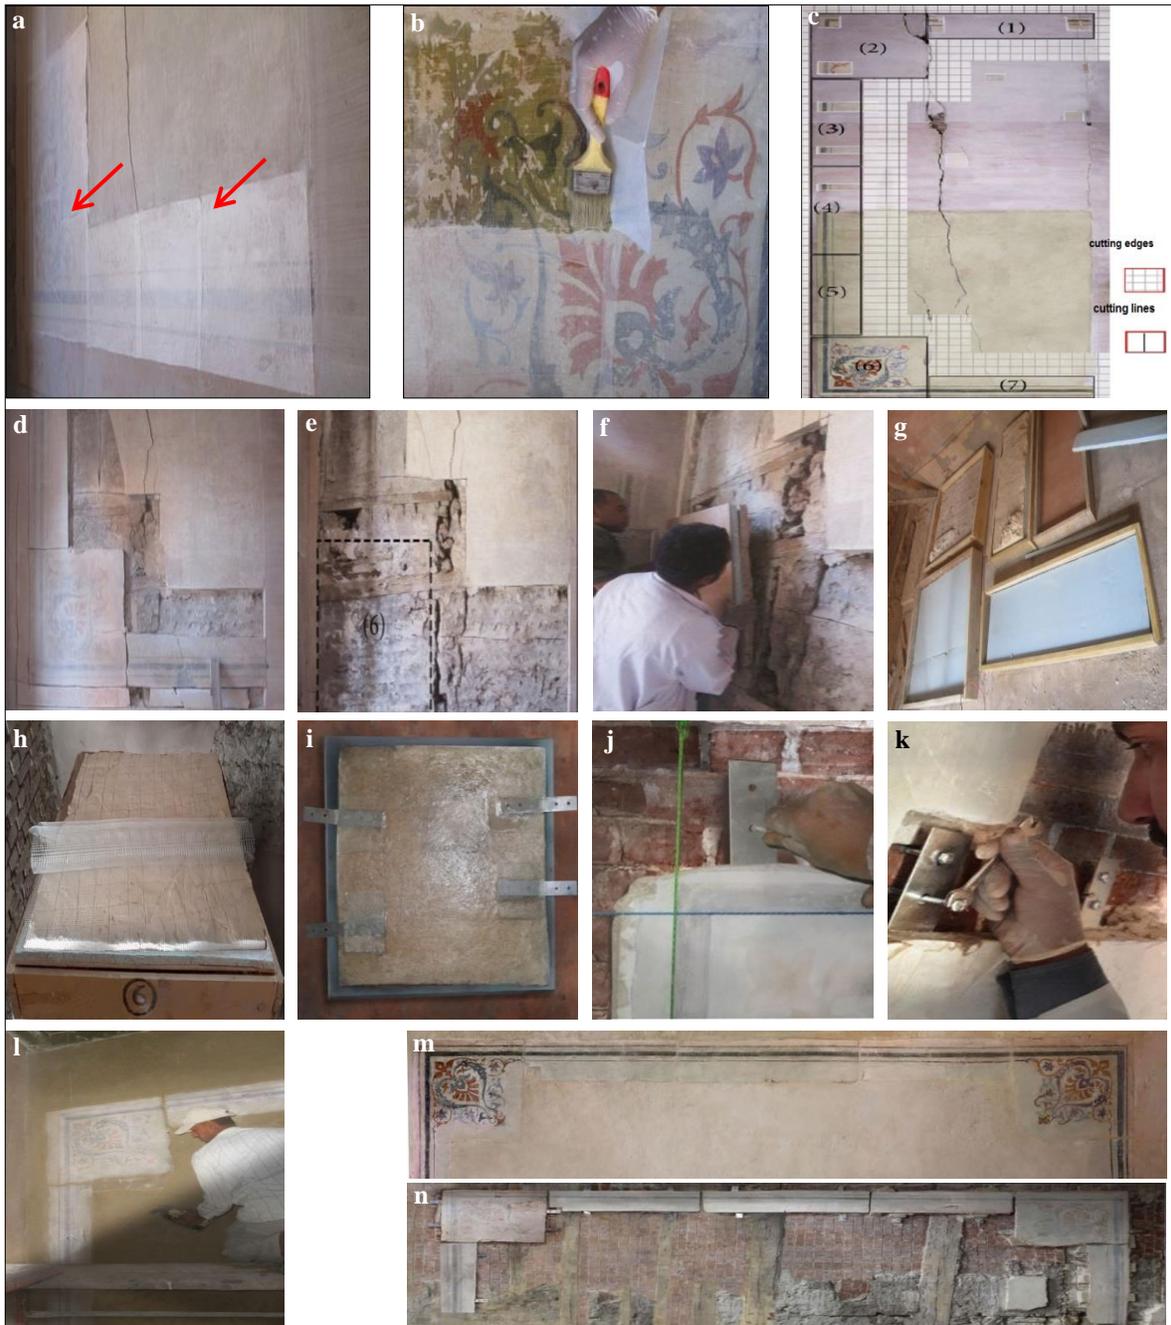
Figure (9) Shows **a.**, **b.** a surface protection layer (facing) by Japanese paper and carboxymethyl cellulose, **c.** documenting mural painting, defining edges and places of cutting, the stages of the restoration of the murals, **d.**, **e.**, **f.** removal of the non-decorated parts around the mural for ease of separation; **g.** protection and storage of separate murals in foam-wrapped boxes, **h.** adding a layer of fiberglass to reinforce the mortar, **i.**, **j.**, **k.**, preparation of stainless steel beams and joints, method of jointing and fixing between the wall panel and the wall, **l.** completion of the outer frame of the panels with a mortar consisting of lime and sand, **m.**, **n.** the murals after mechanical installation, filling the edges with mortar, and removing the surface protection layer and cleaning.

After cementing the surface and colors of the wall paintings, and then treating the fine cracks and the separated layers, injections were made using a diluted calcareous mortar that preliminary supported, then completing the missing parts of the preparation layer with a mortar consisting of calcium carbonate and fine sand to level the mortar at the same level as the surface of the colored layer, and then it was covering the surface with a protective layer of Japanese paper, fig. (9-a,b). Approximate dimensions commensurate with the size of the wall paintings to be removed and fixed with carboxymethyl cellulose adhesive for all the discovered decorations in preparation for the removal process. The cut-outs were located devoid of decoration around the wall panels for ease of separation, fig. (9-c, d, e, f). The cutting was done with a part of the preparation layers with a thickness of 3: 5 cm with great care [50]. The removed pieces were stored in wooden boxes of appropriate dimensions compatible with the size of each piece, lined from the inside with pieces of foam, and numbered according to the work map, fig. (9-g). After completing the architectural restoration of the wall, the wall panels were reinstalled using an alternative carrier of sand and lime reinforced with fiberglass, with dimensions compatible with those of the removed pieces, fig. (9-h). In some cases, it required using stainless steel bars with a length of 35 cm and about 4 cm, fig. (9-i, j, k). The outer framework of the panels

was completed with a sand-lime mortar, fig. (9-l), removing the protective layer,

cleaning the decorations, and then reinforcing them, fig. (9-m).
