## A PROPOSAL FOR PREVENTIVE CONSERVATION AND ACHIEVING SUSTAINABILITY OF THE KHAFRE'S VALLEY TEMPLE IN EGYPT

Ali, A.<sup>(\*)</sup> & Abd El Hameed, O.

*Khafre's valley temple*

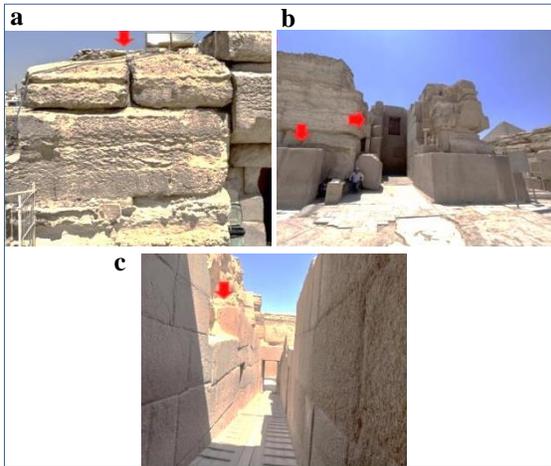
Figure (2) Shows **a.** the walls of the temple that were built of local limestone, **b.** outer and **c.** inner casing with granite blocks

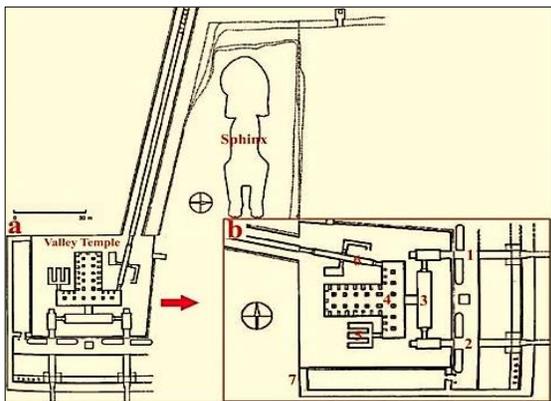
Figure (3) Shows **a.** plan of the valley temple and sphinx (After: Hamilton, 2021), **b.** detail of the temple's parts; 1 & 2. entrances, 3. vestibule, 4. chamber of sixteen pillars, 5. storage chambers, 6. the causeway, 7. temple's enclosure wall.

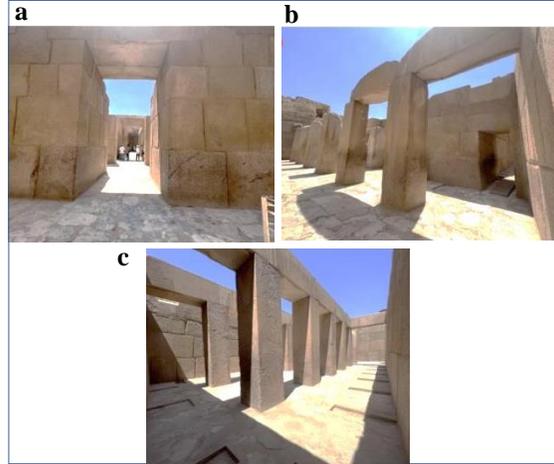
Figure (4) Shows **a.** the corridor to the T-shaped hall, **b.** the complete loss of the original roof of the temple, **c.** sixteen granite pillars and twenty-three bases carved into the alabaster floor

The roof of the valley temple is considered one of the most damaged structural elements

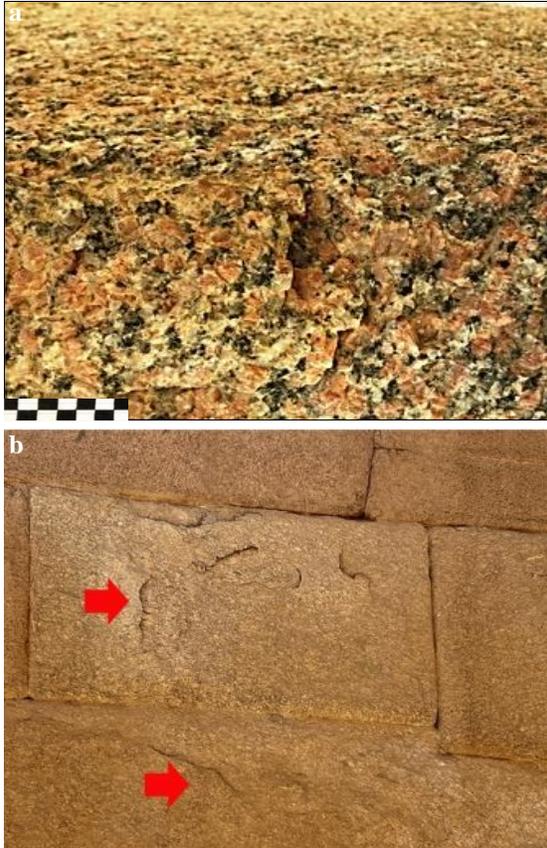
The variation in the physicochemical composition of the granite minerals is one of the most important and most dangerous internal damage factors for this type of stone. It is known that every mineral differs from the other in terms of its physical and chemical composition. Therefore, when these minerals are exposed to any affecting factors, each of them has a different interaction and these results in mechanical stresses inside the stone that eventually leads to cracking and sometimes separation. This is what actually happened to the Temple Valley Stones, fig. (5) [12].

Figure (5) Shows **a.** the different minerals that make up granite **b.** separation in layers due to the variation in the physicochemical composition of the granite minerals

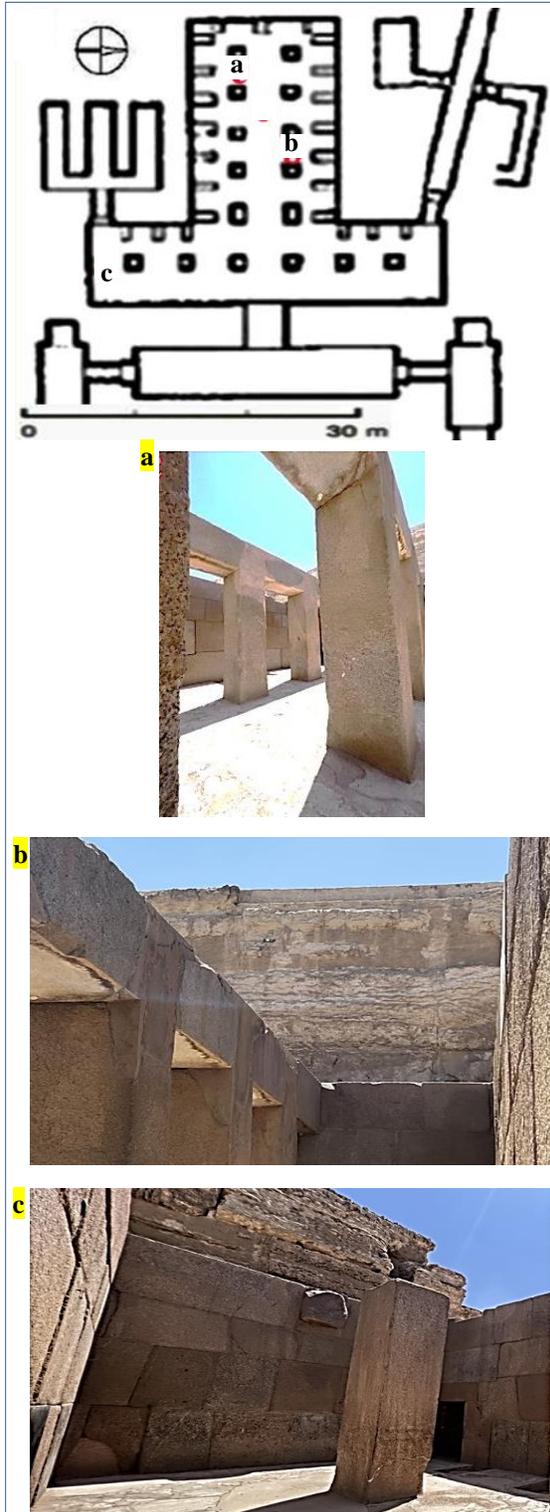
Figure (6) Shows locations of the taken photos on the plan; detachment of the surface layers, chromatic asymmetry and the appearance of dark spots as a general appearance of granite blocks

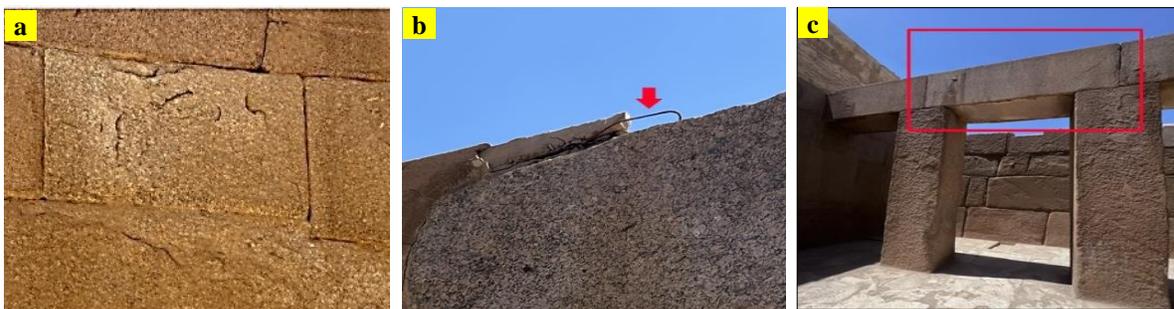
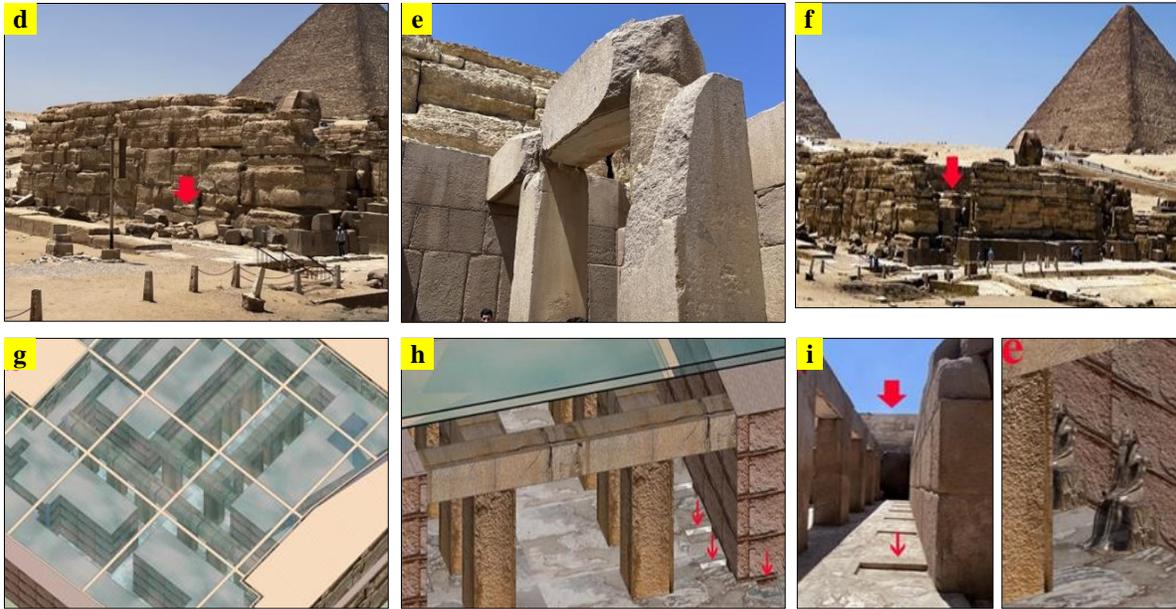
Figure (7) Shows **a.** exfoliation of the surface layers in the form of scales, **b.** separations resulting from the use of metal bars, **c.** separations resulting from the use of Portland cement, **d.** the danger of losing outer granite casing, **e.** the necessity of reinforcing lintels and insuring their stability, **f.** structural restoration of weakened at the lintels and columns, **g.** external limestone blocks proposed to receive the proposed roof loads; the arrow indicates the height of the internal granite casing, **h.** imagine the proposed ceiling, **i.** the temple after the roofing and the necessity of using modern techniques to display models of statues in their bases, **j.** external blocks and statue bases, **k.** models of the statues of in their places.

The temple shows some structural deterioration phenomena such as the complete loss of the ceiling, the appearance of cracks, and the lintels' damage as a result of the use of iron in the reinforcement with a heterogeneous restoration work using Portland cement with granite. As a result, temporary reinforcement of the lintels is proposed removing old and unsuitable restoration work (iron bars, completion mortars with Portland cement) and carrying out shores with wooden or metal structures. Taking into account, all the shores are structurally effective the stability of the soil under the building with the use of light and non-solid materials such as sponge or plastic strips at the points where the shores meet with the building [23]. This is followed by monitoring and treatment of cracks. The used methods to

treat cracks are many and varied according to the size and depth of the crack. There are cracks of medium permeability and depth that appear at the meeting of the lintels with the walls and medium cracks are present in the lintels themselves that represent a structural danger by causing the collapse of the lintel and micro cracks resulting from the discrepancy in the properties of the materials used in restoration from the original building materials. Stitching by stainless steel beams can be used for medium cracks [24] while stitching by regular blocks of granite can be used for the cracks resulted at the joints between the stones to cut the path of those joints. The tiny cracks are considered ineffective structurally, and this is mainly caused by the discrepancy in the properties between restoration and original building materials. Accordingly, completion with unsuitable mortars will be removed then the dust and suspended materials will be thoroughly cleaned using compressed air. After that, the surface is wetted with water and completed with the same type of stone that will be mixed with a suitable bonding agent for good bonding with the original surrounding building material [25].
