NEW MATERIALS FOR ENHANCING THE DURABILITY OF MURAL PAINTINGS OF THE TOMB OF QEN-AMUN TT 93, LUXOR, EGYPT

Orabi, E.^(*) & Sallam, A.

Conservation dept., Faculty of Archaeology, Aswan Univ., Aswan, Egypt

EJARS – Vol. 14 (1) – June. 2024: 37-42

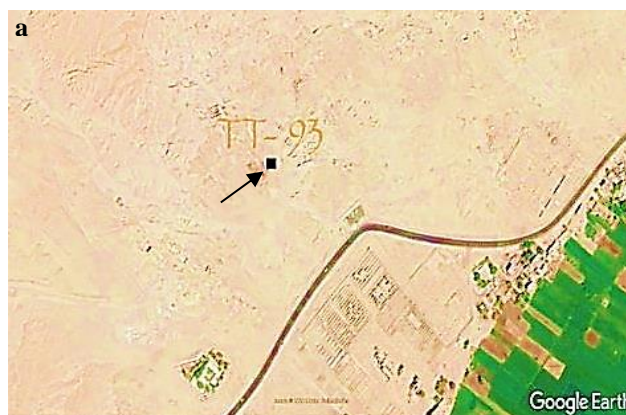
Figure 1 a. the location of the tomb of Qen-Amun-TT93 in Luxor (After: <https://www.kena-mun.com/gallery-miscellaneous>) b. plan of the tomb (After: <https://en.wikipedia.org/wiki/TT93>) c. the main entrance of the Qen-Amun Tomb - TT93

year French Tuscan expedition together to Egypt in 1828, and they visited the tomb of Qen-Amun. In the early nineteenth century, Champollion, Lepsius, Wilkinson, and Prisse d'Avennes visited the tomb, but until the Metropolitan Museum of Art published the tomb of Qen-Amun at Thebes in the late 1920s, which details its exploration and documents its contents, it was largely neglected [1-5], fig. (1).

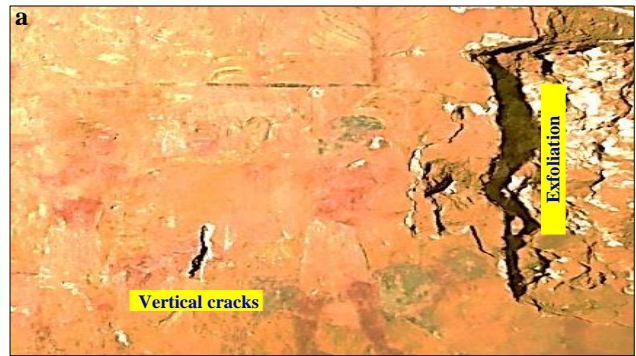
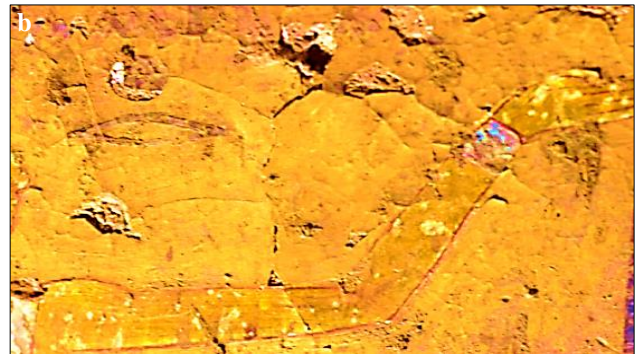
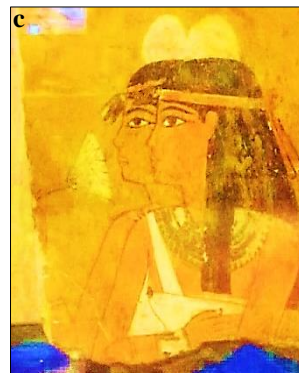
Figure 3 a. vertical cracks, gaps and exfoliation, b. the horizontal crack networks in the mural painting surfaces due to deterioration factors, c. fragment of wall painting, painted with depiction of two women, Tomb of QenAmun (TT93) Luxor Museum, d. mapping of the fragment of wall painting condition and place the crack via AutoCAD

Stone quality in Thebes is poor (impurities contained in the rock, such as halite), so most tomb chapels were plastered and painted rather than decorated with reliefs. The tomb of QenAmun - TT93 suffer from different weathering forms, such as cracks, strength loss, and detachment of plaster due to the harsh weather conditions in Luxor. The wall paintings are exposed to high values of temperature (41-46 °C) in summer and temperatures (7 °C) in winter [9-16]. Based on the visual observations of the Tomb of Qen-Amun - TT93, many vertical and horizontal cracks were observed in the wall paintings, as well as crack networks in the mural painting surfaces due to deterioration factors, figs. (3).

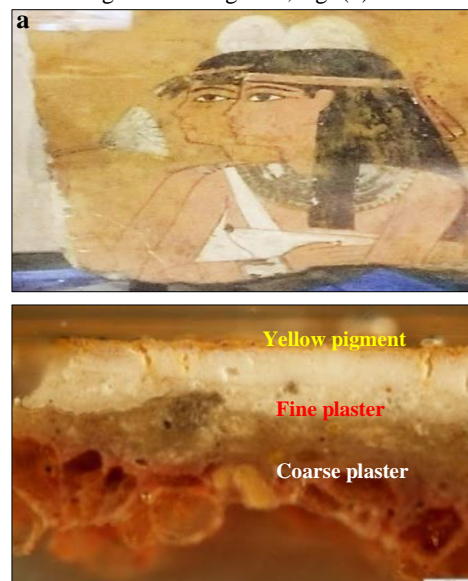
Figure (4) **a**, fragment of wall decoration, painted with depiction of two women, tomb of *Qen-Amun* (TT93), it was returned to Egypt as a gift from the clos foundation, Spain, on 30/1/2009 Luxor, **b**, cross-section image of the fragment with three layers from top to bottom (yellow pigment, fine plaster, coarse plaster) under PLM

The cross-section is useful for the investigation of materials. Examination by PLM was used to examine fragment of wall decoration and identify its three layers. The structures fragment of wall decoration from the top to bottom composed of three layers: **a**) *color layer* (yellow pigment) with 0.1 cm thickness, **b**) *fine plaster* with 0.3 cm thickness, and **c**) *coarse plaster* 1.2 cm thickness. Furthermore, the cross-sectional also attested that the studied sample is composed of quartz, clay minerals, iron oxides, and organic fibers. Moreover, PLM investigation revealed that the yellow pigment formed of very homogeneous and fine grains has many vertical and horizontal cracks and had a loos surface as a result of shrinkage of the clay minerals in the preparatory layers, cracks appear in the painting layer. This suggested that yellow pigment was produced using iron oxides. It also showed that the fine plaster layer composed formed of homogenous fine grains, fig. (4).

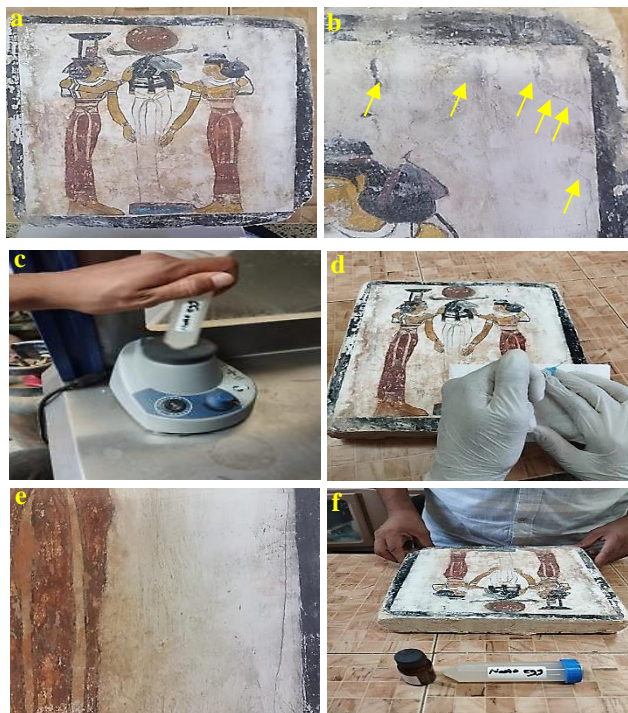
Figure 10 a. Experimental samples prepared with the same characteristics as the mural paintings in the tomb of Qen-Amun (TT93), b. horizontal and vertical cracks before, c. preparation of the eggshell nanoparticles by vortex and ultrasonic, d. cracks injection, e. Cracks after treatment, f. treated sample

As a result of the above studies, a laboratory wall painting, fig. (10-a) was subjected to experiment conservation steps to evaluate the efficiency of tested material using the following criteria:

The 1st step was to apply temporary strips of tissue paper saturated by ethyl silicate 3%, in order to prevent weak parts of the plaster from collapsing, fig. (10-b)

After the mural paintings had been pre-consolidated, the 2nd step was began, where, the surface deposits and dust were carefully removed using an air pump and soft brushes, and the egg shell nanoparticles was prepared using vortex and ultrasonic fig. (10-c).

- 1) Applying syringe of alcohol in the injection hole to prepare the cracks for the nano composite.
- 2) Starting the injection process from the lower to the higher level, and then, injecting the nano composite composed of eggshell nano-particles and ethyl silicate 3% through the crack networks spread in the painting surfaces and the voids between the painting layers using a thin syringe, fig. (10-d).
- 3) Cleaning the surface by suitable organic solvent to remove any harmful materials after treatment, fig. (10-e & f).
