ARCHAOMETRIC STUDY OF THE MEMORIAL STONE ENTRANCE OF KING RAMSES III IN HELIOPOLIS TEMPLE, CAIRO, EGYPT

Shebl, F.^{1(*)}, Ezzat, M.² & Saleh, M.³

1.1. Sphinx site (Gate of king Ramses III)

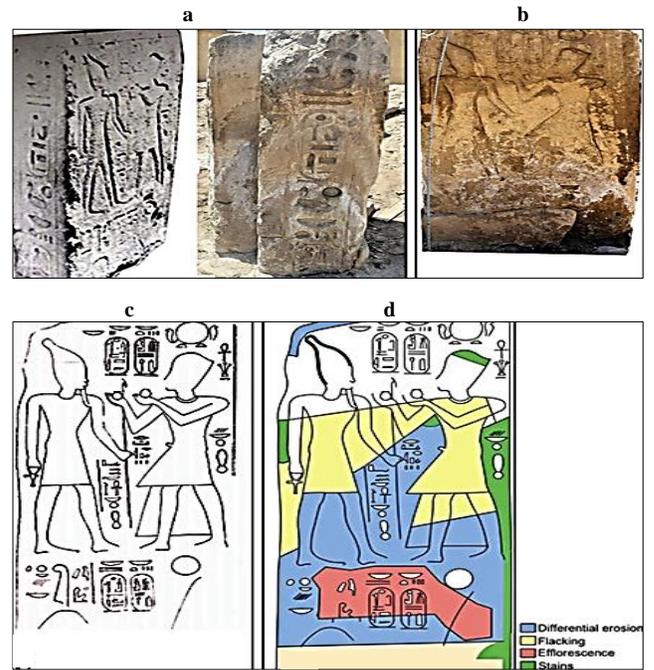
topped by a sun disk, as a symbol of protection [7], and on the other side are hieroglyphic writings bearing the royal titles, fig. (4). Dimensions: 180 cm in length, 85 cm in width, and 55 cm in thickness. Through visual examination, it was noticed that the stone pillar is in a poor state of preservation, as it shows manifestations of crusting and separation of the surface layers as a result of subsurface salt crystallization, especially in the lower parts, which almost completely fell, which led to obliteration and loss of the inscriptions on it. A deterioration map was drawn to identify the main damage aspects of the artifact [6].

Figure (4) a. stone pillar at the time of discovery in 1974, b. the pillar condition in 2022, c. details of the pillar inscriptions, quoting Saleh, A., 1983, d. deterioration map of the current actual condition of the pillar, 2022.

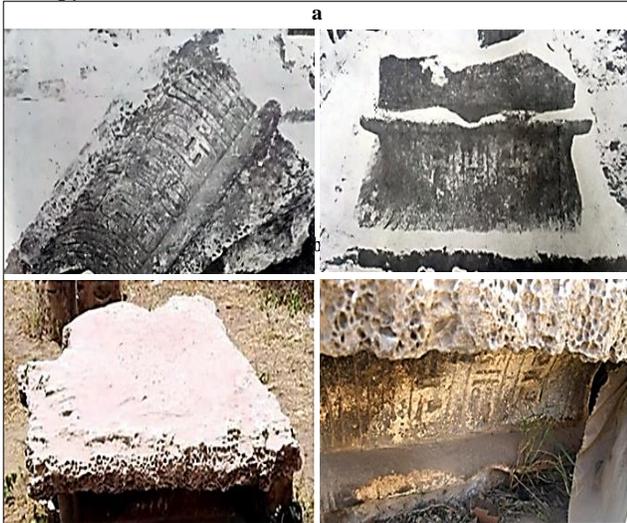
Description: A limestone cornice with a special inscription bearing the name of King Ramses III inside a royal cartouche, in addition to some plant decorations, fig. (5). Dimensions: the length of the cornice surface is 220 cm, its width is 160 cm, and its height is 90 cm. Through a visual examination of the cornice, it was found that this artifact suffers from many manifestations of damage, including the presence of remnants of soot as a result of the site's exposure to fire, which led to obliteration of some inscriptions. It was also noted the existence of gaps and voids in the upper area of the cornice, a phenomenon known as tafoni appearance, *Tafoni* or *honeycomb* is a weathering phenomenon found in diverse environments throughout the world. It occurs on limestone, sandstone, and other rock types in natural outcrops, *Honeycomb* weathering is a term used to describe numerous small pits no more than a few centimeters wide and deep, separated by the intricate network of narrow walls and resembling a honeycomb [8]. The cornice was found in an up-side-down position adjacent to the soil [4], which explains the occurrence of the phenomenon of tafoni and crusting of the surface of the cornice [9].

Figure (5) **a.** the shape of the stone cornice at the time of detection and it appears in an up side down position, **b.** the shape of the stone cornice, 2022. Tafoni or honeycomb aspects are shown at the top of the stone cornice.
