COMPARATIVE ANALYTICAL STUDY OF THE MATERIALS USED IN WALL PAINTING OF HISTORICAL PALACES

Ali M. F. and Darwish S. S.

Department of Conservation, Faculty of Archaeology, Cairo University, Egypt
amanybakra@hotmail.com

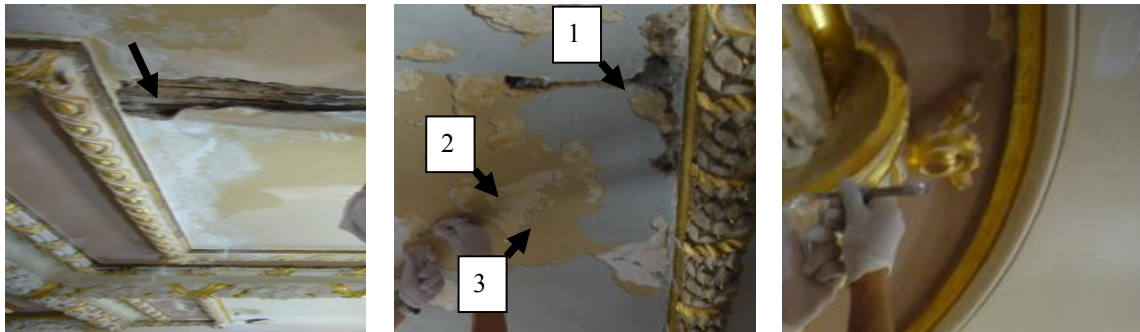
Figure (1) Show a Separation of all layers from the wooden support in the ceiling of Abdeen Palace, b samples from the paint layer Of Abdeen Palace:1= green colour,2= creamy yellow colour, 3= brown colour, c the gilded parts Of the ceiling Of Abdeen Palace.

pure gold. Abdeen Palace was so called as it was built on the debris of a house owned by the Turkish Prince Abdeen Bey. Some parts of the wall painting in Abdeen Palace were perfectly preserved, while in others, there were powdering or flaking paints. In some area the painting layer was entirely lost, but the plaster survived in good condition while in other large areas, there was a complete loss of plaster. Moreover, there were considerable portions in danger of further loss as a result of separation of the painted plaster from the wooden support of the ceiling, [fig. \(1- a, b, c\)](#). **Case Two (El Safa Palace):** It was built by Prince Mohamed Ali in 1939 in Alexandria. To the right side of the

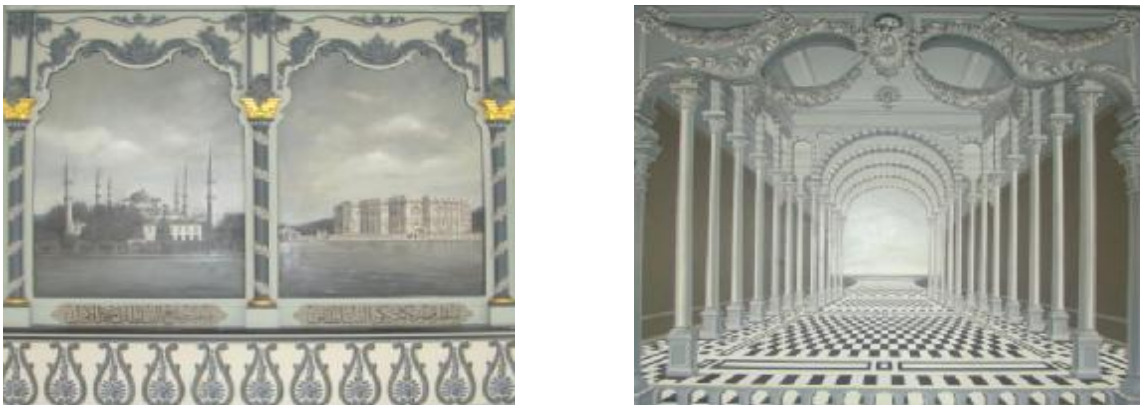
Figure (2) Show Oil wall painting of tea hall in El Safa Palace

palace, there is a big tea hall, whose length is 45m and contains beautiful oil wall paintings of famous old palaces in Istanbul. Wall paintings in this palace suffer from many aspects of deterioration such as cracking and loss of some of the paint and binding layers, [fig. \(2\)](#). The aim of this work is to identify the composition of the materials used in the construction and decoration of the wall painting in Abdeen palace in Cairo and El Safa palace in Alexandria, and study the techniques applied as well as the state of deterioration. The obtained results will be used to lay out a scientific plan for restoration and preservation.

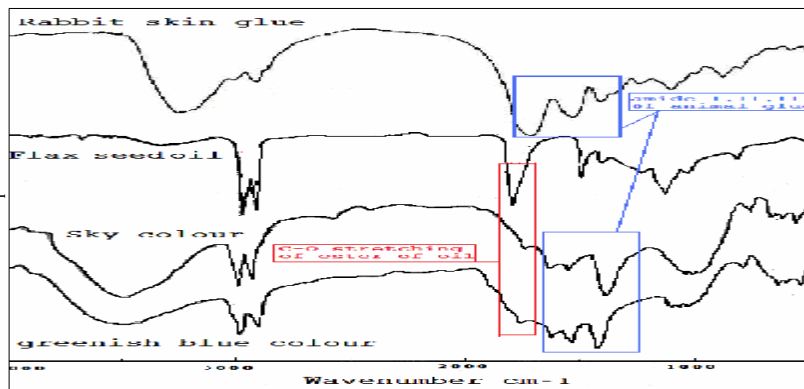
Fig 8 Shows comparison of FTIR spectra of paint layers samples of El Safa Palace

analyzed to identify the binders used with these colors. The results were compared with standard samples of both animal glue and vegetable oil (flax seed oil). Results showed that the tested samples have a high proportion of animal glue with a proportion of flax seed oil table (5), fig. (8) [12].
