Original article

MONITORING AIR POLLUTANTS AND DUST IN LUXOR MUSEUM OF THE
ANCIENT ART

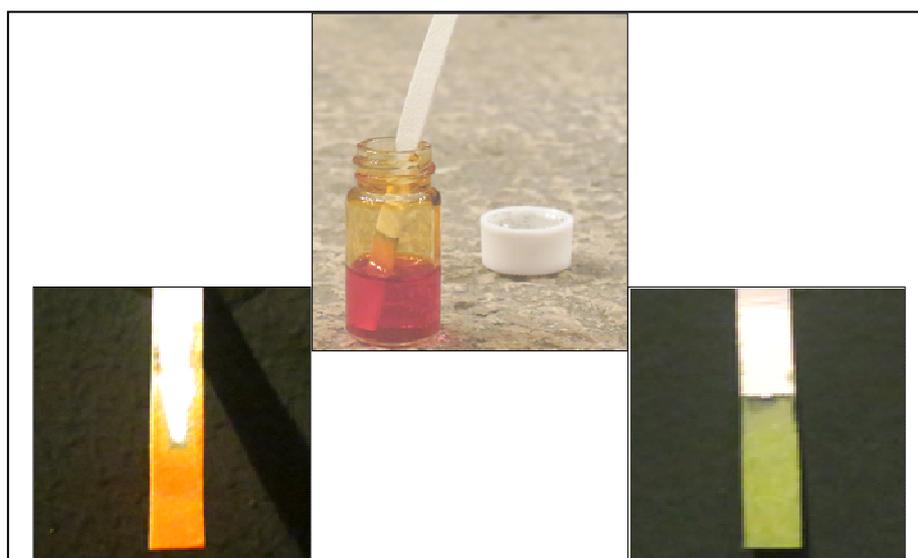
checker had to be compared to the scale color which gave the result of the PH value of the museum's air. The researchers used **12** checkers; **6** of which were used at the old museum, on the 1st and 2nd floor, and the other **6** were used at the new extended part, on the 1st and 2nd floor. Because RH value in the museum was less than 40 %, the monitoring process was kept for 48 hours. Monitoring was conducted twice; in April and July, 2014, and the results were almost the same, fig. (1).

Fig. (1) Shows change of the checker color due to the PH value

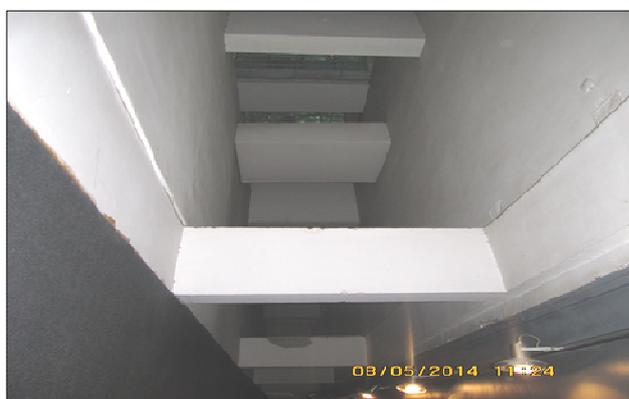
Fig (8) Shows the unpainted concrete bars over the open display areas

Results prove that Luxor museum has a percentage of some pollutants, e.g. ammonia, organic acids and dust. They result from the upper uncovered parts of the interior walls of the museum and the air conditioning system that has no filters to prevent air pollutants. Dust and air pollutants with high temperature and relative humidity are responsible for the damage of the wooden bases, acceleration of organic materials and stone deterioration according to the XRF and the FTIR investigations. However, no Filters or monitor devices are used to minimize or control air pollutants inside the museum. Therefore, the current study recommends that: * Modern monitoring and measuring air pollutants devices, such as the passive indicator, used in the study, or the digital devices that can monitor more than one kind of pollutants are needed. * Prevention filter must be used. * Vacuum cleaners must be used to avoid the fin dust inside the museum.
