CHARACTERIZATION AND RESTORATION RECOMMENDATIONS OF
SOME ADOBE SHRINES AT EL-BAGAWAT CEMETERY, KHARGA OASIS,
WESTERN DESERT - EGYPT

Abd El-Hafez, M.

Conservation dept, Faculty of Archaeology, Cairo Univ., Giza, Egypt

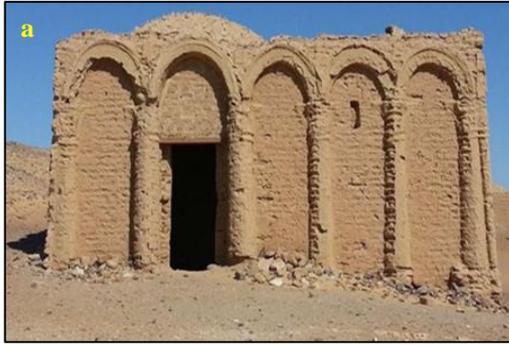
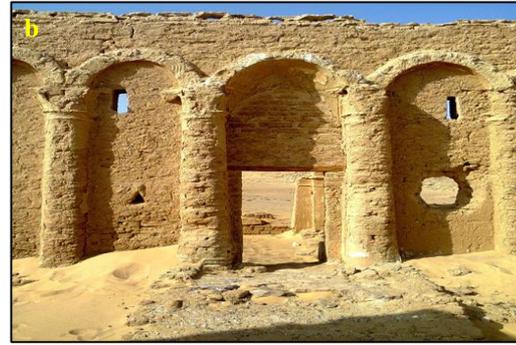
Figure (1) Shows the main Façades of **a.** shrine No. 66, **b.** shrine No. 90

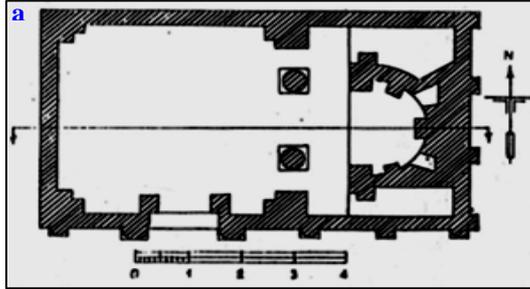
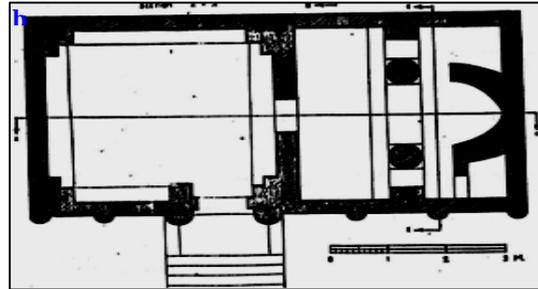
the fourth century A.D. The church of shrine No. 66 was built on a little-high hill. A square burial well is in front of the apse, fig. (3-a) shows plan and sections of the shrine No. 66). The church of shrine No. 90 is located in the southern part of El-Bagawat cemetery, its entrance located in the southern façade. A deep; rectangular burial well was dug in the floor in front of the apse, fig. (3-b) shows

plan and sections of the shrine No. 90). It is clear that there is some similarity in planning between the two shrines. The current paper focuses, mainly, on detecting the damage and its causes on two of unstudied adobe shrines at El-Bagawat

Figure (3) Shows plan, of the shrines **a**, No. 66, **b**, No. 90 at El-Bagawat cemetery, after (Fakhry, 1951).

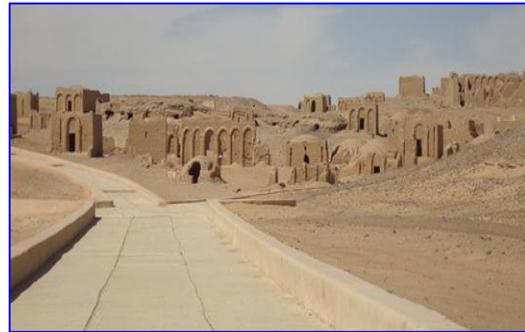
most common techniques in the Egyptian adobe architecture. The walls of shrines No 66 and 90 at El-Bagawat cemetery were built by technique known as the English Bond; it's mean that the first layer of bricks are placed as "headers", the next course of bricks are placed as "stretchers", the thickness of mortar jointing between the bricks on average; in finger size [5,8]. Arches, domes and vaults are common in construction at El-Bagawat cemetery as a distinctive feature of Roman and Coptic architecture, fig. (4).

Figure (4) Shows general view showing the front of El-Bagawat cemetery with many shrines that have arches and domes.

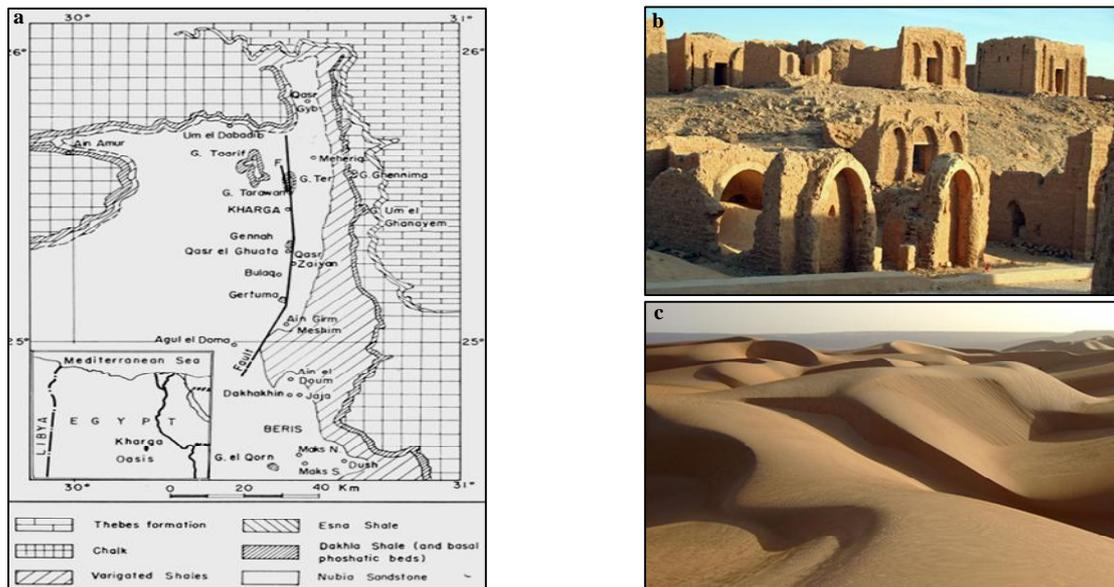
* The geological formations found in Kharga oasis belong to the following rock units from top to bottom, fig. (5-a) [9]. Travertine and loess deposits; Thebes formation; Esna shale; Chalk; Dakhla shale; Phosphatic beds; Purple and variegated shales; Nubia sandstone.

Figure (5) Shows **a.** a map showing geological formations of Kharga oasis “after: Said, 1962”, **b.** adobe shrines that built on the shale deposits/stone formation at El-Bagawat cemetery, **c.** sand dunes spread throughout the oasis.

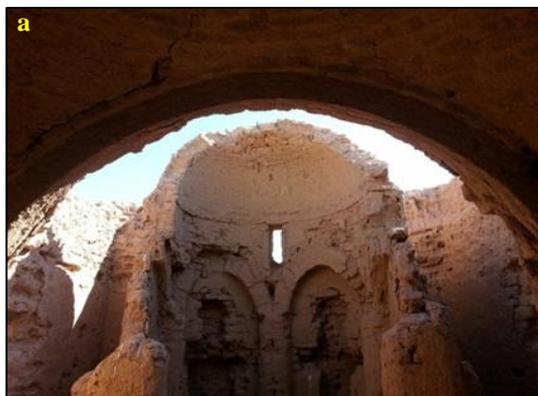
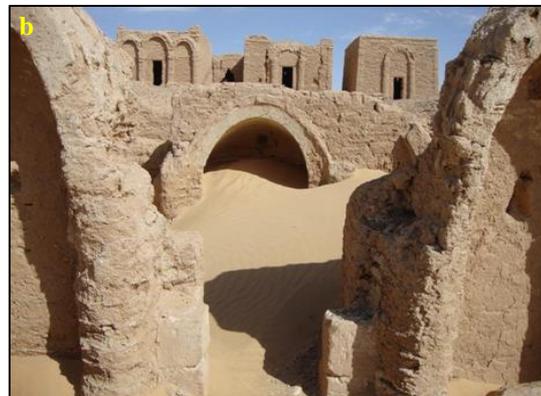
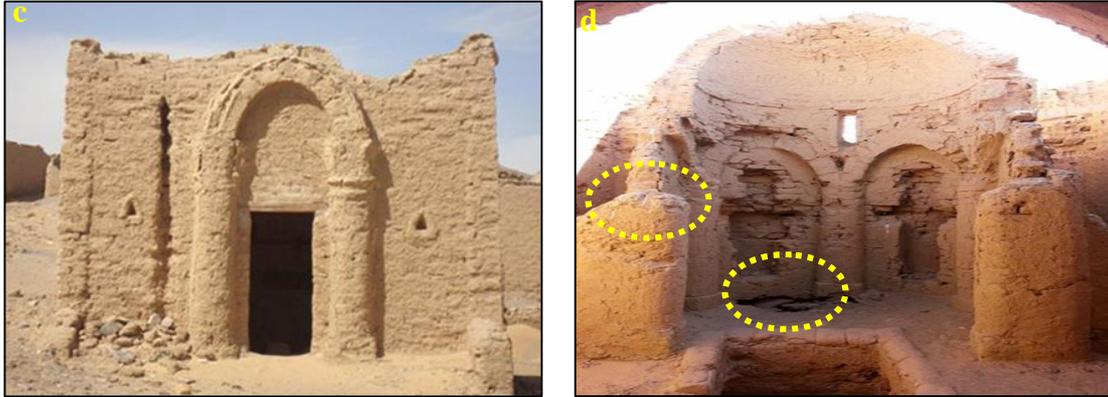
The high values of temperature mostly affected the adobe shrines at El-Bagawat cemetery. It caused increasing in loads, which is called “temperature (or) thermal loads”; these loads appear in the form of cracks/ fine cracks and often weakness and disintegration of plasters. The structural conditions, wind and rain effects play a major role in boosting the action of thermal loads. Wind has the destructive action in El-Bagawat cemetery, so the most façades of shrines were deteriorated by wind erosion and undercutting due to windstorms. The sudden precipitation of rain destroyed many adobe walls and blurred the features of adobe façades of the shrines, fig. (6-a,b,c). The **biological hazards** are playing an essential role in deterioration of most adobe building at Kharga oasis. The white ants “Termites” are considered the main factor in deterioration processes; they feed on cellulose found in wooden elements or in the straw used in mud brick manufacturing. After the termite attacks; most shrines at El-Bagawat became destroyed. The participation between climatic factors and biological agents has led to definite damage to all shrines; specially shrines No 66 and 90. On the other hand, wild bees, beetles and moths have a severe role in deterioration and distortion of the mentioned shrines. For example; wild bees build their solid nests on the building materials, beetles and moths attack the organic building materials; as well as, the organic secretions of these insects are harmful and deforming to the building materials. In addition, bats, rats, reptiles, fierce dogs and wolves are considered an important source of biolog-

ical damage of El-Bagawat shrines; because of the farness of the site from inhabitedness. These animals previously mentioned are digging tunnels and making drillings, holes and scratches due to the direct friction with the building: soil; walls and architectural elements. This severe factor caused a structural dysfunction in many architectural elements of the studied adobe shrines, fig. (6-d). With the same context, the scientific and analytical studies conducted by the researcher proved that the bat excretions; in particular, contribute significantly in the deterioration of historic building materials causing: aesthetic; biogeophysical and biogeochemical damages, as a result of presence of phosphate salts in bats guano which accumulated on the building materials. The main detected salts are: Brushite ($\text{CaHPO}_4 \cdot 2\text{H}_2\text{O}$); Whitlockite ($\text{Ca,Mg,Fe}[\text{PO}_3\text{OH}/(\text{PO}_4)_6]$) and Newberyite ($\text{MgHPO}_4 \cdot 3\text{H}_2\text{O}$) [11]. Furthermore, there is another kind of risk that affects the studied shrines at El-Bagawat cemetery, which is the *absence of heritage management plan* and lack of future vision for conservation, development and upgrading of the area under the study architectural heritage. The officials neglected these archaeological sites for a long time, this led to make these sites considered lawful by the antiquities thieves; therefore, many of devastation and demolition works were done. On the other hand, there are no paved roads lead to the majority of sites. Recently, the New Valley governorate has established some roads lead to some shrines at El-Bagawat cemetery. As well, there is no documentation of that architectural heritage; these make restoration procedures too difficult.

Figure (6) Shows deterioration effects in shrine No. 66 **a.** fine and medium cracks due to thermal changes (thermal loads) and structural reasons, **b.** sand sediments filled and covered the shrines as a result of wind and sandstorms, **c.** loss of façades mud brick features due to the mutual influence between rainfall and severe windstorms, **d.** effects of biological hazards. Rats, reptiles and fierce dogs dug tunnels and holes in the floor under walls causing damage and collapse. Also, the effects of organic secretions of birds contain Nitrates

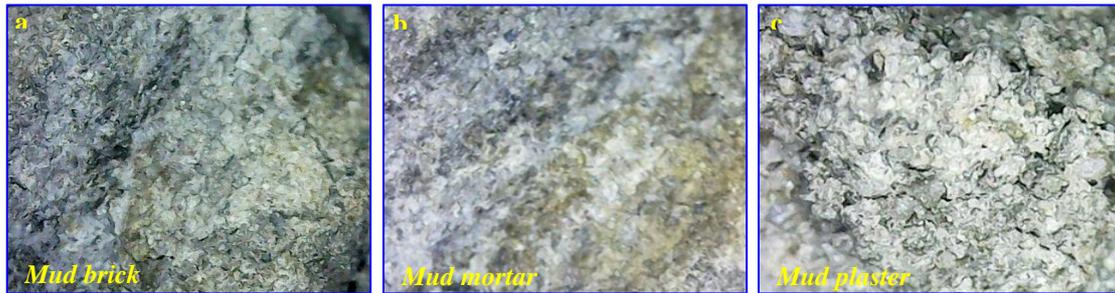
This allows seeing even the smallest details, in high resolution, directly on the computer screen [14]. Figure (7-a, b, c) shows the precise surface details of building materials; mud brick, mud mortar and mud plaster. It is very clear

that these building materials have a large amount of sand combined with the desert shale distinguished by red and green colors. The mud brick blocks were well made, but there are many cracks/

micro cracks due to environmental changes; especially large temperature changes, also there is a loss in organic material in some parts due mostly to insect action.

Figure (7) Shows the precise surface details of building materials large amount of sand, also the organic material and micro cracks specially in adobe blocks and mud plaster

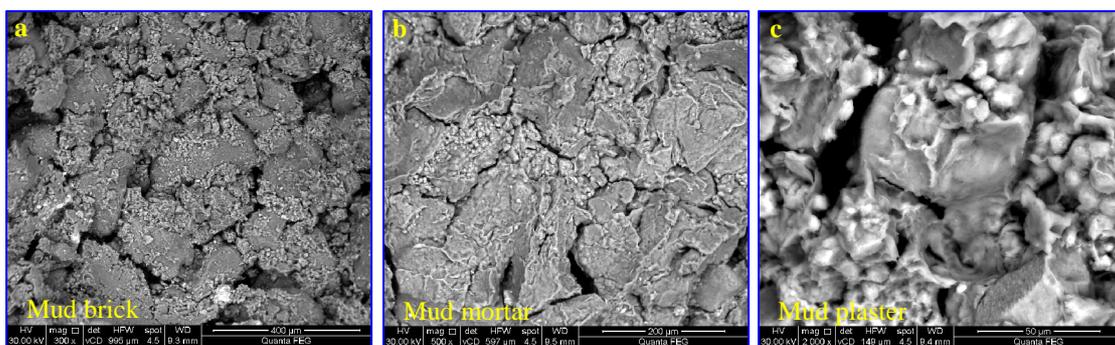
The results showed that the mud brick samples, fig. (8-a) has many of internal cracks and voids as attested by El-Gohary, (2012) [15]. Also there is some disintegration and rotation in quartz grains, in addition to a weakness in the binding materials (clay minerals) due to environmental weathering especially high temperature and wind erosion. White ants have an important role in degradation processes of the archaeological mud brick in studied shrines at El-Bagawat, they devour the organic material and leave mud blocks weathered and pierced. In a similar way, the damage

occurred in mud mortar, fig. (8-b) and mud plaster, fig. (8-c). Moreover, EDX results of archaeological mud brick, tab. (2) refer to the variety of silica percentage in the different samples, this refers to the increase of sand in some samples (mud blocks) and the decrease in other samples. In addition to the increase of organic material as a result of the existence of Phosphorus element (P), also, all mud brick samples contain a proportion of lime and iron compounds because of the existence of (Ca) and (Fe) elements.

Figure (8) Shows photomicrographs of some weathered and eroded surfaces, internal cracks and voids due to environmental and biological factors

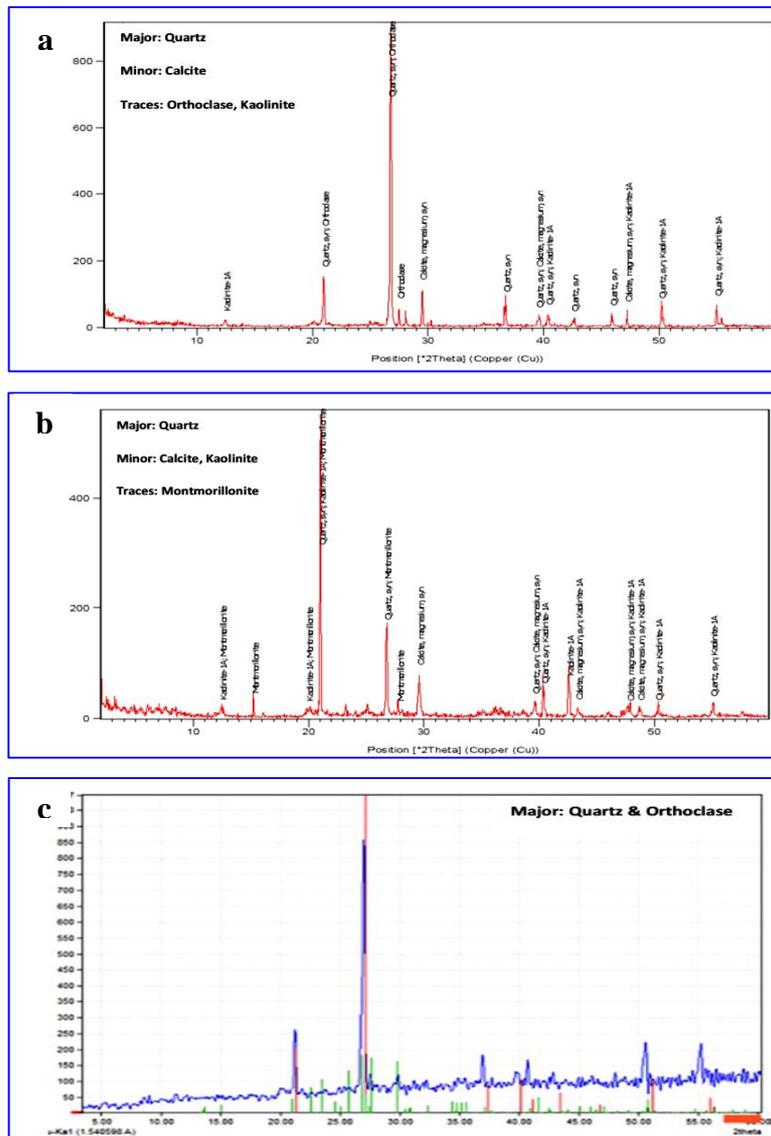
The results of collected from the archaeological shrines showed that the two studied shrines were built of mud brick blocks with same mineralogical components. The abundant ingredients of the studied mud brick samples are Quartz, Calcite, Orthoclase and Kaolinite, fig. (9-a). Also, there is a clear similarity in the mineralogical composition between studied mud brick, mud mortar and mud plaster samples. The abundant

minerals of the studied mud mortar samples are Quartz, Calcite, Kaolinite and Montmorillonite fig. (9-b), while the main compounds of the studied plaster samples are Quartz and Orthoclase fig. (9-c). Notable, that the presence of both Quartz and feldspar abundantly in the mineralogical composition of the shrines building materials donates them some of hardness and resistance.

Figure (9) Shows XRD patterns of the studied samples from shrines no. 66 and 90 **a.** mud brick, **b.** mud mortar, **c.** mud plaster.

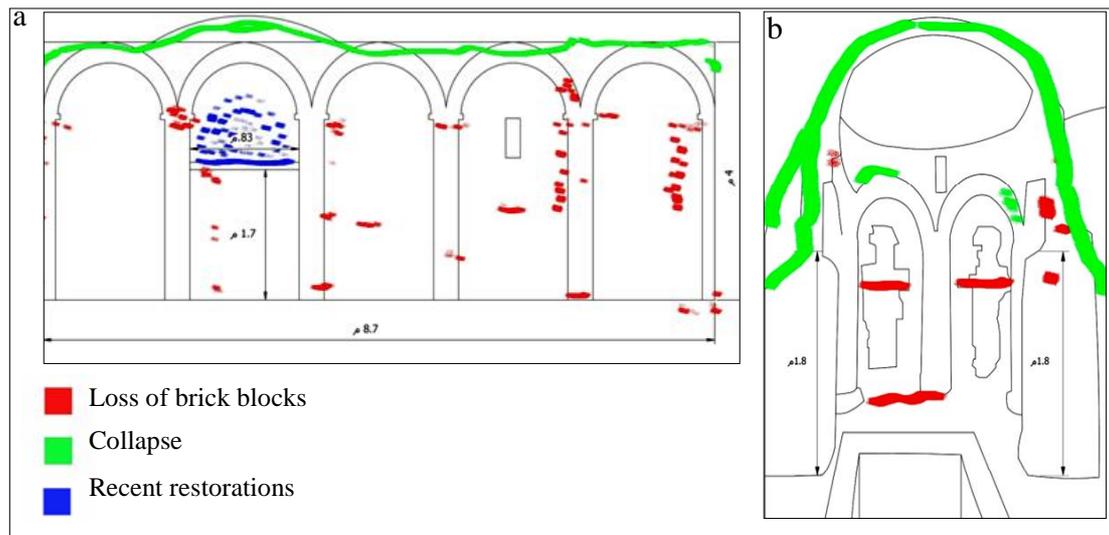
of all architectural heritages at El-Bagawat and El-Kharga oasis. Documentation procedures should include description of the current status and deterioration aspects. In this regard, the researcher used the AutoCAD software 2016 to present a geometric documentation of the deterioration aspects of shrine No. 66, fig. (10) as a model to be applied to all archaeological shrines at El-Bagawat. It is clearly shown that the main aspects represented in the loss of mud bricks in some parts; furthermore, there is a collapse in some parts of the shrine, especially the upper parts exposed to rainfall.

Figure. (10) Shows a geometric documentation of the deterioration aspects of **a.** of southern façade, **b.** of the interior of shrine No. 66, El-Bagawat cemetery, Kharga oasis.

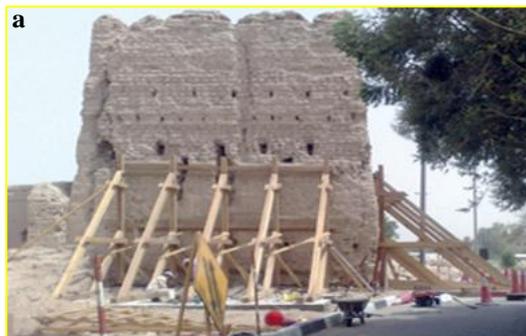
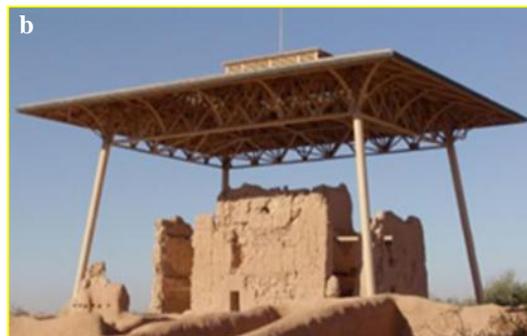
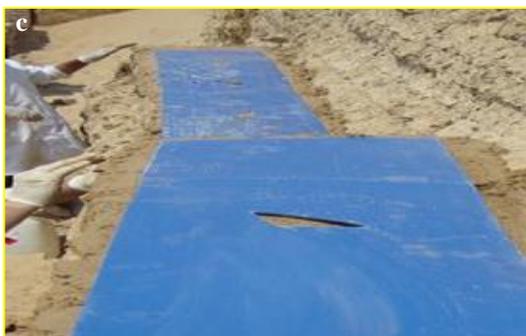
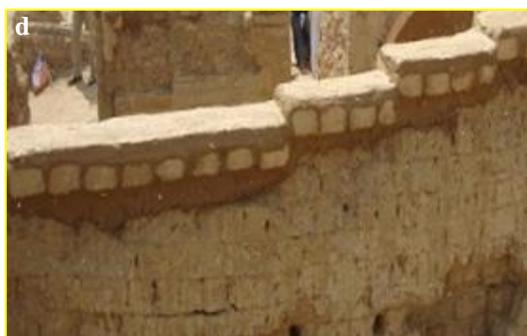
Figure. (11) Shows **a**, applicable technique for prop up the cracked/damaged shrines, **b**, a model for covering by shelters and capping method carried out by the researcher in a similar adobe building **c**, application of plastic sheets, **d**, protective courses.

- * supporting the works to protect the shrines from collapse, especially vaults because of their extreme weakness fig. (11-a).
- * covering the shrines and similar mud brick ruins at El-Bagawat cemetery with shelters to keep the adobe shrines out of direct sunlight and rainfall effects, fig. (11-b), with noticing that these shelters should not distort the archaeological site, also; they should have a slope system to drainage.
- * Using the selected mud brick to restore, complete and reconstruct the damaged and lost parts through building one or

two courses on the upper parts of the walls, if possible, to make as protective courses for the lower archaeological parts (*capping*). In addition, narrow strips of plastic sheets (0.9 mm in thickness) between the original surface and capping layer could be used as indicators when additional conservation or intervention is needed, fig. (11-c, d) [19].
