## DIAGNOSTIC INVESTIGATION OF DECAYING LIMESTONE IN HISTORICAL BUILDINGS AT THE MAMLUKS CEMETERY- CITY OF THE DEAD, EGYPT

### 1.3. Sultan Qaytbay mosque

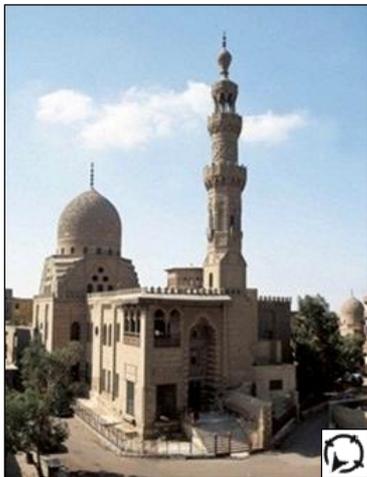
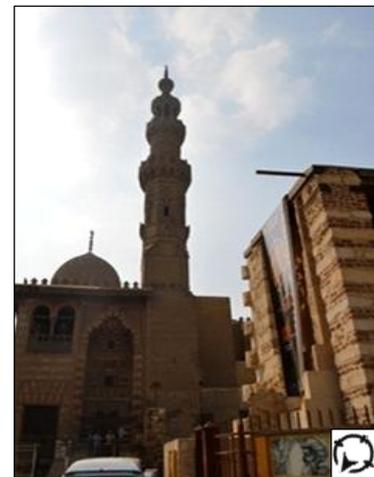
smooth limestone, bound together with mortar. More specifically, the materials used for constructing the masonry walls are, as follows: \*) **Limestone** – chiseled or smooth stones used in the two faces of the double bearing walls, and not irregularly-shaped stones. \*) **Mortar** (binding material) – lime mortar is one of the most mortar types used in the construction of most Islamic buildings in Cairo. Moreover, they mixed lime with *Homra* (red/fired brick powder) to give lime some mechanical and physical prosperity [21]. The ground plan of the madrasa consists of a square courtyard with a polychrome marble floor and a ceiling with a central skylight. The nave is surrounded by four *Iwans* (arcades). The biggest is Kiblah *Iwan*, which overlooks the nave utilizing a horseshoe arch and includes a magnificent *Minbar* (the tribune) decorated with intricate geometric ornamentations. The mosque has a unique Mamluk dome style. The transition zone from a square to the circularity of the dome consists of nine tiers of intricately detailed stone (*muqarnas*). The dome is decorated with ornaments of carved stone. In our case, limestone shows severe patterns of decaying that notably affect the aesthetic and historic appearance of the mosque. Climatic factors, groundwater, human activities, and air pollution are the man causes of these changes and/or alterations, e.g. salt efflorescence, exfoliation, bleeding, irregular material loss, bio-deterioration, and black crust.

Figure (2) Shows Sultan Qaytbay mosque (879 AH / 1474 AD)

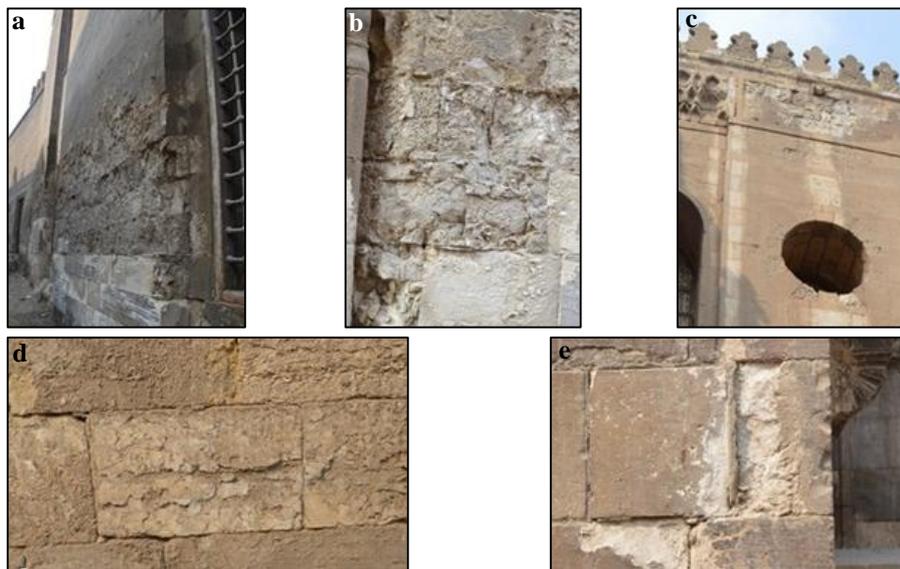
past activities that happened in the Qaytbay mosque area. It could be achieved through direct observation of the outer part of the mosque walls and studying the environmental, social, economic activities, as well as community facilities of the wider area. CICS of Qaytbay Mosque area shows that continuing deterioration of historic structures due to the misuse of residents, lack of public investment, regular upkeep of city infrastructures, absence of essential community facilities and services, and hard attack of the surrounding environmental factors (groundwater, humidity...etc.) [7,20,24]. The results indicate that there are various damage phenomena, such as cracks patterns, stone bleeding, salts crystallization, and damping, fig. (3).

Figure (3) Shows weathering phenomena of the limestone used in Qaytbay mosque **a.** **b.** lower parts, **c.** upper parts, **d.** and **e.** middle parts of the mosque walls

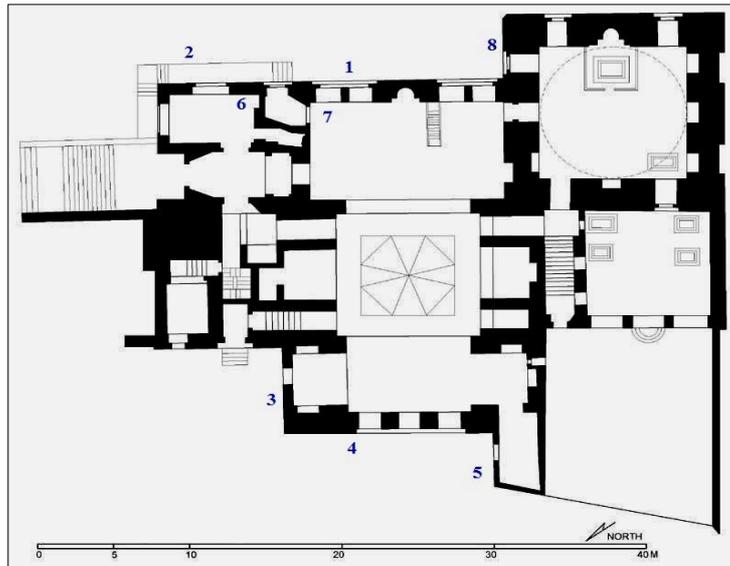
Many limestone samples were collected from the main building material used in the mosque, fig. (4). They included eight limestone samples inside and outside, as

well as upper and lower partitions of the building. They were obtained by carefully removing relatively small stones using a chisel or by falling stones.

Figure (4) Shows the location of sampling inside and outside the building

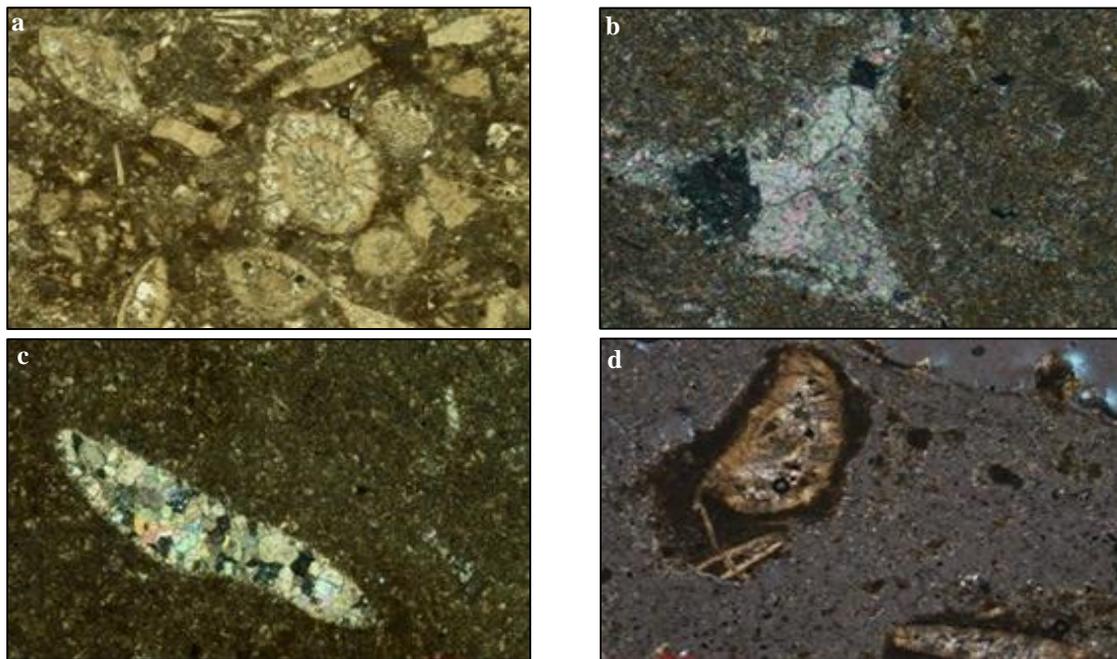
Based on the classification of Dunham, 1962 [15], the petrographical characteristics of the samples were identified as carbonates (samples no. 1, 4, 5, 7, and 8), and carbonatic fragments (samples no. 2, 3, and 6). The carbonate samples contained micrite matrix crowded with minute foraminiferal tests with a coarser shell that partly re-crystallized as micro sparry calcite, fig. (5). Microscopically, the samples are large foraminiferal (nummulitic/packstone), and they are composed of skeletal allochems of different sizes and shapes, along with some scattered quartz

grains (sample no. 1). Some samples showed carbonate cuttings. Each of them was bioclastic lime-mudstone to wackestone. These rock cuttings were dark gray to reddish dark gray and brownish to reddish. They are relatively hard carbonate rock (packstone/wackestone). However, (samples no. 2, 3, and 6) under crossed Nicols showed that they were iron-stained rock salt, mainly of halite composition (NaCl), including rock particles of fossiliferous limestone (carbonate fragments).

Figure (5) Shows thin section photomicrographs for samples (1, 5, 6, 2), where, **a.** under plane-polarized light (PL), and **b.**, **c.** and **d.** under crossed polars/Nichols (CN)

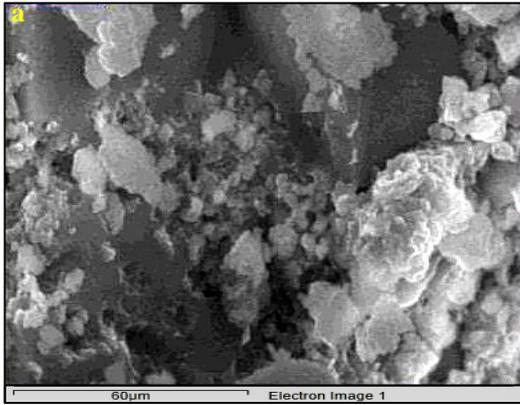
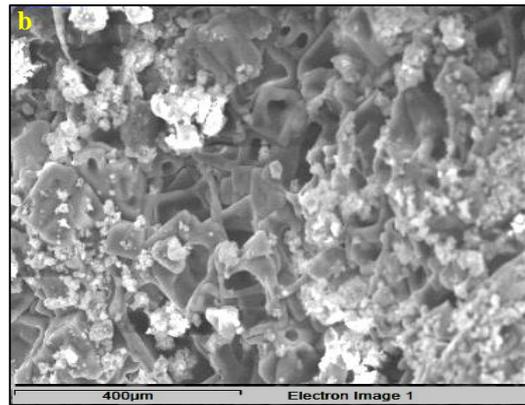
SEM captures fig (6-a & b) indicate that limestone samples had wide ranges of deterioration and fault features. The deterioration features included cavities,

micro-cracks, small fissures, smoothing in the outer surface of calcite grains, eroded pits, and salt crystals, such as halite [10, 12, 26]. Halite crystals existed

as a major salt because it is the predominant salt species in the Egyptian soil. Moreover, Micro-cracks and cavities resulted from the textural characteristics of sedimentary rocks and the effect of deterioration processes. EDX results, tab. (2) and fig. (6-c & d) there showed differences

Figure (6) Shows SEM photomicrographs of investigated samples **a.** sample 1, **b.** sample 2

SEM micrographs fig. (6-a,b) indicate that limestone samples have wide ranges of deterioration features, including cavities, micro-cracks, small fissures, smoothing of the outer surface of calcite grains, eroded pits, and salt crystals, e.g. halite [10,12,26]. Halite crystals existed as a major salt since it is the predominant salt species in the Egyptian soil [34]. The presence of micro-cracks and cavities resulted from the textural characteristics of sedimentary rocks and the effect of deterioration processes. Moreover, SEM micrographs illustrate that all parts of the mosque walls' have been exposed to

several damage processes that caused damage products, such as salts on stone surfaces and between internal grains. The obtained results of the chemical elemental ratios by EDX, tab. (1) refer to deterioration processes affecting limestone due to chemical-physical weathering processes. These different ratios are responsible for deterioration forms (Al, Na, Si, S, and Fe). Furthermore, the obtained elemental ratios are clear evidence of the different deterioration mechanisms affecting the stone surfaces that result from the surrounding deterioration factors in the Mamluks cemetery. Therefore,

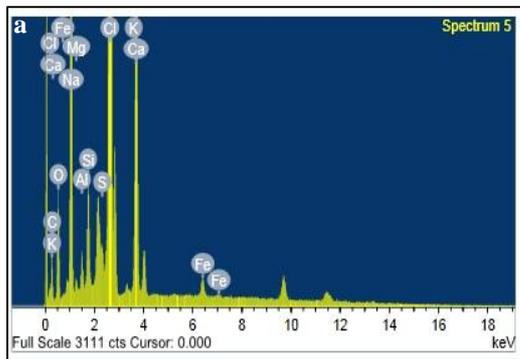
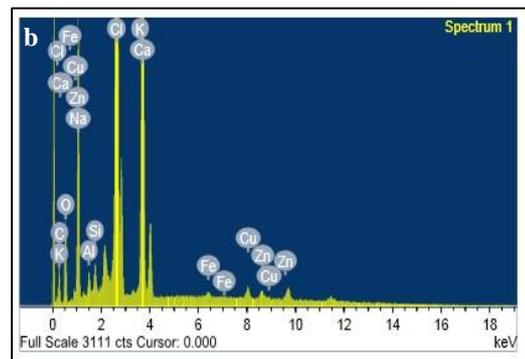
in the elemental ratios that are responsible for deterioration forms (Cl, Ca, Na, O, and C). Such elements indicated the different deterioration mechanisms affecting the limestone as a result of different deterioration factors dominating the area of study.

Figure (6) Shows EDX chart of investigated samples **c.** sample 1, **d.** sample 2

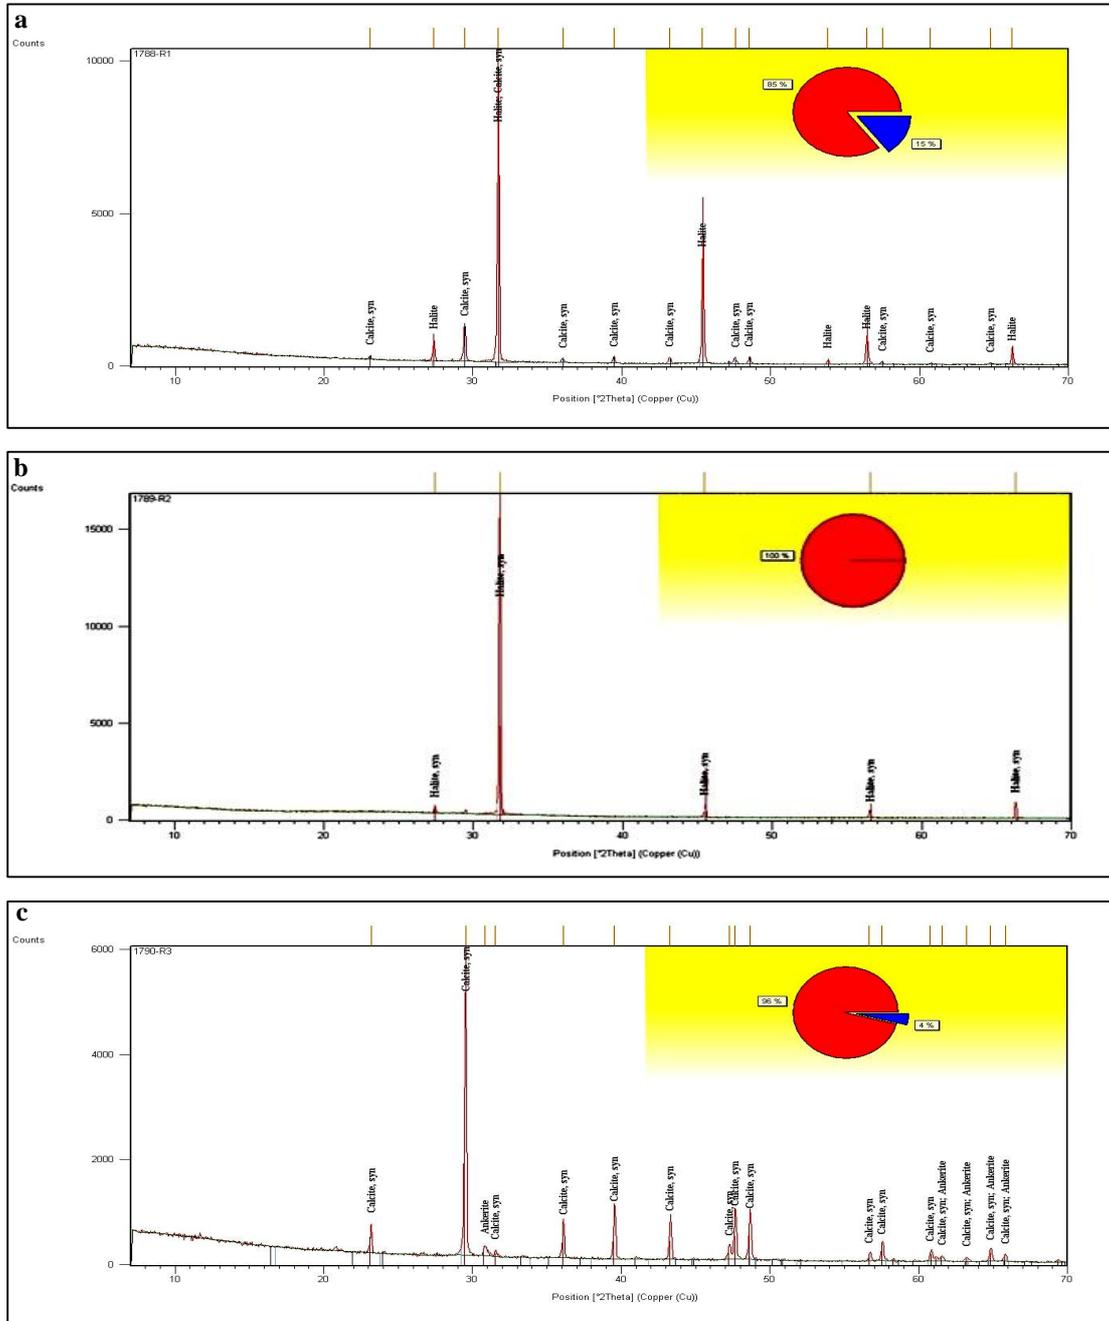
minor, and trace minerals. The results are listed in table (1) and shown in fig. (7-a, b,c)

Figure (7) Shows XRD patterns of limestone **a.** sample R1 (card number: Halite 01-071-3741, Calcite 01-085-1108), **b.** sample R2 (card number: Halite 01-071-4662), **c.** sample R3 (card number: Calcite 01-085-0849, Ankerite 00-041-0586)

As indicated in tab. (2) and fig. (7-a,b,c), the XRD results showed that the weathering products affecting the limestone in the Mosque varied according to the sampling location (inside or outside the building) and height on walls. In the 1<sup>st</sup> category (sample R<sub>1</sub> and R<sub>2</sub>), the presence of halite NaCl, as a major mineral, clarified the severe weathering processes to limestone. It often results from the chemical reaction between calcite- the main component of the limestone- and different contamination ions that in the groundwater (e.g. SO<sub>4</sub>, NO<sub>x</sub>, and Cl). This process particularly accelerated with alternative cycles between the air temperature and the sources of moisture (wetting and drying cycles) [36]. However, the higher value of weathering products, particularly halite was due to the combination of surrounding deterioration factors, especially groundwater, sewage, and lack infrastructure

system [10,26]. In the 2<sup>nd</sup> category (sample R<sub>3</sub>), the presence of calcite CaCO<sub>3</sub> as a major mineral was due essentially to some sheltered areas that have not been affected by the dissolution process [37]. However, the weathering products as minor or trace minerals were because the samples are away from the effect of the weathering process. Ankerite [Ca(Fe<sup>2+</sup>,Mg)(CO<sub>3</sub>)<sub>2</sub>], it is rhombs have a dark core of iron oxide and clear outer rims [38]. It is closely related to dolomite but differs in having magnesium replaced by varying amounts of iron (II) and manganese. It is one of the minerals of the dolomite-siderite series and appears because of the weathering products resulting from the soiling and dusting mechanisms, the chemical transformation of some minerals, such as Hematite to Goethite [10], or the hydration phenomena that affect some dominated minerals in the area.

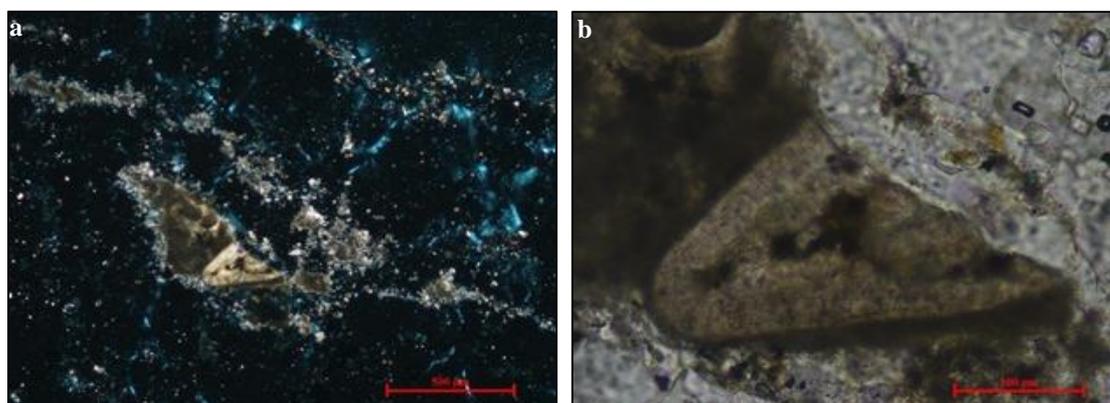
cleavage, and the fossiliferous iron-carbonate fragments were corroded by the salt crystalline material. Sample (no. 6), fig. (8), indicated that it is a stylolite crystalline salt mass containing dark carbonate fragments of fossiliferous iron-stained micritic limestone. The transparent salt (of halite composition) crystals showed strong cleavage and fluid inclusions, few fibrous gypsum crystals, and other impurities. The elongated cleavage and irregular stylolite fractures, as well as voids or joints, were stained by iron oxide impregnations. Otherwise, the nummulite shell was corroded by the development of recrystallized fibrous salt. Occasionally, the salt crystals grew most rapidly, so developing a chevron texture such texture may be formed by the arrangement of the inclusions.

Figure (8) Shows thin section photomicrographs for sample (no. 6) **a.** crossed polars/Nichols (CN), **b.** under plane-polarized light (PL) with stylolite crystalline salt mass containing dark carbonate fragments of fossiliferous iron-stained micritic limestone

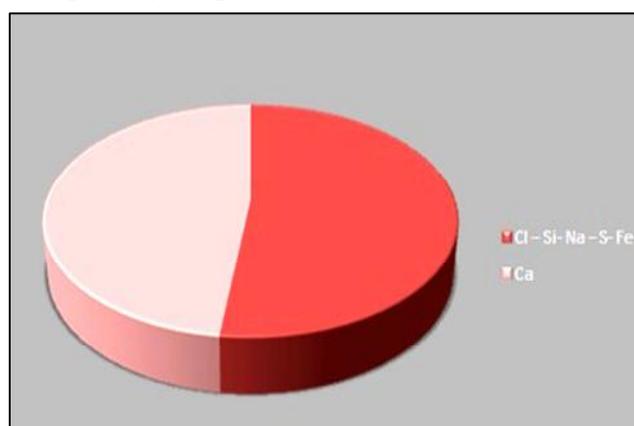
tion, and sewage because of the absence of infrastructure maintenance in the area. The relation of the deterioration products (i.e. Cl, Si, Na, S, and Fe) and the essential component of limestone (Ca) was rated 52%:48%, fig. (9). The high ratio of deterioration elements suggested severe deterioration factors. Furthermore, the high ratio of degradation in the lower and higher parts of Qaytbay Mosque walls (higher than 2 meters) was due to the effect of salt weathering on the building materials.

Figure (9) Shows the ratio between the deterioration products and the limestone components
