**STUDY OF DETERIORATION AND DEGRADATION OF OVERLAID
WOODEN DOORS IN OTTOMAN CARAVANSARY IN BULAQ, CAIRO,
EGYPT**

This paper presents an analytical study of the deterioration and degradation phenomena of two overlaid wooden doors from Ottoman period caravansaries: (A) Hassan Pasha caravansary- X century BC - XVI century AD and (B) Ibrahim Sarhan caravansary- X Century BC- XVI Century AD in Bulaq, Cairo, Egypt. To identify the deterioration and degradation in the types of wood used, microbiological study, Scanning Electron Microscopy coupled with X-ray Energy Dispersive (SEM-EDX), X-ray Diffraction (XRD) were conducted. The data obtained were used to evaluate the status of conservation of overlaid wooden doors (wood and Iron) and to identify the suitable treatment methods.

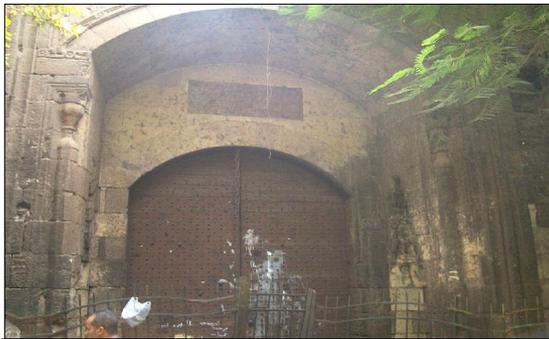
entrance walls, bearing the main arch. This entrance has an overlaid wooden door, with two leaves, of 320 cm in width, and 410 cm in height. each leaf includes 43 iron bands fixed together with iron nails. **(B)** Ibrahim Sarhan Caravansary construction No.43, fig. (2) is founded in Sook-Al-Asr street in Bulaq, to the right side going towards Sabtteya direction. This Caravansary lies in front of Hassan Pasha's one. It was built in the XVI century. This Caravansary was called a Caravansary of cheese. There are no remains left of this Caravansary except the ground floor and main entrance, which includes wooden door with two leaves, of 310 cm in width, and 410 cm in height [4], and each leaf has four iron bands as shown in figure 2. This research focuses on the overlaid wooden doors, covered with iron, to save

Figure (1) Overled wooden door of Hasssan pasha

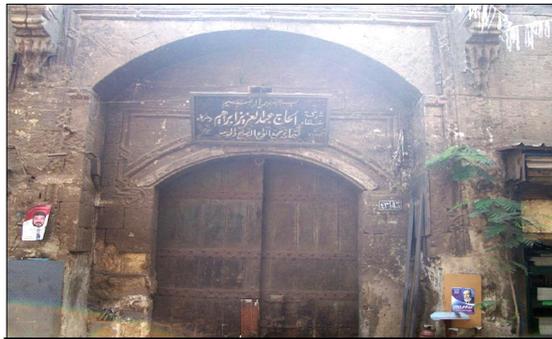
Figure (1) Overled wooden door of Ibrahim Sarhan caravansary

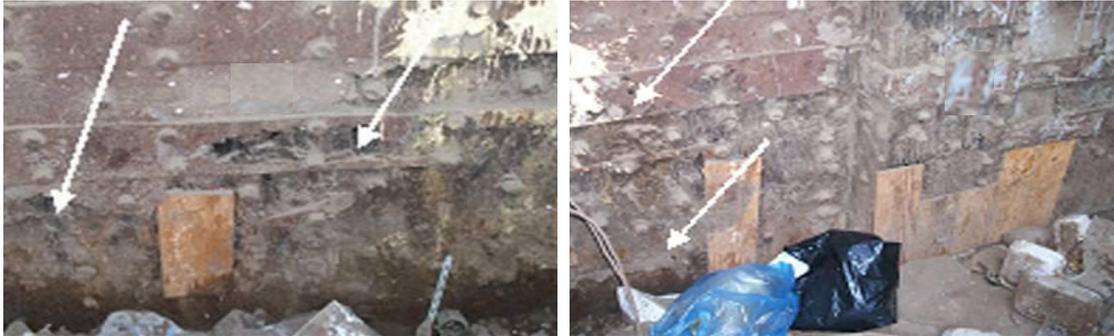
Naked eye examination highlighted many layers of iron corrosion, spots of salts and spots of

microorganisms as a result of high moisture in the door area, as shown in fig. (3) .

Figure (3) deterioration phenomena on Overlaid wooden door of Hassan Pasha caravansary

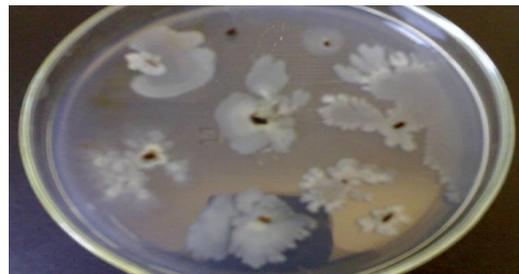
result of high moisture content in wood and of the presence of alkaline elements like (Na^+ , K^+). Micro organism samples were taken to identify the type of species fig. (5).

Figure (5) light microscope photo of bacteria infection *Bacillus Sp.*

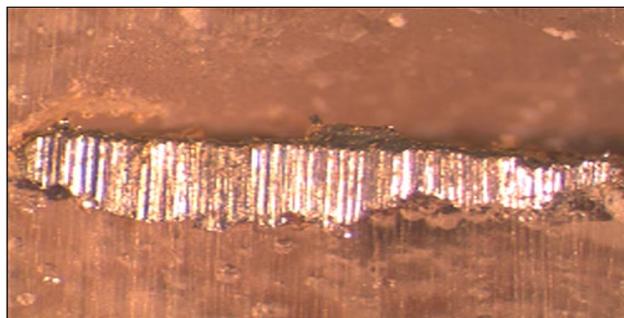
Stereo-microscope is the most useful means in showing the thickness of corrosion layers and the core metal as shown in fig. (6). This figure reflects

the characterization of degradation products and the interaction of the object with the environment [9].

Figure (6) stereo-microscope photo the corrosion layers and the iron core of Hassan Pasha caravansary under.

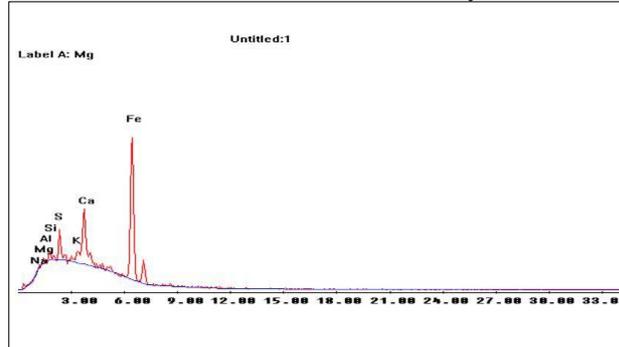
Table (1) & Figure (7) EDX microanalysis of the iron bands in Hassan Pasha caravansary

SEM-EDX examination showed the presence of the clay, corrosion products and salts on iron bands surface in Hassan Pasha caravansary,

as listed in tab. (1) and shown in fig. (7). Also, SEM micro photos show the wood fibers, with salts in between its, fig. (8-a, b, c).

Elements		In. %
Fe		61.6
S		13.6
Ca		12.2
Main of components clay minerals	Si	5.0
	K ⁺	2.5
	Al ³⁺	2.0
	Na ⁺	1.4
	Mg ²⁺	1.3

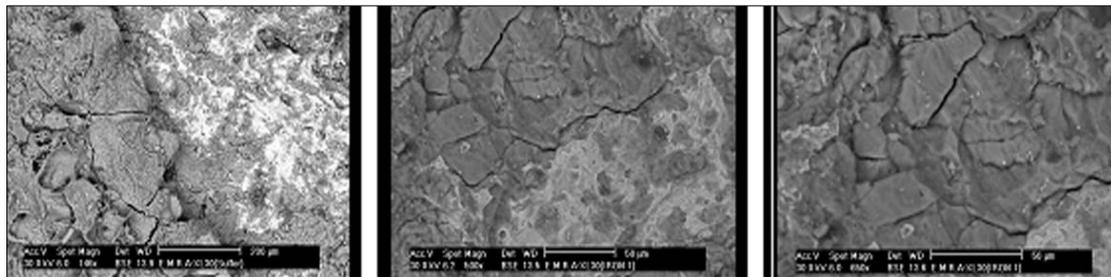
Figures (8) SEM micro-photographs of the studied samples taken from Hassan Paha caravansary **a** X-146, **b** X-650 **c** X-1500 showing clay minerals, corrosion, and salts layers affected iron surface

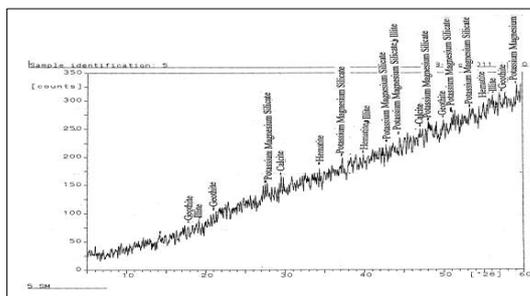
XRD analysis of the Hassan Pasha overlaid wooden door iron bands figs. (9 & 10) showed the presence of potassium and magnesium silicate ($K_2Mg_5Si_{12}O_{30}$) card 10-0008, Hydromolysite ($FeCl_3 \cdot 6H_2O$), card (33-0645), Illite ($KAl_2Si_3AlO_{10}(OH)_2$), card (02-0042) Calcite ($CaCO_3$), card (5-0586), Hematite (Fe_2O_3) card (13-534) and Goethite ($FeO \cdot OH$), card (17-0536). In addition XRD analysis of the salts present between wood fibers on overlaid wooden door of Hassan Pasha showed the presence of Aragonite ($CaCO_3$), card (0-1067),

Figure (9) XRD patterns of the iron sample of Hassan Paha caravansary

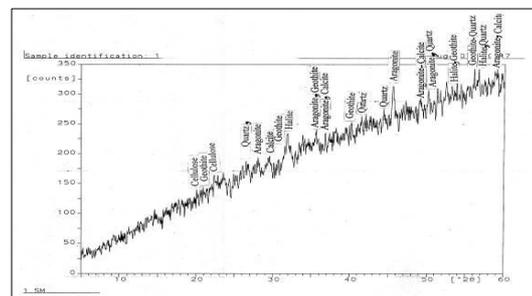
cellulose ($(C_6H_{10}O_5)_n$ card (3-226), Halite ($NaCl$) card (5-0628), Calcite ($CaCO_3$), card (5-0586), Quartz (SiO_2), card (5-0490), and Goethite ($FeO \cdot OH$), card (17-0536). From specialized point of view, it could be said that the presence of hydrated phases of clay minerals as illite and iron oxide type goethite, has a strong effect on the microstructural elements of the overlaid wooden door [10]. The presence of salts type Aragonite have the specific effect of the calcium carbonate at high temperature.

Figure (10) XRD patterns of the salts in the wood sample of Hassan Paha caravansary

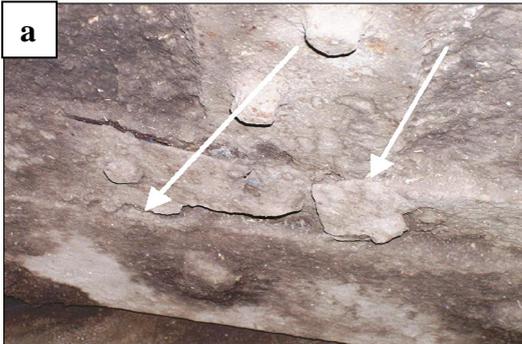
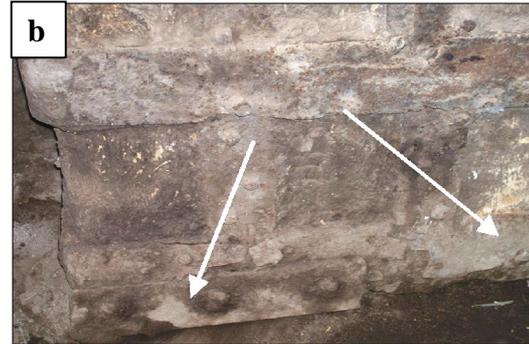
Naked eye examination showed that there are many layers of iron corrosion, spots of salts and spots of biodeterioration and biodegradation as a result of high moisture in the door area, fig. (11). This high levels of humidity

and its changes may induce changes in size and shape causing internal stresses on overlaid wooden doors. High humidity can develop chemical reaction and create a favorable habitat for microbiological degradation [11].

Figure 11 (a, b) deterioration phenomena on Overlaid wooden door of Ibrahim Sarhan caravansary

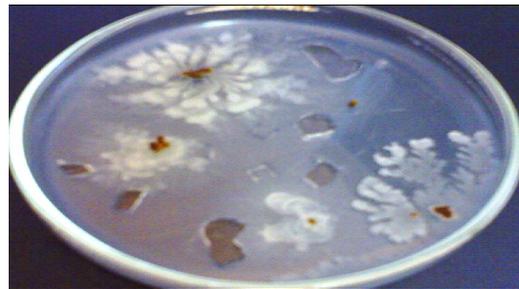
With the optical microscope is studied the type of old wood, which is *Pinus Nigra*, fig. (12). Shows that the type of bacteria is *Bacillus Sp.* which

feeds on the bonding material between cellulose fibers, destroying the mechanical properties of wood, as shown in fig. (13).

Figure (13) light microscope photo of bacteria infection *Bacillus Sp.* Said, M., Bacterial disease dept., Agricultural research center, 2011

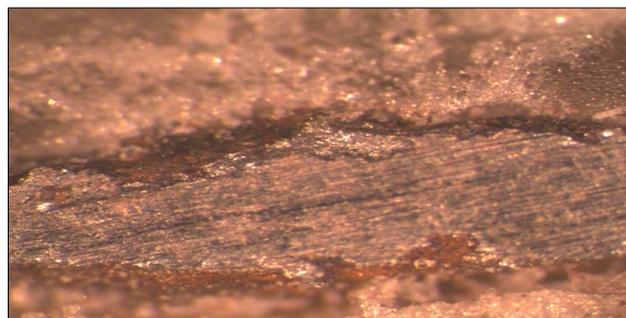
Stereo-microscope is the most useful way in showing the thickness of

corrosion layers and the core metal, as shown in fig. (14).

Figure (14) corrosion layers of Hassan Pasha caravansary under stereo-microscope.

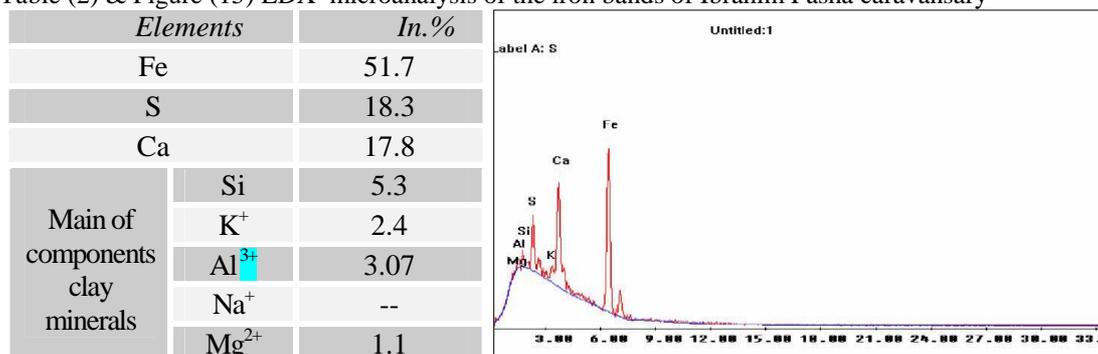
Table (2) & Figure (15) EDX microanalysis of the iron bands of Ibrahim Pasha caravansary

The results of microanalysis evaluated according to data listed in tab. (2) and EDX spectra, fig. (15) showed that iron (Fe) is the main element and has a concentration of 51.7 % , sulfur (S) 18.3 % , calcium (Ca) 17.8 % , silicon (Si) 5.3 % and the rest of the elements is the compensation of clay minerals. The SEM microphotographs

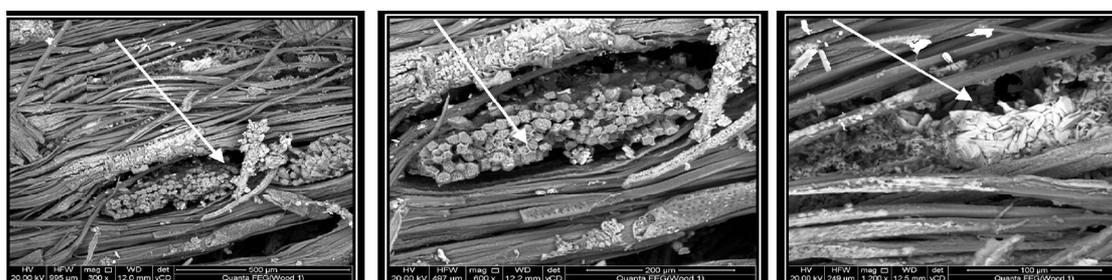
show the clay, corrosion and salts on iron surface, fig. (16), and salts between its fibers closing the wood pores. These photos present the damage occurring from many salts which crystallize between fibers, and compress the wood fibers under the iron band.

Figures (16) SEM micro-photographs of the studied samples taken from Ibrahim Pasha caravansary **a** X-600, **b** X-600 **c** X-1200 showing clay minerals, corrosion, and salts layers affected iron surface
