DECAYING PATTERNS OF QUEEN KHENUT TOMB IN SAQQARA, GIZA, EGYPT

Abdelmegeed, M.^(*), Khalaf, M. & Reffaaf, M.

EJARS – Vol. 11 (1) – June. 2021: 29-37

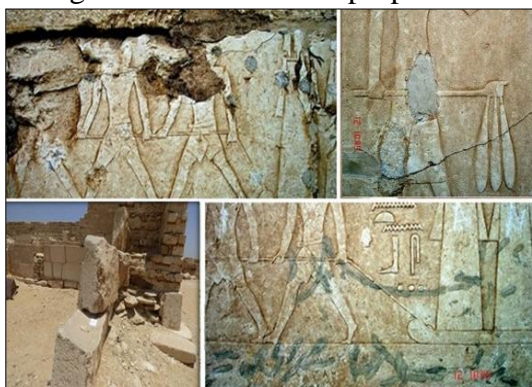
Dissolution, micro cracks and cracks are the most visible damage forms in the limestone used in the construction of monumental buildings in Saqqara region. Queen *Khenut's* tomb is a clear example that suffers from cracking, bleeding and weathering decaying in the constructional masonry units. From the visual survey of limestone in queen *Khenut's* tomb revealed a variety of characteristic decay patterns like; cracking, exfoliation, bleeding and delamination due both internal and external factors, fig. (2). Otherwise, exterior surfaces haven't shown visible salt crystallization (efflorescence) in many places. Salt crystallization beneath the surface (sub-fluorescence) or within the pores (crypto-fluorescence) is barely visible in the exfoliation pieces. The cycle of heating and cooling during the day and night has caused deformation and cracks due to dimensional changes in the limestone. The decaying patterns in queen *Khenut's* tomb are not uniform in damage rate on all limestone blocks. Many of them are in a fully bad situation, suggesting that the limestone blocks have different mineralogical and mechanical properties.

Figure (2) Shows decaying patterns in building materials "queen *Khenut's* tomb"

Limestone is the main building materials used in the construction of monuments in Saqqara. All the historical limestone buildings in Saqqara have been prone to weathering actions. Limestone in queen Khenut's tomb revealed a variety of characteristic decay patterns (cracking, exfoliation, bleeding and delamination) due to internal and external factors. The portion and amount of noncarbonate and clay minerals and components in addition to decay products had a significant effect on the deterioration of limestone used in queen Khenut's tomb. The discontinuities of the internal structure with different amplitudes crossing the stones as irregular planes may accelerate the decay processes resulting in the limestone. Thanks to the absence of moisture sources, limestone of queen Khenut's tomb had suffered neither the black crust nor biological growth. The results of the laboratory tests and in situ investigation indicated that limestone used in queen Khenut's tomb suffer from a loss of surface component materials, cavities, and dissolution due to the critical action role of the dust particles in the air and small particles from air pollution. Limestone is the most building material that is often highly characterized by discontinuities-structure surface due to internal components of scales and shell-like structures. At various scales, this physical component is associated with material loss of the original stone. Limestone used in the construction of historical buildings in Saqqara has low compressive strength values due to the defects in its internal structure and decaying products. An increasing occurrence of cavities exhibit weak zones during the application of compression and tensile forces. Limestone decaying patterns in Saqqara historical tombs are initially alarming. This stresses the shortage of restoration and preservation procedures and the need to begin in the measures, e.g. cracks treatment and consolidation of weak

and loose stone material. Finally, environmental management and rehabilitation procedures must be considered.

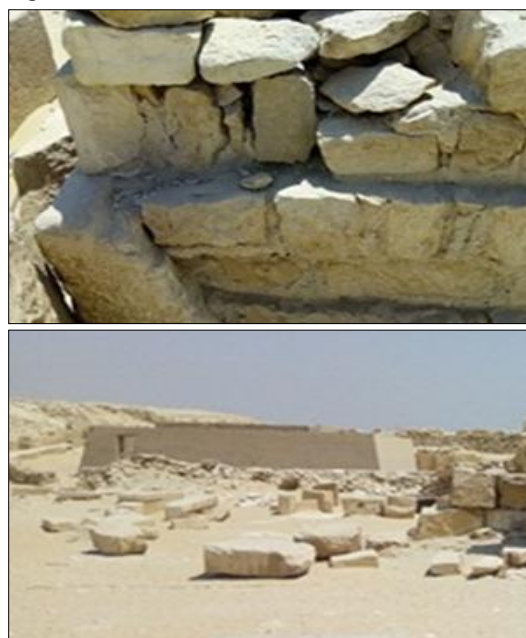
Fully and semi-deteriorated limestone samples (i.e. having visible and slightly visible decaying patterns) were taken and from the walls' courses and fallen stone blocks, fig. (3).

Figure (3) Shows the samples collected from the tomb

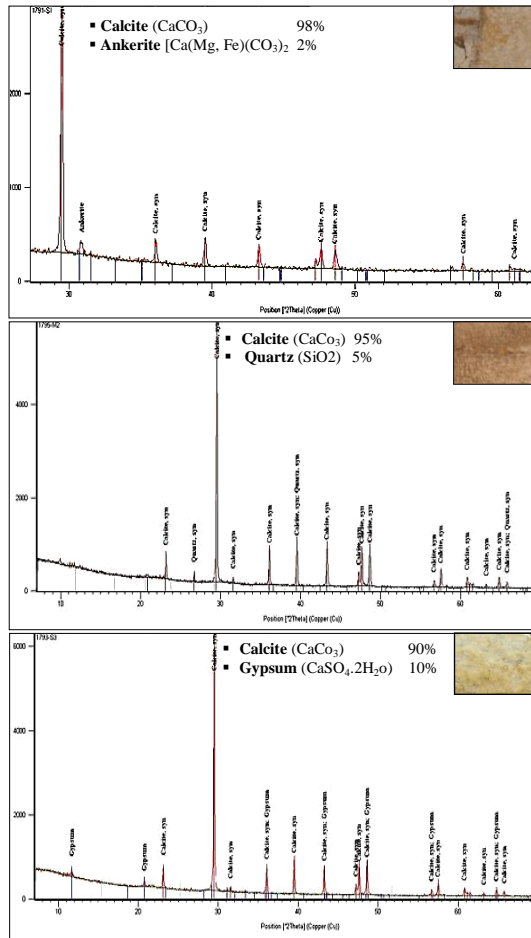
The mineralogical composition of limestone and weathering products phases were recognized by XRD proved that they are occurring in two groups. The 1st group composed of Calcite (CaCO₃) as a main component of limestone. The 2nd one includes Ankerite [Ca(Mg,Fe) (CO₃)₂, Gypsum (CaSO₄.2H₂O) and Quartz (SiO₂) as different weathering products, all of these minerals are shown in fig. (4).

Figure (4) Shows XRD patterns of investigated limestone samples

According to the XRD patterns of the tested samples presented in fig. (4-a,b,c) it could be concluded that limestone used in queen *Khenut's* tomb was mainly derived from carbonate rocks (crystalline to microcrystalline limestone). Moreover, calcite (CaCO₃) appeared as a major mineral of limestone (up to 98%) used in queen *Khenut's* tomb. The presence of gypsum (CaSO₄.2H₂O), quartz (SiO₂) and ankerite [Ca(Mg, Fe) (CO₃)₂], as minor and trace minerals, mostly refer to the deterioration forms and products in the limestone, tab. (6). These compositions indicated that the observed detachment of stone crusts, cracking and subsequent loss of limestone materials resulted from soiling, black and whitish crusts and salt deposits in the pore space of limestone units. Table (6) Mineral compositions of limestone used in queen *Khenut's* tomb

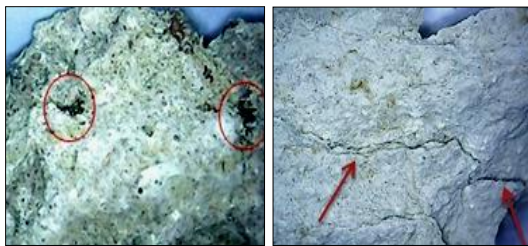
Through using DM, digital image capture systems and the image analysis software it could be noted that the investigated samples show some deterioration features such as caves and micro-crack, fig. (5)

Figure (5) Shows DM photographs showing the caves and micro-cracks distributed in the surface of limestone samples

DM investigation showed that, on one hand the surfaces of limestone suffered loss and detachment of materials making unequal volume cavities, fig. (5). On the other hand, it showed the structural discontinuities of the limestone used in the tomb. The loss of the stone materials mainly, due to the processes of salt crystallization, resulted from the cyclic action of the water and of the thermal radiation [30-31] and helped the development of materials detachments. Moreover, low cementation level and pitting features are observed on the stone surface, which could, in turn, enhance granular disaggregation processes. Within the same context, the petrographic features, fig. (6) illustrates that the limestone in the tomb is classified as carbonates and salts with carbonate fragments stone. In addition, the samples contain micrite matrix crowded by minute foraminiferal with a coarser shell that partly re-crystallized micro sparry calcite. Moreover, the stone is composed of carbonate cuttings; each of them is brocclastic lime mud stone to weak stone. This structure generally presents heterogeneous granular texture; with a very rare matrix and low cementation level between the internal components, leading to a fair development of inter-granular porosity. Therefore, the cracks spread due to the incompatible and low cementation level in the internal components of the limestone used in the tomb. The microstructure features, fig. (7) illustrated that the inner micro-laminations lost continuity of the calcite grains and cohesion between inter-granular compositions. Also, the resulted data tab. (4) affirmed that the presence of Si-based compounds and Fe, Al, Mg state to clay minerals fill the micro-laminations of the samples. These minerals that enhance the micro-cracks inside the laminations within the stone body and the cracks on the stone surface.
