**STUDY THE ROLE PLAYED BY FUNGAL GROWTH IN THE
DETERIORATION OF LIME MORTARS, AN EXAMPLE FROM TUNISIA**

Moussa, A.¹, Mansour, M.¹ & Ayed, N.²

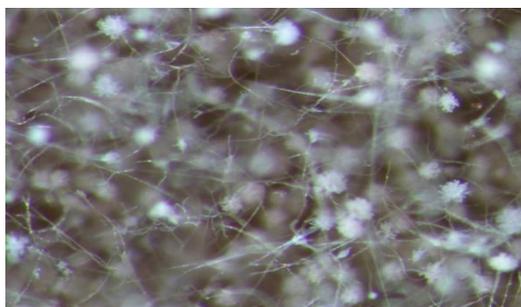
Figure (1) the fungal flora *Aspergillus ochraceus* (the collating mortar of the red brick)

The biological investigation of the genera isolated from the lime mortar samples that were derived from the forte of Kelibia revealed that the fungal flora *Aspergillus ochraceus* represents the dominant fungi constituting (100%) of the total fungal isolates from the collating mortar of the red brick, fig. (1). *Aspergillus tamareii* was detected upon the red pigmented plaster remains in the citadel walls, fig. (2). The fungal flora *Ascosphaera apis*, fig. (3). has been detected upon the mortar sample with red

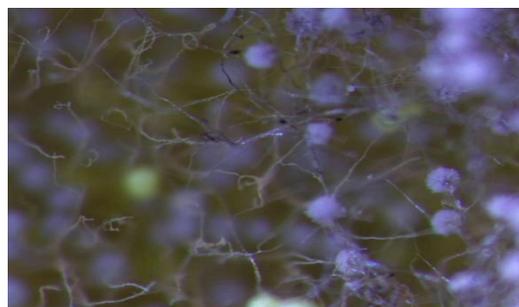
Figure (2) the fungal flora *Aspergillus tamareii* (red pigmented plaster remains in the citadel walls)

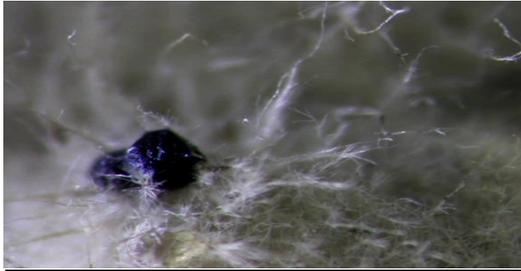
Figure (3) the fungal flora *Ascosphaera apis* (mortar sample with red and yellowish aggregates)

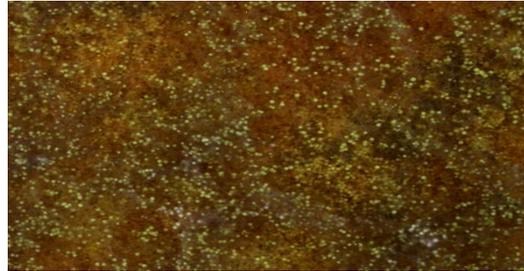
Figure (4) the fungal flora *Eurotium repens* (the collating mortar of the wall mosaic)

and yellowish aggregates, which was derived from the eastern outer wall of the citadel, while the fungal flora *Eurotium repens*, fig. (4), and *Eurotium chevalieri*, fig. (5), were detected in the isolates taken from the collating mortar of the wall mosaic in the archaeological site. The isolates taken from the collating mortar of the ground mosaic inside the archaeological site have shown the presence of the fungal flora *Doratomyces sp*, fig. (6) and the fungal flora *Cladosporium cladospriedes*.

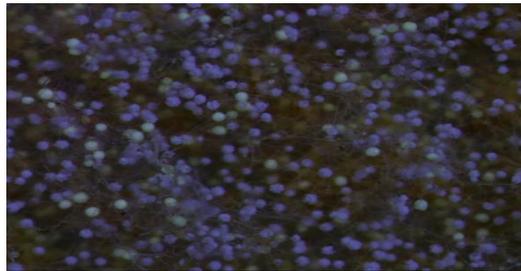
Figure (5) the fungal flora *Eurotium chevalieri* (the collating mortar of the wall)

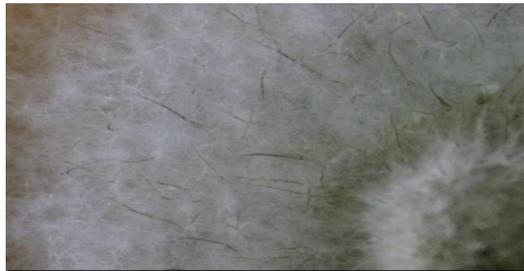
Figure (6) the fungal flora *Doratomyces sp* (the collating mortar of the ground mosaic)
