STONE IN ARCHITECTURE AND SCULPTURE, DETERIORATION AND CONSERVATION

Łukaszewicz, JW.

EJARS - Vol. 10 (2) - Dec. 2020: 103-112

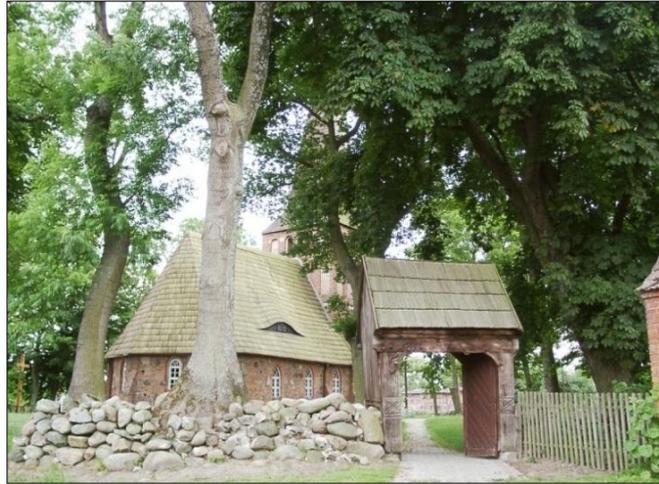
Figure (1) Shows Iwięcín, branch church of our lady the queen of Poland in Iwięcín (Poland, Zachodnio-Pomorskie Province)

were chosen or individually selected, taking into account the properties of the rock. Therefore, for the construction of foundations, bases on which wooden or later ceramic constructions were built, durable granite of very low porosity was chosen, fig. (1). It ensured high strength, durability and stability of the structure and protected it against capillary movement of ground water in higher parts of the structure to materials of higher porosity, such as wood or brick. Unfortunately, with time and under the influence of many factors, all stones are eroded and corroded. The speed of these processes depends on the type of stone and the conditions of its exposure [1].

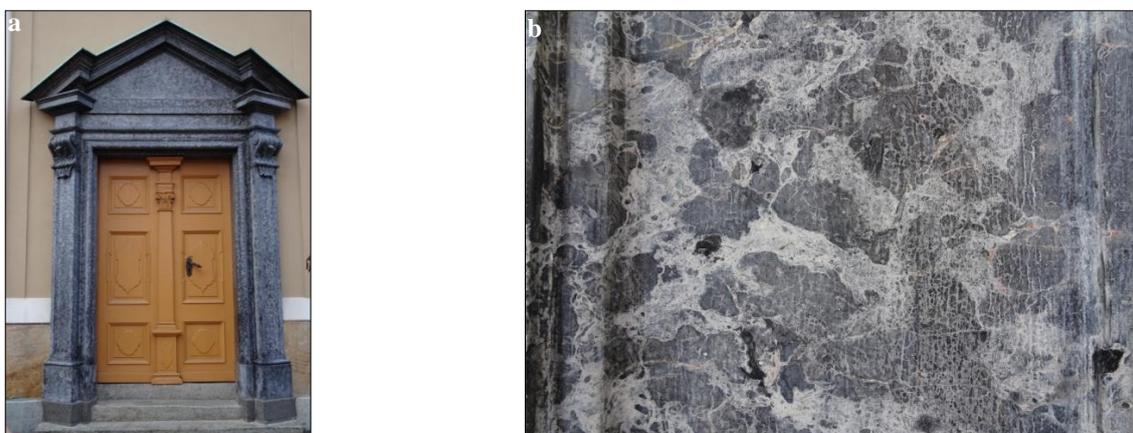
Figure (2) Shows **a**. Toruń, church of the holy spirit, southern elevation, portal made of compacted limestone from Dębnik, **b**. Dębnik fragment (photos by the author)

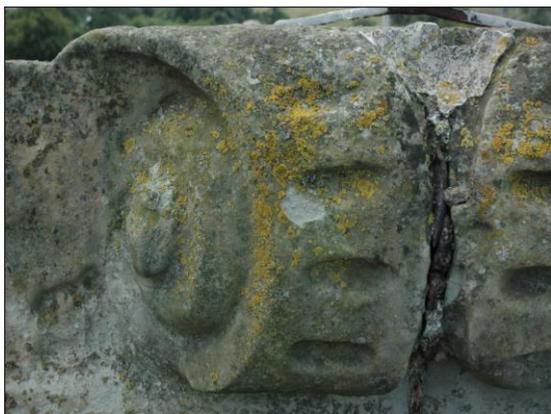
Figure (3) Shows Gdańsk, lowland gate, capstone, Gotland sandstone, biological corrosion (*photo by the author*)

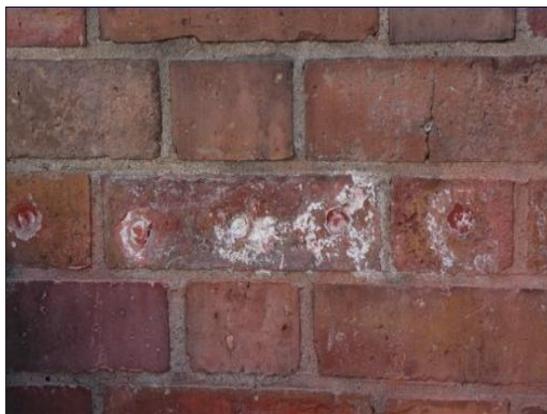
Figure (4) Shows horizontal insulation incorrectly made with water glass and cement (*photo by the author*)

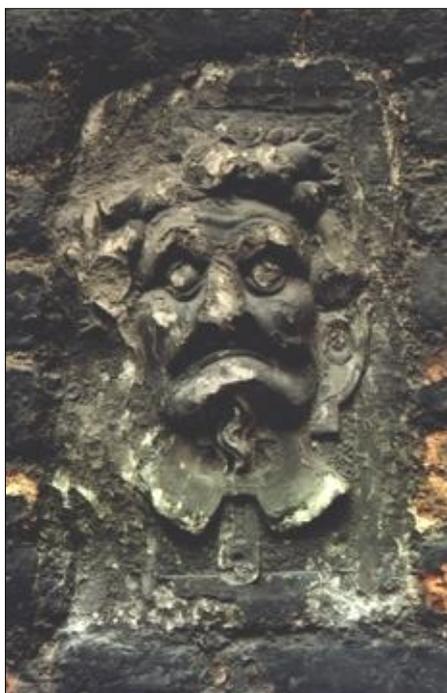
Figure (5) Shows great armory in Gdańsk, relief covered with black, corrosive layers (*photo by the author*)

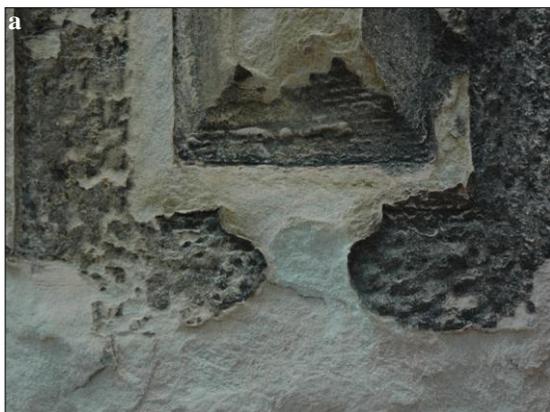
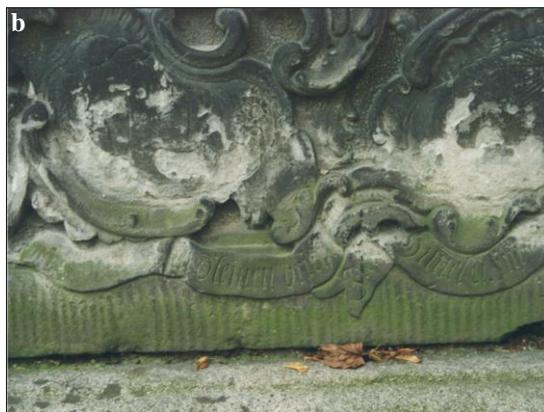
Figure (6) Shows **a.** architectural detail from Gotland sandstone, disintegration of stone under corrosive layers (*photo by the author*), **b.** fragment of the epitaph of Gottfried Mentzl and his wife Anna Rosina, disintegration of stone (sandstone with silica-loam sand binder) under the layers, action of salt and microorganisms (*photo by W. Domasłowski*)

During the drying of the stones, the salt solutions will increase their concentration until they crystallize. The crystals that form as a result of the crystallization pressure will cause the surface of the stones to break down and disintegrate. One should not forget about human activity as well. In the past, the use of strengthening methods or horizontal insulation using water glass has caused strong salinity of the monuments, as well as the use of mortars with cement binder, fig. (4). All destructive factors, regardless of their nature, cause changes taking various forms. One of the first symptoms of these changes is the formation of gray and black *corrosive layers* (*black crusts*) on the surface, which are formed as a result of chemical and physical transformations between the substrate and the corrosive factors. Hence, the composition of layers is variable, depending on the chemical nature of the stone substrate and the environment in which the object is exposed, fig. (5). However, some properties of these layers are common and testify to their harmfulness towards the monument. These are: grayish color, compact texture and good adhesion to the ground. Due to the low porosity and dark color of the layers, they heat up easily, expand thermally, which leads to the formation of internal stresses and on the border of the layer and the substrate, which results in the formation of cracks, delamination of the stone and detachment of the crusts together with the substrate layer, the more so as the material underneath is very weakened, fig. (6-a, b). Disintegration of

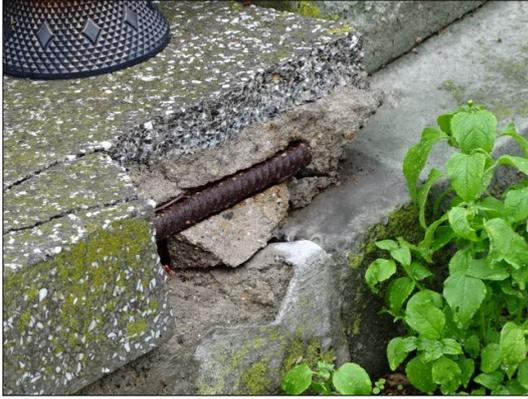
Figure (7) Shows architectural detail destroyed as a result of material stress caused by corrosion of steel elements (photo by the author)

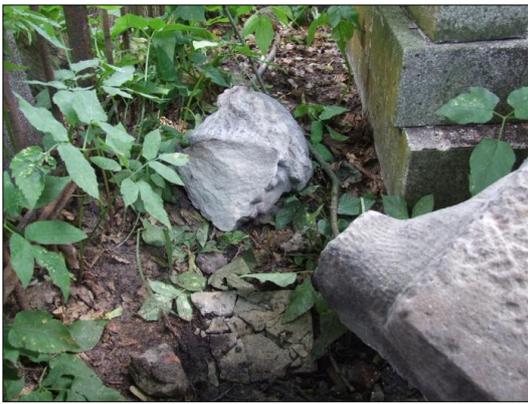
Figure (8) Shows sculpture of Christ from the tombstone of Prof. Mieczyslaw Limanowski at the St. George cemetery in Torun, after an act of vandalism on 26-06-2010. (photo by A. Gralińska-Grubecka)

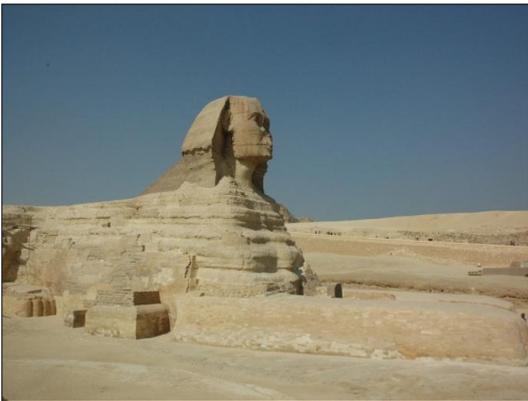
Figure (9) Shows Giza, the Great Sphinx, the destruction caused by sand and wind (photo by the author)

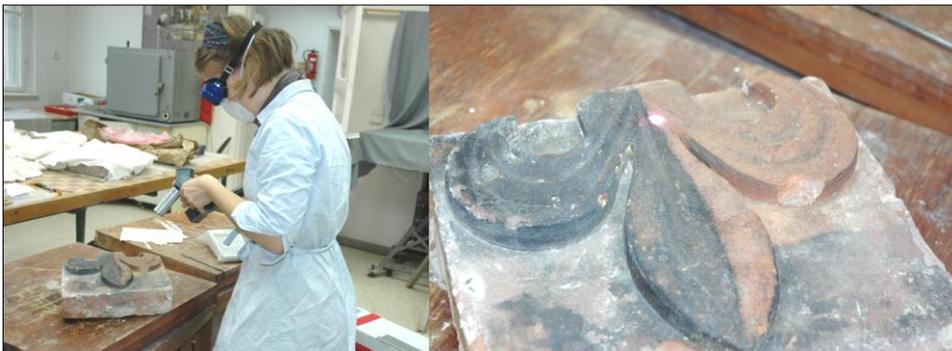
Figure (10) Shows cleaning of a ceramic architectural detail by laser ablation using a laser developed in the Military Academy of Technology in Warsaw (WAT) by Prof. Jan Marczak (photo by the author)

of $\lambda = 1064, 532, 266$ and 213 nm). This method was developed and applied in Poland by Prof. Jan Marczak from Military Academy of Technology (WAT) in Warsaw, in cooperation with the Intercollegiate Institute of Conservation and Restoration of Works of Art, fig. (10) [7,8]. Modern methods include the "Le gommage" rubbing method developed by Thomann-Hanry, using very fine aggregates, even up to $50 \mu\text{m}$ administered at low pressure and the use of dry ice (solid CO_2). Although the first attempts to use dry ice were made as early as the 1950s, the method has not found a wider application. Nowadays it is also proposed; the advantages of dry ice are emphasized, which is odorless, non-poisonous, chemically inert, biostatic, with a low hardness on the Mohs scale equal to 2. The only problem is the very low temperature of dry ice (-78.9°C), which can cause thermal shock and turn out to be extremely harmful in case of damp objects, causing rapid freezing of water in pores, fig. (11).

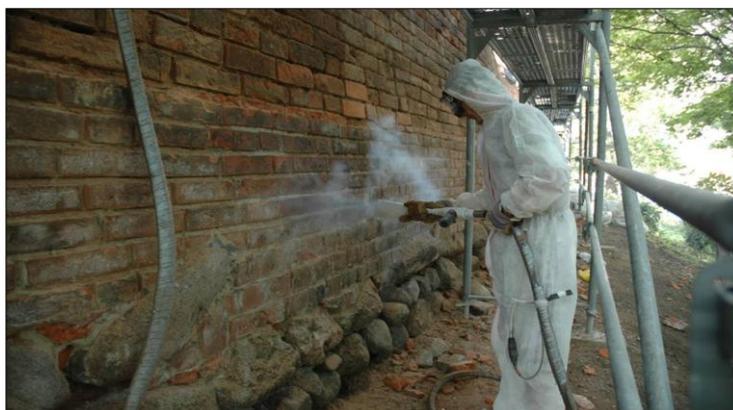
Figure (11) Shows dry ice cleaning, freezing of a damp wall (photo by the author)

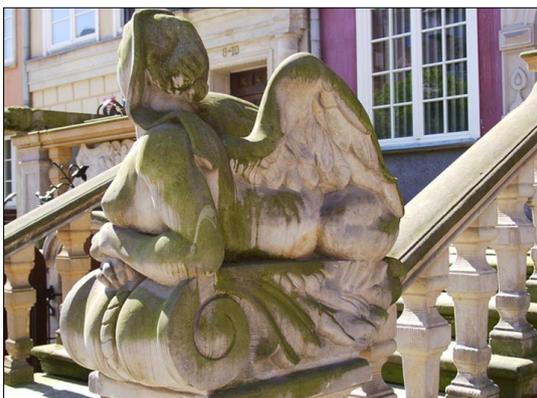
Figure (10) Shows details of Gdańsk lintels, after hydrophobization, biological damage (photo by the author)

In order to protect stone monuments from water, hydrophobization is a popular treatment. As in the case of consolidation, this treatment can be carried out using the surface method by introducing hydrophobizing preparation to the depth of a few millimeters, or deep, structurally, to a few to several centimeters. The most popular preparations are solutions, emulsions, microemulsions or creams containing alkylpolysiloxanes. Their effectiveness is varied. By performing this treatment we change the natural hydrophilic properties of stones to hydrophobic, which prevents capillary movement of water in the pores of stone. However, it does not protect against penetration of water vapor and its condensation inside the material. The basic criterion for deciding on hydrophobization is the certainty that the object is fully protected against water penetration and does not contain water-soluble salts. Otherwise, hydrophobization may not only fail to protect the object against water, but also contribute to a very rapid destruction of the object, fig. (12).
