THE ENVIRONMENTAL FACTORS AFFECTING THE ARCHAEOLOGICAL BUILDINGS IN EGYPT "III DETERIORATION BY SEVERE SEISMIC HAZARDS"

El-Gohary, M.

EJARS – Vol. 11 (2) – Dec. 2021: 147-164

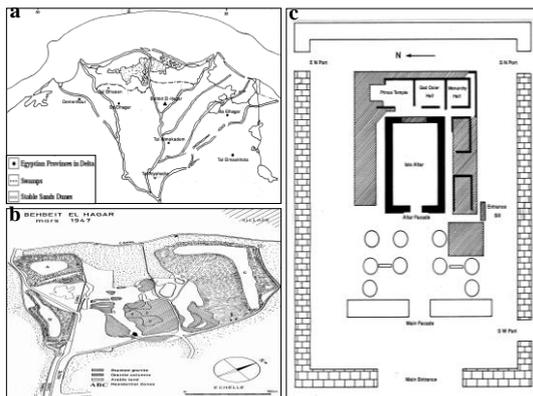
Nektenebo II temple is located in the middle of the Nile Delta, about 8.5 Km., fig. (1-a) from Samannoud town "the ancient capital of Nome XII of Lower Egypt" in (31° 02' N, 31° 17' E) [22-25]. The temple is located in the modern village of Behbit el-Hagar, which is known in hieroglyphic as (*tb-ntr*), fig. (1-b). This village is one of the most well-known ancient towns belonging to the 12th region in Lower Egypt [23, 26]. According to Favard-Meeks [27], the temple and its architectural features, fig. (1-c) are very important Egyptian archaeological sites that were investigated by De bois Ayme and Jollois during the French expedition in chapter 25, volume 5 of *Déscription del' Egypte*. They drew different maps for the temple site and its surrounding area as well as defined its boundaries by 362 m. long and 241 m. wide. Moreover, they stated the presence of some architectural remains, whose measurements are 18-20 m. high and 9-10 m. thick, in addition to 4 open areas from the west side, 1 from the southern and the other from the northern side.

Figure (1) Shows **a.** map of Behbit el-Hagar in El-Gharbia governorate, **b.** map of Nektenebo II temple area, **c.** features of Nektenebo II temple

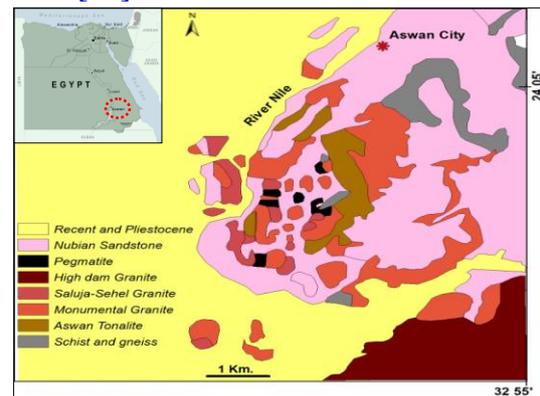
Figure (2) Showing map of granite quarries used in the study area belonging to *Precambrian formation* (modified after Dixon & Golombek 1988)

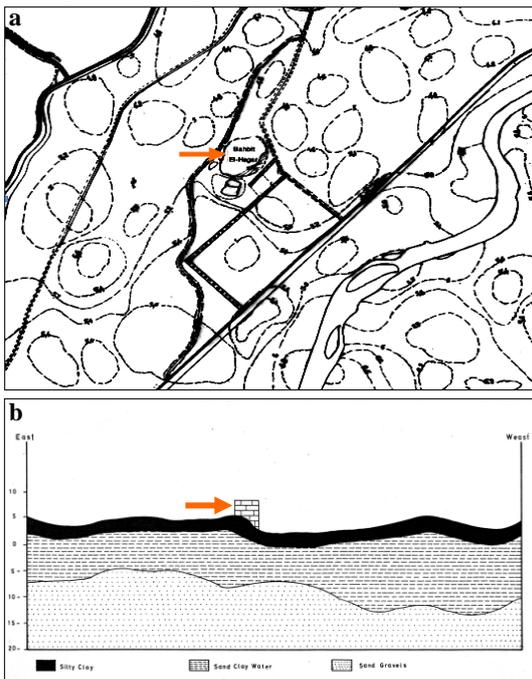
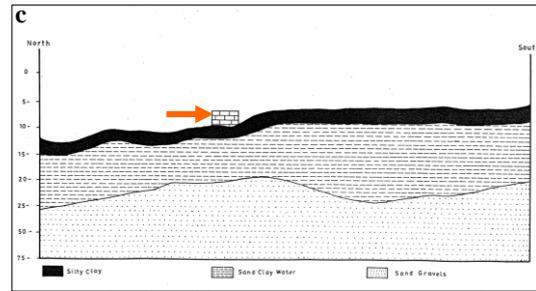
Nektenebo II temple, fig. (3-a) was built on the part of the existing Nile Delta, which is essentially composed of sand and gravels covered by layers of clay. These layers were formed through the last 7000-8000 years by Nile floods [38]. For defining these features, topographical survey was conducted using digital Theodolite to find out the specific topographical contour map and land levels of the area. It proves that it is characterized by several structural units and features, as follows: Presence of some lower sites below the surrounded cultivated lands at about 1.42 m., some canals and ditches that serve cultivated lands in this area that lead to leakage of the domestic waste water and its aggressive salts under the temple, as well as high quantities of clay assessed by 15-20 m. and bordered by a hill composed from sand and gravels, fig. (3-b, c).

Figure (3) Shows **a.** topographical map of temple area, (After, El-Gohary, 1996), **b.** west east direction **c.** north south direction of lithographic section of temple

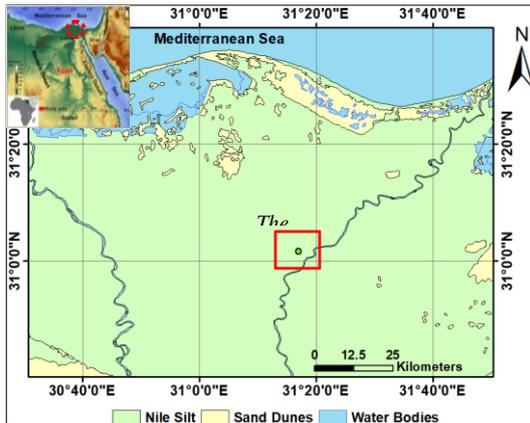
- *) Superficial layer of ground with unique thickness. It extends from east to west, varies between 1-2 m. with average 1.4 m., and is composed essentially from mud, muddy silt and silt.
- *) Layer with thickness ranging between 4.5-14 m. It is essentially composed of the same silty material that filled the ancient Nile branches.
- *) Layer differs from the previous because it is characterized by greatness of its grains, especially towards the bottom

direction which was thought to have composed the ground water table in this area.

Figure (4) Shows geological map of the study area

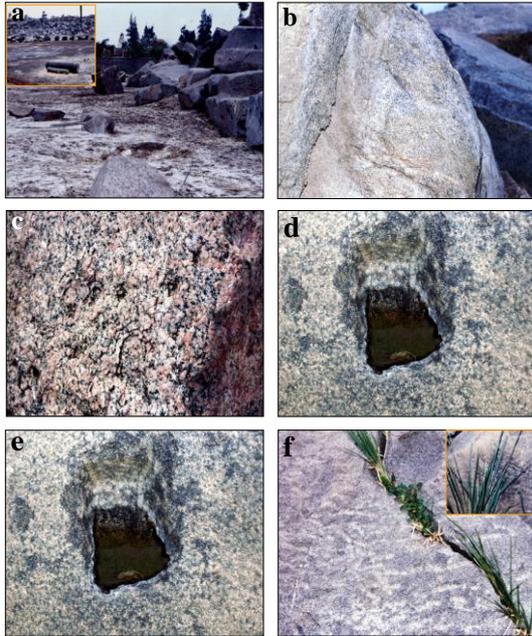
Using (CICS) showed that both macro and micro deterioration factors led to total disintegration of the monumental buildings and their different architectural components [62,63]. Seismic actions, as macro agents, are the most destructive factors affecting the archaeological buildings [42]. Weathering as micro agents may also cause a rapid change in the initial petro-physical properties of rocks and so limit their durability index [64]. Our case study was highly affected by both *micro* and *macro* deterioration factors along time. It is still exposed to other harmful forces, especially the ones related to theft and vandalism [36]. The results of field site observations demonstrate the following: Direct effects of seismic actions, such as ground motion, faulting, collapsing and complete destruction of the whole structural elements, especially some columns, entrances and thresholds, fig. (5-a); sliding and overlapping of granite

rock blocks and detachment of some layers (scaling and flaking forms), fig. (5-b); indirect effects such as crystallizing of some salt species owing to water evaporation process, fig. (5-c); mechanical destruction due to the alternative cycles of freezing and thawing (*frost actions*), fig. (5-d); presence of some biological and microbiological colonization that creates a suitable environment for lichens and wild bees, fig. (5-e) and growth of some species of higher plants (*barssica nigra*, *chene podium*, *cylindrica imperata* and *savada monica*) that cause some mechanical deterioration forms due to plant growth (*aggressive cracks and micro fissures*). Also, there are effects of chemical deterioration forms through sap roots (colored crusts on stone surfaces), fig. (5-f) .

Figure (5) Shows different deterioration forms dominated in the temple of Nektenebo II in Behbit el-Hagar

due to the effects of earthquakes, alternative cycles of rain water through frosting and desolation actions. In addition, there are some falling down parts, some scale layers, aggressive cracks and micro fissures and detachment of small thin stone elements in flaking pattern. In addition, presence of some colored crusts resulted from biological and microbiological colonizations and wiled bees. All of these features and weathering products could be used to develop appropriate methodologies for cleaning the granite blocks and suggesting appropriate surface treatments for practical usage. These procedures should be focused on different chemical and petrophysical properties, such as pore structural changes related to the progress of degradation, and using pore structural measurements to assess and predict the effectiveness of the selected appropriate treatment materials used for this purpose. This paper showed the importance of developing appropriate action plans, materials and techniques that evaluate the state of deterioration and help map the risks of damage. Hence, further investigations are needed for an accurate qualification and quantification of the site deterioration. Also, more reliable and effective structural conservation plan should be developed to preserve the site and reconstruct the temple. This plan is based on different steps of structural conservation according to two main processes: The first is the reconstruction of the main temple building and the second is foundation strengthening and the third wall grouting.

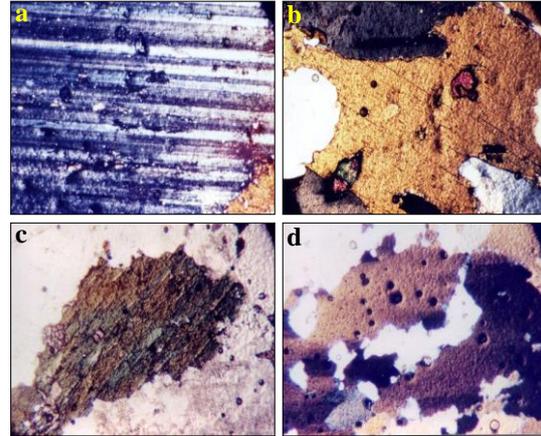
The investigation results assert that the essential components of the samples are *Plagioclase*, *Orthoclase*, *Quartz*, *Biotite* and *Zircon*. In addition, there exist some degraded minerals, such as *Chlorite* (green color), as well as other minor minerals, such as *Kaolinite* (gray color), *Epidote* (pale greenish-yellow), *Zoisite* (blue color), and *Saussurite* (light red color) which

resulted from weathering processes affecting the main components of the temple stone blocks, figs. (6-a, b, c, d).

Figure (6) Shows different petrographic features characterize the studied samples in the temple of Nektenebo II - (all 60-X)

ence of Continuous sources of polluted ground water. *Petrographically*, the data collected through investigations using this technique, fig. (6-a, b, c, d) proves that the main components of granite samples are plagioclase and orthoclase, which belong to the feldspars group. They are the most important minerals in igneous rocks [101, 102]. Quartz grain containing wavy extinction that resulted from sub-grains forming in response to strain, biotite with good basal cleavage and pleochroic haloes surrounding. Zircon inclusion were highly affected through different aggressive alteration mechanisms and created different degradation forms. Geologically, the partial degradation and alteration of mineral from brown biotite into green chlorite are attributed to weathering processes affecting feldspars. Chlorite is a secondary mineral characterized by fairly robust to weathering into clay minerals [103,104]. In addition, the presence of kaolinite, which is a clay mineral, is essentially due to the alteration processes affecting feldspars, feldspathoids and other silicates [105,106]. Epidote may be associated with hydrothermal alteration, weathering, diuretic alteration of orthoclase and plagioclase [107,108]. Also, it may be formed from the breakdown of chlorite or saussuritization of plagioclase. *Zoisite* may be produced from the breakdown of calcium plagioclase through hydrothermal alteration. Saussurite is a weathering product attributed to the alteration of Ca-plagioclase [109,110]. *Chemically*, EDX data, fig. (7-a & b) asserted that the primary elemental components of the granite sample are (Si, Al, Fe and K), which vary between 76.11 and 93.01 %, in addition to the elements of weathering products (Ca, Na, S and Cl) that vary between 6.99 and 23.89 %). These products came from the dominated deterioration factors in the study area, such as groundwater, rain waters, aggressive atmospheric pollutants as well as freezing and thawing phases [36]. Such factors lead to the chemical corrosion and decomposition of stone materials [111-114]. *Morphologically*, SEM observations,

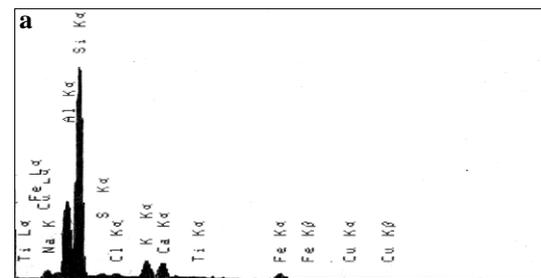
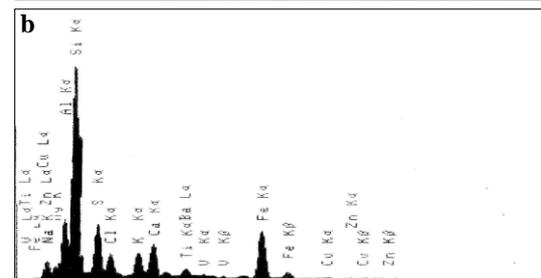
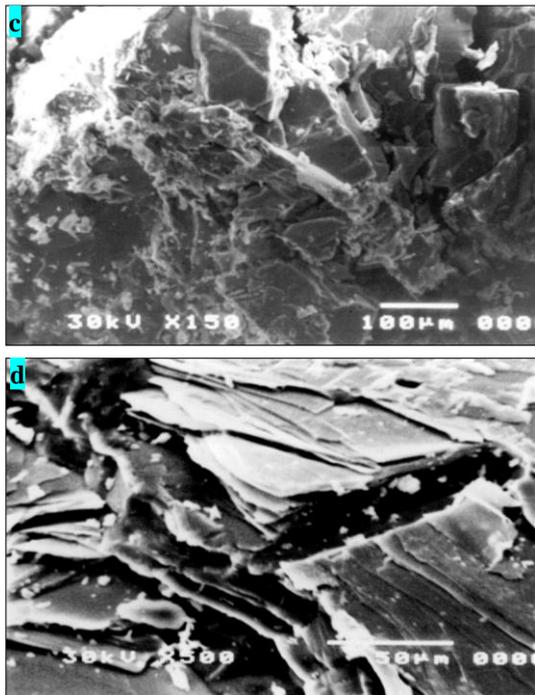
The investigations have shown that the samples are composed of several elements which are listed in tab. (1) & figs. (7-a, b). Within the same context, SEM remarks indicate that they are characterized by obvious disintegration and decomposition in mica sheets. In addition to brittleness and weakness appearance, the elemental charts and SEM photomicrographs are shown in figs. (7-c, d).

Figure (7) Shows **a, b** EDX charts and **c, d** SEM photomicrographs of investigated samples in the temple of Nektenebo II

fig. (7-c & d) illustrate that the deterioration forms affected the stone blocks due to the severe effects of alternative cycles between heat and cold as well as the other mechanical weathering actions attributed to wind erosion. Moreover, the most noticeable deterioration forms indicate that the stone body was highly affected by the chemical aggressive actions of groundwater as well as other actions of acid rainfall [115]. Organic substances between the stones cracks resulted from the effects of biological and microbiological factors [116]. *Mineralogically*, XRD results, fig. (8-a, b) affirm that the investigated samples contain the main components of Egyptian granite which is characterized by normally pinkish color with abundant pink porphyroblasts, small feldspar crystals, quartz and dark ferromagnesian, and small crystals of apatite [117]. Moreover, the resulted data confirmed that the final stage of weathering effects lead to some products particularly, kaolinite according to the following formulas [28].

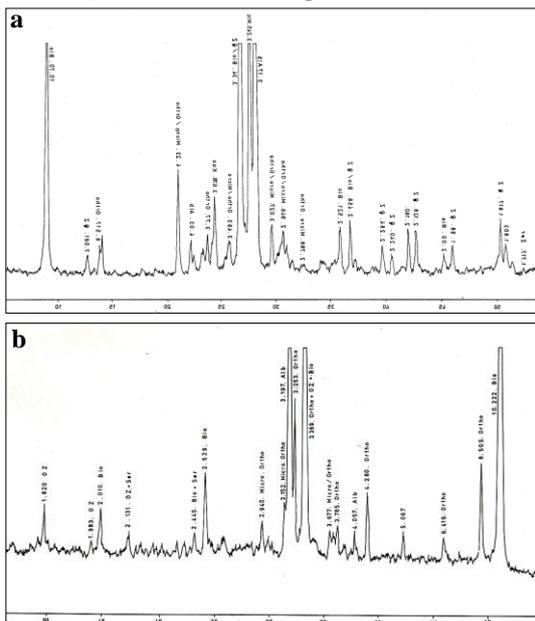
XRD results show that the main components of the investigated samples are Biotite [$K(MgFe)_2AlSi_2O_{10}(OH)_2$], Albite [$NaAlSi_3O_8$], Mica [$KAl_2(AlSi_2O_{10})(OH)_2$] and Orthoclase [$KAlSi_3O_8$] as major minerals; QZ [SiO_2] and Microcline [$KAlSi_3O_8$] as minor minerals and traces of Zircon [$Zr(SiO_4)$], as shown in figs. (8-a, b).

Figure (8) Showing XRD patterns of investigated samples in the temple of Nektenebo II

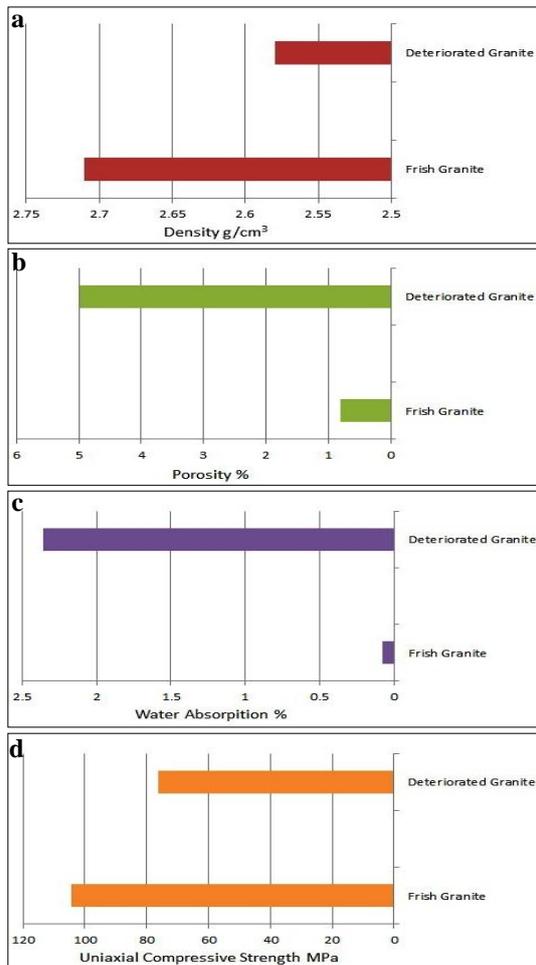
The geotechnical study of deteriorated granite (5 samples) adapted for evaluating the same physio-mechanical properties of the original mentioned above proved that all of these properties were negatively affected by weathering processes. Where, density (γ_d) = 2.58 g/cm³, porosity (η) = 4.98 %, water absorption (WA) = 2.36 % and uniaxial compressive strength (UCS) = 76.08 MPa respectively. These results are shown in figs. (9-a, b, c, d).

Figure (9) Shows the main physio-mechanical properties of fresh and deteriorated granite samples

properties of deteriorated samples proved that they were highly affected by environmental situation dominated in the study area, particularly after the effects of macro and micro seismic hazards affected previously the study area. From specialized point of view, it could be asserted that the measured effective physio-mechanical parameters were negatively changed as shown in, fig. (9). Where, (γ_d) was decreased 5.8%, (η) increased 99.8 %, (WA) increased 99.9 % and finally (UCS) decreased 27.1 %. Reality, the negative changes in of these measurements affected rock body inherently have attributed essentially to the flaws or the presence of small cracks, in addition to the relative orientations between major flaws and loading directions as argued previously by Fookes et al. [118] and Keunbo et al [119] in their studies. Furthermore, it may be resulted due to the alternative cycles of frosting and desolation actions [120], or to the weakening of the bonding strength at rocks interface that influences the lifespan of rocks [121]. At the end it could be asserted that all factors mentioned above led to the aggressive deterioration forms in damaged blocks that need urgent conservation and rehabilitation processes to alive the temple under the study.
