GEO-ENVIRONMENTAL FACTORS THREATENING THE OLD CAIRO
ARCHAEOLOGICAL SITES: BABYLON ROMAN FORTRESS, CASE STUDY

Metwaly, D.^{1,2}, Elewa, H.¹ & Saleh, M.^{2(*)}

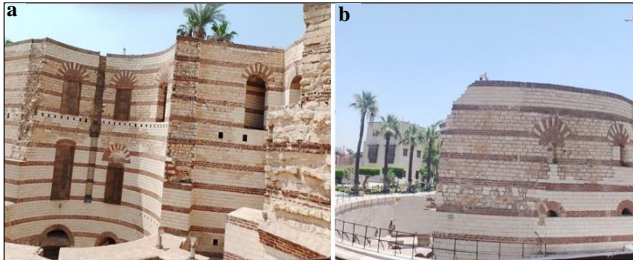
The Roman tower is located at the entrance to the fort and consists of five-sections of limestone; each section consists of seven rows of limestone, while the sections made of mud bricks are seven sections consisting of three rows connected by lime mortar, which commonly used in the Roman era. This tower contains a group of windows topped by a semicircular arch with equal distances that are arranged around the entire tower [1], fig. (2).

Figure (2) a. remains of the Roman tower guarding the Roman canal, b. exterior of the Roman tower that flanked the entrance to Trajan's canal.

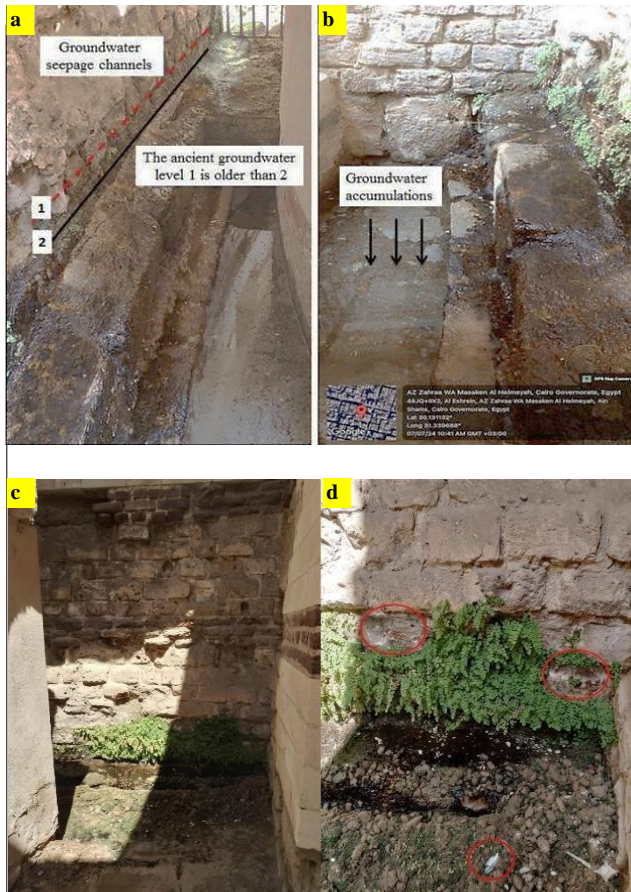
Fieldwork revealed that the Roman tower's surface was harmed by biological and water contamination, and groundwater had pooled there. Furthermore, salt crystallization was discovered in the lion-head's chamber. The damage to the Roman tower throughout time is depicted in the following pictures, fig. (4). The Roman tower's interior is cold, dark, and shielded from the powerful winds that define the surrounding area due to its walls, and small windows. The Roman tower is a perfect home for bats because of these elements.

Figure (4) **a**, groundwater seepage channels showing that the ancient groundwater level 1 is older than 2, **b**, groundwater accumulations formed in the Roman tower, **c**, Surface deterioration due to rising groundwater level, **d**, signs of damage due to groundwater (groundwater accumulations, dense vegetation formed on the wall, crystallization of salts, presence of pigeon feather remains), **e**, different aspects of damage in the chambers containing the lion's Head dock, **f**, effect of the groundwater level rising and the resulting crystallization of salts on the walls, **g**, the sparse plants that grew due to groundwater, **h**, the presence of pigeon feather remains, **i**, & **j**, bats and pigeon droppings (the red boxes) on the floor of some chambers of the Roman tower, **k**, bats droppings (the red boxes) on the wall of the Roman tower hydro-chemical characteristics of ground-water

Based on the previous results and the fieldwork, we can conclude that the internal environment of the Roman tower is a suitable habitat for bats, which explains the presence of an environment that encourages the growth of microorganisms that feed on the bloodstains left by bats on the walls of the Roman fortress. By following TDS ranged from 6133 mg/l in 1984 to 6251 mg/l in 2000, to 764 mg/l in 2024 with a significant decrease in the sample collected by the authors it can be concluded the possible reason for the decrease in salinity may be due to the water drainage system installed in the study area to reduce the groundwater level. It was also noted that the concentration of nitrate in ground and surface water is high 5.4 mg/l, and it can reach high levels due to seepage from cultivated land or contamination with waste of human or animal origin. The highest concentrations were observed in areas with human activities, compared to normal soil solutions, those near human settlements and sites are rich in nitrates and chlorides; microorganisms from organic wastes produce nitrates, and chlorides are provided by the consumption of sodium chloride. XRD results showed small amount of halite NaCl (4.4%) in stone samples and 0.4% in mortar samples This can be explained by the fact that the continuously increasing humidity, combined with the cold environment inside the Roman fortress, did not allow the salts to fully crystallize. SEM scanning images of limestone and mortar show signs of deterioration. Specifically, signs of damage associated with the dissolution of water-soluble components,

- 1) Develop robust restoration plans that account for historical and environmental changes.
- 2) Monitor and control urban sprawl and sewage leakage near the Babylon Roman Fortress.
- 3) Immediate and comprehensive conservation efforts should be achieved to preserve this valuable cultural heritage site it for future generations
