*Original article***COMPARATIVE MATERIAL AND DETERIORATION STUDY OF STUCCO DECORATIVE CONSOLES ON MOHAMED ALI PASHA-ERA FACADES IN EGYPT**Mahmoud, S.<sup>1</sup>, Abdelrahim, Sh.<sup>1(\*)</sup>, Khallaf, M.<sup>1</sup>, & Afifi, H.<sup>2</sup><sup>1</sup>Conservation dept., Faculty of Archaeology, Fayoum Univ., Fayoum, Egypt<sup>2</sup>Conservation dept., Faculty of Archaeology, Cairo Univ., Giza, Egypt\*E-mail address: [saa00@fayoum.edu.eg](mailto:saa00@fayoum.edu.eg)**Article info.****Article history:**

*This research paper focuses on studying the materials used in stucco consoles of historical building facades in the period of Muhammad Ali Pasha and their deterioration, specifically in the stucco consoles of Al-Shanawi palace in Mansoura and the building No. 17 in Mohamed Mahmoud St. in Cairo. Both structures are from the same period but differ in their surrounding environmental conditions, such as humidity levels, pollution exposure, and maintenance practices, which may contribute to the differences in their deterioration rates. Various examination and analysis techniques were employed to confirm the deterioration and changes between them. It was confirmed by the analytical a

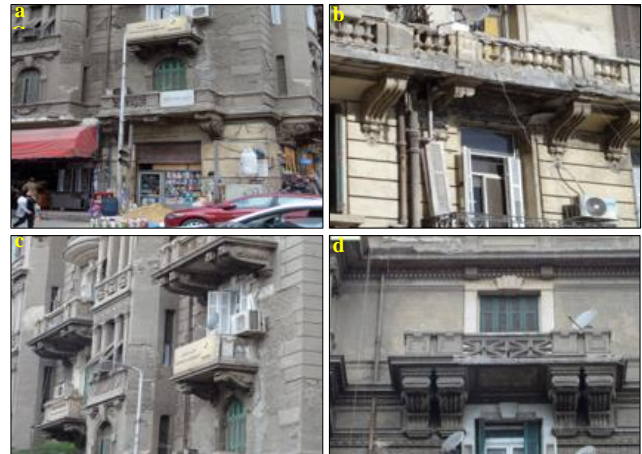
**Figure (3)** the various facades of the building 17 Mohamed Mahmoud St.; **a.** the shape of the stucco consoles and the black calcification layers on them resulting from the accumulation of aerosols from transport vehicles sample (S3), **b.** the loss of some parts of the stucco consoles under the balcony sample (S4), **c.** the different types of consoles in the same building, **d.** damage aspects in the form of blacking calcification on the stucco decorations.

Analytical and investigative research considering most documentation processes [16]. It offers a long-term framework for defining conservation, maintenance, treatment, and management methods [11]. Four samples were taken from the fallen and detached parts of the stucco decorations of consoles adorning the facades of two historic architectural buildings: Al-Shennawi palace in Al Mansoura, Dakahlia governorate, and a historic residential building at 17 Mohamed Mahmoud Street in Khedive Cairo. In order to ensure successful repair operations, the goal is to determine the mineral composition, surface texture, and deterioration products of the stucco samples. figs. (2 & 3).
