Original article

CHARACTERISTICS OF STUCCO EMPTIER IN  
AL-ZAHIR BAYBARS AL-BANDAQDARI MOSQUE, CAIRO, EGYPT

EJARS – Vol. 16 (1) – June 2026: 43-48

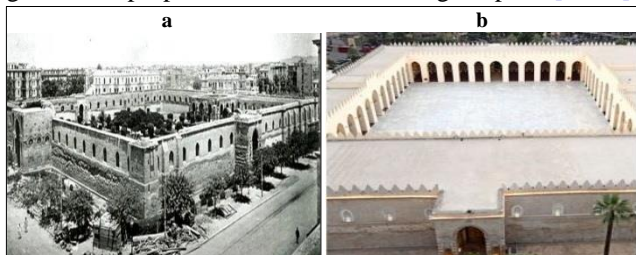
**Figure (1)** general view of the Al-Zahir Baybars Al-Bandaqdari mosque in Cairo; **a.** before restoration, **b.** after conservation processes

Baybars is one of them, located in the Al-Zahir neighborhood northwest of the northern Cairo wall. Figure (1) shows a general view of the Al-Zahir Baybars Al-Bandaqdari mosque in Cairo. It has two minarets, but it is distinguished by three huge entrances that stand out from the zenith of the mosque's wall with decorations inspired by the entrance to the Al-Aqmar mosque. King Al-Zahir Baybars started to build this mosque in the year 665 AH on the field where he played ball. He completed it in 667AH and made the rest of the square a park inside the mosque. The French have taken a fortress, as Al-Jabarti says, transforming its minaret into a tower and placing cannons. A 1250 m length of sides is about 106 m×103 m, and the height is 12.92 m [14]. In this study, we document, examine, and evaluate a few damaged window wall stucco samples that were gathered from the Al-Zahir Baybars mosque in Cairo, which dates back to the Mamluk era. Various analytical techniques were used to determine the chemical composition of the top surface layer, bulk core, and mortar samples. In addition, the surface and core morphologies have been investigated via stereo-optical, polarizing light, and scanning electron microscopes. Furthermore, the collected sample's density, porosity, and water

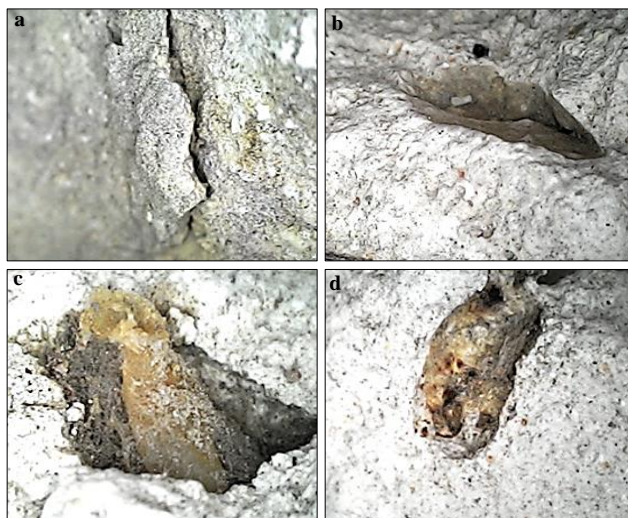
A portable USB digital microscope investigation showed multiple degradation phenomena on the investigated stucco, including mechanical, chemical, and biological damage: microscopic investigation revealed severe cracking and matrix degradation, fig. (4-a) as indicated by deep vertical fractures and microfractures at the crack edges. This damage was accompanied by disintegration and spalling, fig. (4-b), producing separate surface holes and detached stucco crusts due to physical weathering. Biological deterioration is represented as nests of wasps' remains in the stucco as a biological deterioration affected many open archaeological sites, as shown in figs. (4-c & d).

**Figure (4)** stereo light microscopy images, 40x; **a.** & **b.** macro and micro-cracks, **c.** & **d.** nests of wasps

The integrated analytical results offer comprehensive insight into the composition, microstructure, and deterioration mechanisms of the stucco emptier at Al-Zahir Baybars mosque. The biological deterioration of stucco by nests of wasps' remains was observed by the portable USB digital microscope [19]. In all samples gypsum (CaSO<sub>4</sub>. 2H<sub>2</sub>O) is the dominant mineral confirming its historical role as the primary binder, aligning with Mamluk architectural practices where gypsum was favored for its rapid setting and high plasticity in intricate carvings [6]. However, the detection of anhydrite (CaSO<sub>4</sub>), particularly in the mortar layer (ZB3), suggests a significant partial thermal transformation from dihydrated gypsum to the dehydrated phase. This phase transition is likely a technological marker of the original calcination process or a result of centuries of exposure to Cairo's hyper-arid environmental fluctuations and high-temperature cycles, which agreed with Afifi, et al. [20] and Abdelrahim, et al [23]. The presence of calcite (Ca CO<sub>3</sub>) further deepens the understanding of the material's change. While it could be viewed as a simple filler, the specific carbonate bonding observed in FT-IR, along with the absence of geogenic limestone textures in PLM suggests a more complex role for the calcite [24-28]. It was suggested that this calcite is primarily a carbonation product. This indicates a sophisticated "composite binder" technology where a

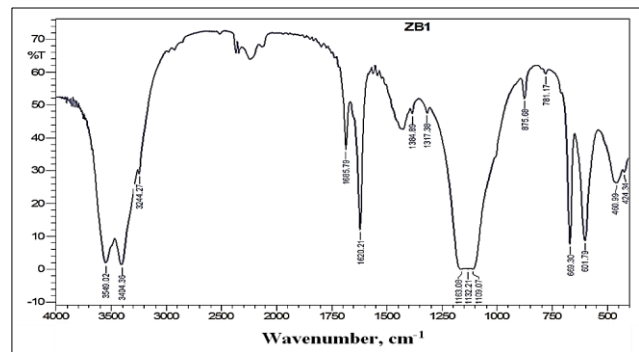
The broadness and specific positions of the carbonate absorption bands 1317-1384 cm<sup>-1</sup> and out-of-plane bending near 781 cm<sup>-1</sup>, fig. (8) suggest that the identified calcite is a secondary product formed through the carbonation of a lime-based binder, rather than the use of primary crushed limestone as a filler. Sulfate stretching bands between 1109-1163 cm<sup>-1</sup> and bending modes at 601-669 cm<sup>-1</sup> confirm the presence of gypsum. The FT-IR spectrum of sample ZB1 exhibits a broad OH stretching band between 3244-3594 cm<sup>-1</sup>, which is consistent with the structural water present in gypsum. While a sharp OH band near 3640 cm<sup>-1</sup> would be required to confirm residual Ca(OH)<sub>2</sub> and thus a burnt lime origin, the current spectrum more clearly supports the presence of gypsum alongside calcite phases. Furthermore, the FT-IR spectra were essential for screening the samples for any residual organic binders, such as linseed oil or animal glues, which are historically known to be added to stucco to improve plasticity.

The absence of characteristic C-H and C=O stretching bands in the organic regions (around 2850-2950 cm<sup>-1</sup> and 1700-1740 cm<sup>-1</sup>) confirms that these specific samples were formulated using a purely inorganic mineral system, providing a clear understanding of the original recipe and its long-term stability.

Figure (8) FTIR spectra of the collected (ZB1) stucco sample
