## STUDY OF THE PAINTED DOME OF THE CHURCH OF ARCHANGEL GABRIEL, CAIRO

This study was carried out in preparation for the conservation of the oil painted dome of Archangel Gabriel church located at Haret El Saqqayeen in Abdeen (Cairo). Stratigraphic, chemical and environmental studies were conducted to examine the painting technique and to assess the conservation state of the dome. The dome was imaged using Multi-spectral imaging and samples were collected from representative areas. Cross-sections were investigated by the means of scanning electron microscopy coupled with dispersive energy of X-ray spectrometer (SEM-EDS) and stereo microscopy. Fourier transformed infrared spectroscopy (FTIR) and gas chromatography-mass spectroscopy (GC/MS) was employed for the identification of the paint medium. X-ray diffraction (XRD) and the colorimetric measurements were conducted for characterization the differences of hues between the original and non-original pigments. As a part of the study, the environment within the dome was measured with data loggers and gas sampling. The results showed that the painted dome dates back to two different periods. The older paintings were applied before 1907

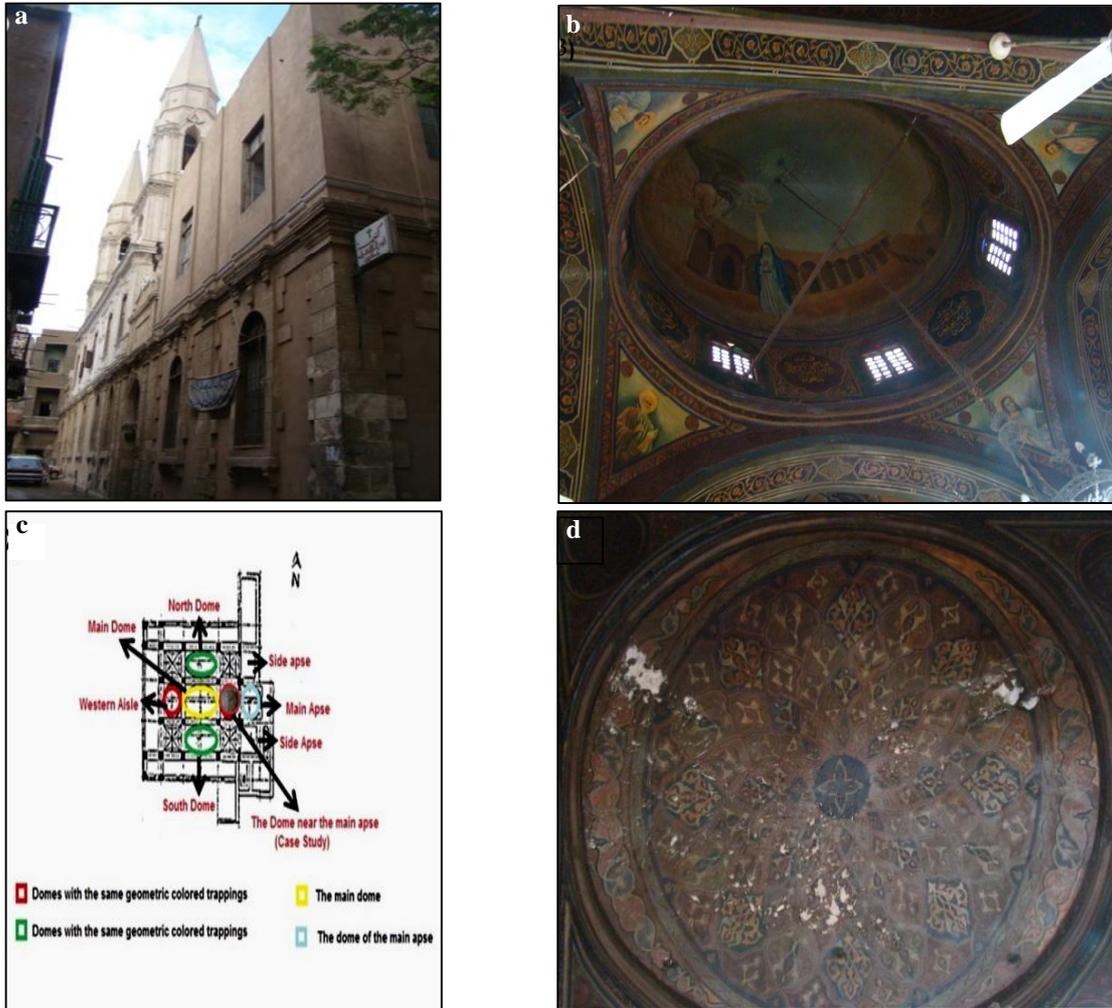
Figure (1) Shows **a.** out view of Archangel Gabriel church, Haret El Saqqayeen in Cairo, **b.** the central dome with the unusual depiction of the joyful annunciation in which the Archangel Gabriel joyfully heralds the Holy Virgin St. Mary by the Christ birth, **c.** & **d.** the selected painted dome

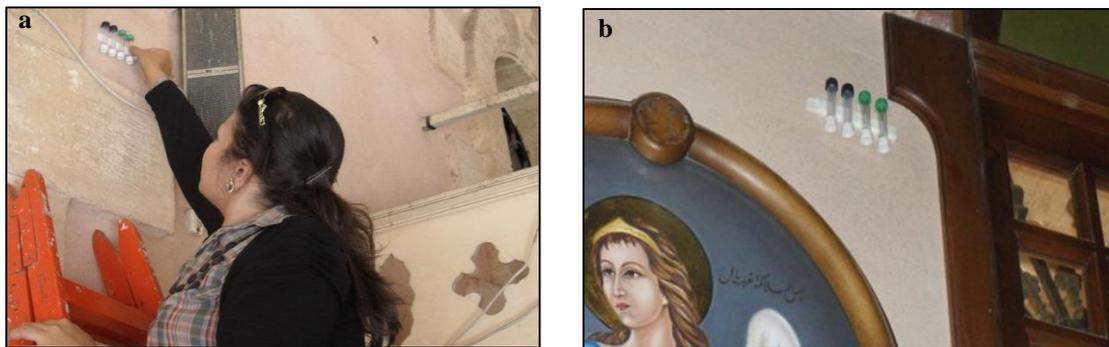
By comparison of the pollutant concentrations inside and outside the church, fig. (4) the results demonstrated that SO<sub>2</sub> concentrations inside the church were low (2.67ppb) compared to outdoor (12.27 ppb). Whereas the NO<sub>2</sub> concentrations were high in both outdoor (27.005 ppb) and indoor (21.75 ppb) environments demonstrating the existence of internal source inside the church may be candle burning [16]. The concentration of O<sub>3</sub> inside the church was 2.97 ppb. The results of gas pollutant concentrations showed that the concentrations of both NO<sub>2</sub> and O<sub>3</sub> are high. It is noted that a max.

Figure (4) Shows the locations of diffusion tubes **a.** outdoor the church (left), **b.** indoor the church (right)
